LIMITED OCCURRENCE INVESTIGATION REPORT – FINAL

Reference Number	CA18/2/3/10390						
Classification	Accident	Date	18 November 2023	Time	1230Z		
Type of Operation	Training (Part 141)						
Location							
Place of Departure	Brits Airfield (FABS), North West Province		Place of Intended Landing	Brits Airfield (FABS), North West Province			
Place of Occurrence	On an open field near Brits Airfield						
GPS Co-ordinates	Latitude	25°32'27.5" S	Longitude	027°46'36.13" E	Elevation	3 710 ft	
Aircraft Information							
Registration	ZS-GPD						
Make; Model; S/N	Grob-Burkhaart Flugzeugbau, Twin Astir glider (Serial Number: 3010)						
Damage to Aircraft	Substantial			Total Aircraft Hours	671.25		
Pilot-in-command							
Licence Type	Glider Pilot Licence (GPL)		Gender	Male		Age	66
Licence Valid	Yes	Total Hours	1 086.6		Total Hours on Type	380	
Total Hours Past 30 Days	47.0		Total Flying Hours on Type Past 90 Days	63.4			
People On-board	2+0	Injuries	0	Fatalities	0	Other (on ground)	0

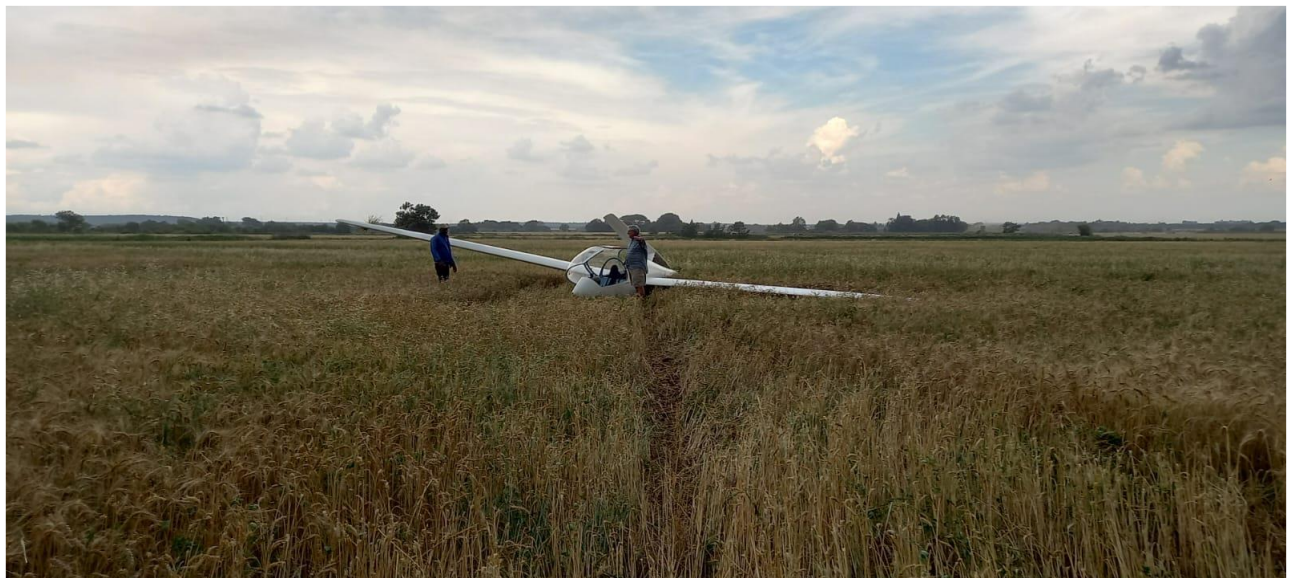
Figure 2: The aircraft as it came to rest after the accident. (Source: Pilot)

Probable Cause
The instructor pilot disconnected the glider from the tug aircraft at a height of 150 feet AGL due to the tug aircraft experiencing a downdraft; as a result, the instructor pilot conducted an unsuccessful forced landing on a field.
Contributing Factor
Insufficient thermals to sustain lift.
Safety Action(s)
None.
Safety Message
None.
About this Report
<i>The decision to conduct a limited investigation is based on factors including whether the cause is known and the evidence supporting the cause is clear, the level of safety benefit likely to be obtained from an investigation and that will determine the scope of an investigation. For this occurrence, a limited investigation has been conducted, and the Accident and Incident Investigations Division (AIID) has relied on the information submitted by the affected person/s and organisation/s to compile this limited report. The report has been compiled using information supplied in the initial notification, as well as from follow-up desk top enquiries to bring awareness of potential safety issues to the industry in respect of this occurrence, as well as possible safety action/s that the industry might want to consider in preventing a recurrence of a similar occurrence.</i>
