AIRCRAFT ACCIDENT REPORT AND EXECUTIVE SUMMARY

Reference:		CA18/2/3/10391	
Aircraft Registration	ZS-PSZ	Date of Accident	23 November 2023		Time of Accident	1439Z	
Type of Aircraft	Robinson R44 Raven II		Type of Operation		Private (Part 91)		
Pilot-in-command Licence Type	Private Pilot Licence (H)		Age	39	Licence Valid	Yes	
Pilot-in-command Flying Experience	Total Flying Hours		161.90	Total Hours on Type		108.50	
Last Point of Departure	Ultimate Heli in Midrand, Gauteng Province						
Next Point of Intended Landing	Ultimate Heli in Midrand, Gauteng Province						
Damage to Aircraft	Destroyed						
Location of the accident site with reference to easily defined geographical points (GPS readings if possible)							
Open field approximately 1.5 nautical miles (nm) south of Ultimate Heli at GPS co-ordinates determined to be 26°3'7.22" South 28°7'11.31" East, at 4 800 feet (ft) above mean sea level (AMSL)							
Meteorological Information	Surface Wind: 070°; Wind:10kt; Temperature: 31°C; Dew Point: 12°C; Visibility: 9999m

Probable Cause							
Undetermined engine stoppage followed by an unsuccessful autorotation which resulted in the helicopter descending uncontrollably and, consequentl

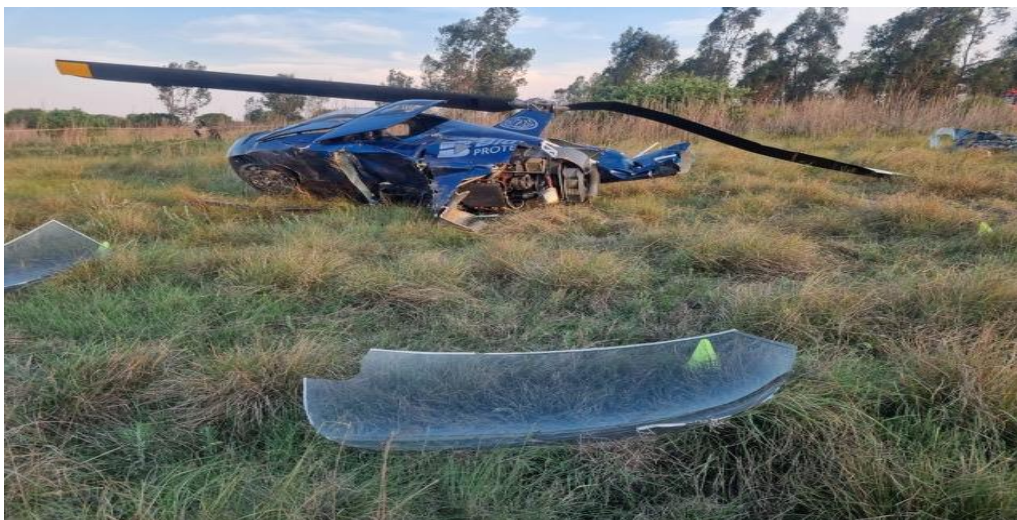
1.3.1. The helicopter was destroyed on impact.

Figure 2: The helicopter at the accident site. (Source: Operator)

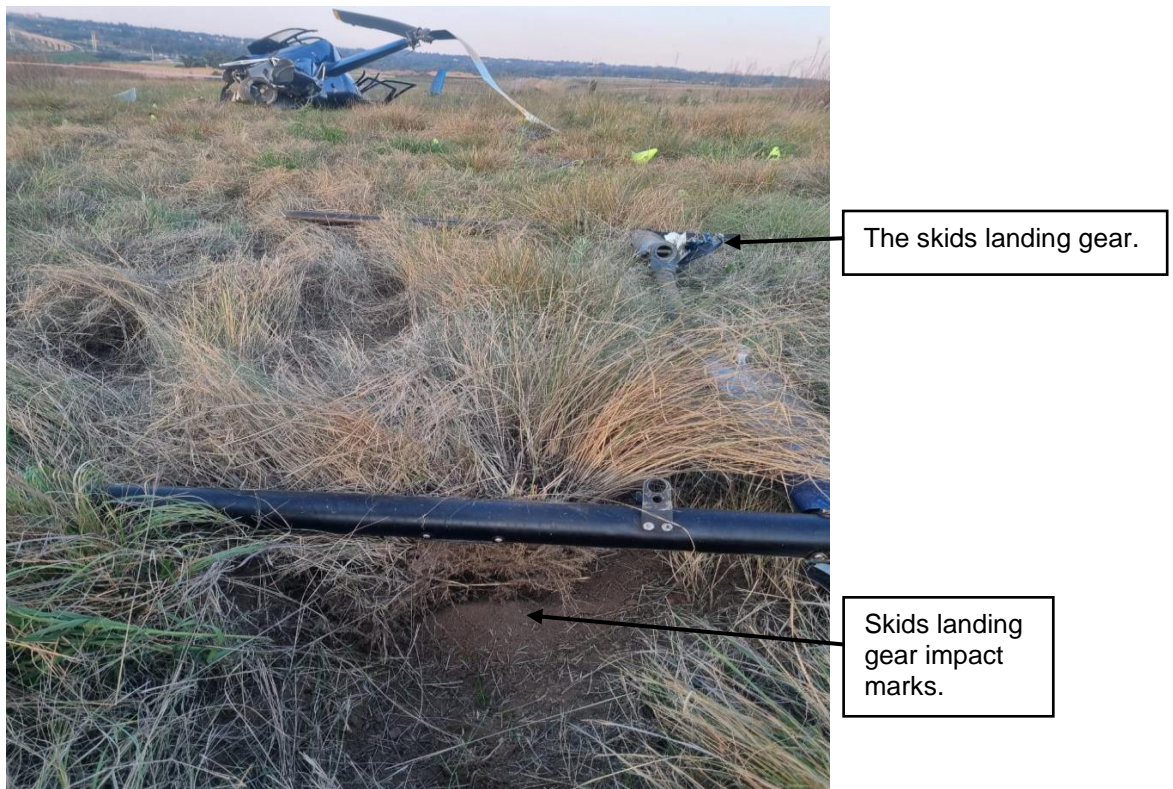
1.12.1. Examination of the wreckage revealed that all damage to the airframe and systems had resulted from impact with the ground. There was no evidence to suggest that the helicopter had not been structurally intact prior to the accident. The helicopter impacted the ground hard with the skids landing gear which broke off. The helicopter's fuselage bounced after impact and came to rest approximately 10 metres (m) from the initial point of impact. The helicopter

battery separated from the battery box. The vertical stabiliser, tail rotor guard and tail skid were damaged and disrupted.

Figure 5: The wreckage and the broken skids landing gear.

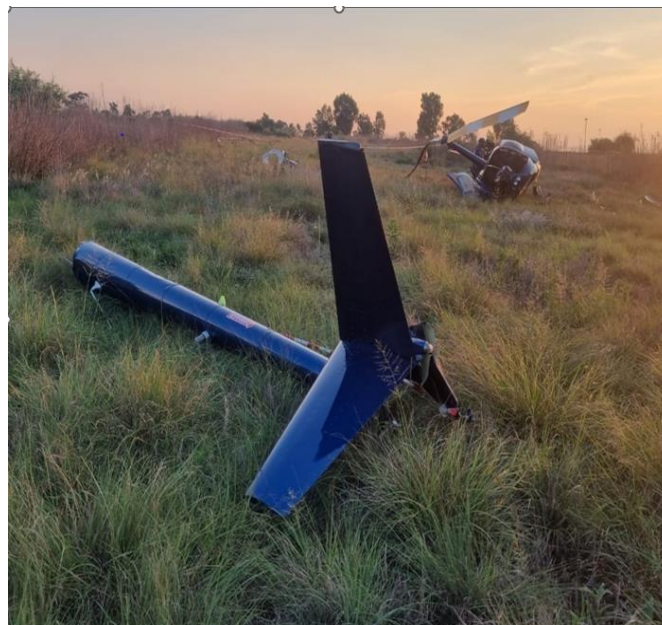
Figure 6: The main wreckage and the severed tail boom.

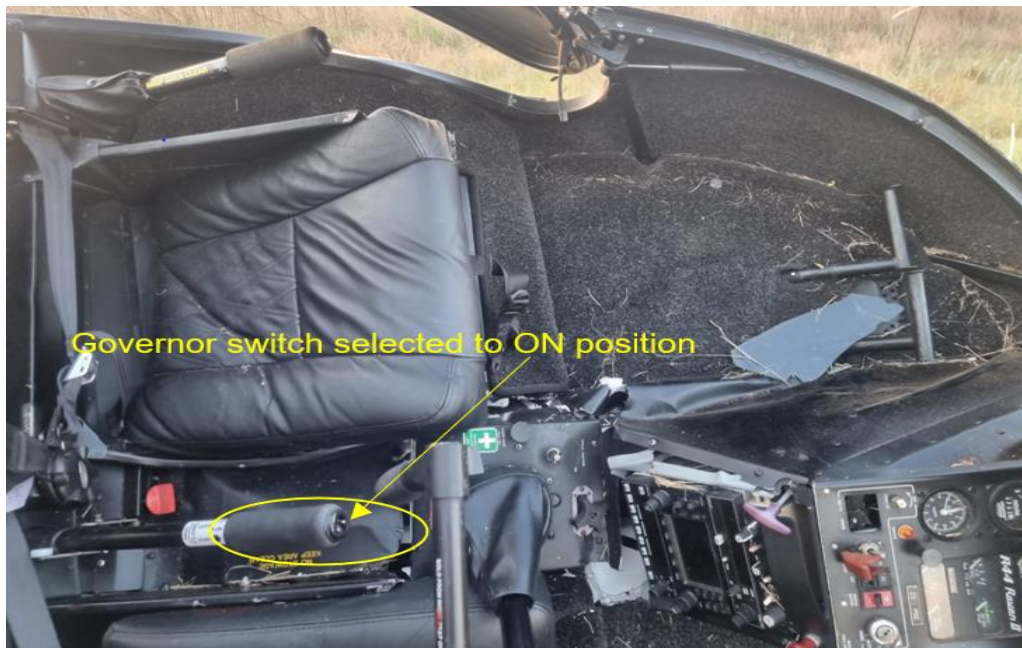
1.12.4 The right-side throttle/twistgrip was in a position close to idle. The pilot and co-pilot throttles/twist grips both moved in unison when the pilot's (right side) throttle was activated. The collective pitch lever was found in the UP position and the governor switch was selected to the ON position, consistent with a normal flight.

Figure 7: The pilot's collective pitch control stick in the UP position and the governor switch in the ON position.

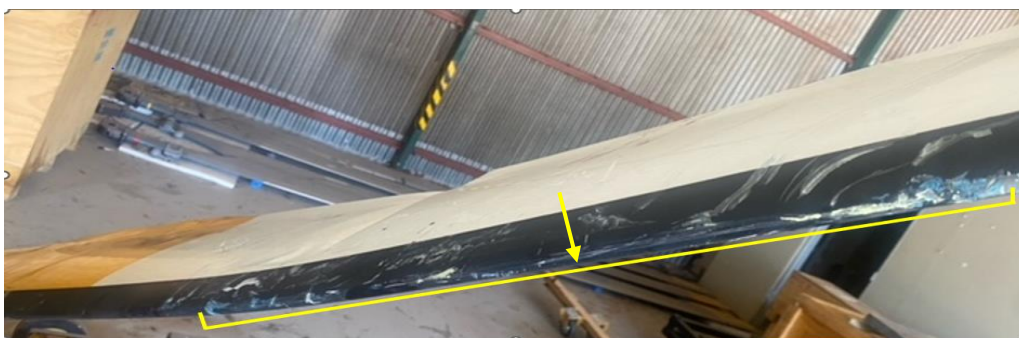
1.12.9 Drive train to the main and tail rotors could not be established. The main gearbox housing was intact and attached to the bottom of the main rotor mast and the centre frame. The main gearbox rotated freely and exhibited continuity from input to the main rotor drive shaft, and the free-wheeling sprag clutch operated as expected. One of the pitch links broke at the adjusting course area; it displayed signatures consistent with compression loads emanating from impact. The main rotor blades showed little to no damage along their respective spans towards the blade tips, which was consistent with low rotor revolutions per minute (RPM) at the time of impact. The main rotor blade with serial number 7282 had dents and scratches on the leading-edge inboard area (white painted portion), which indicated impact damage with the tail boom structure.

Figure 8: The main rotor blade leading edge area showing the impact print.

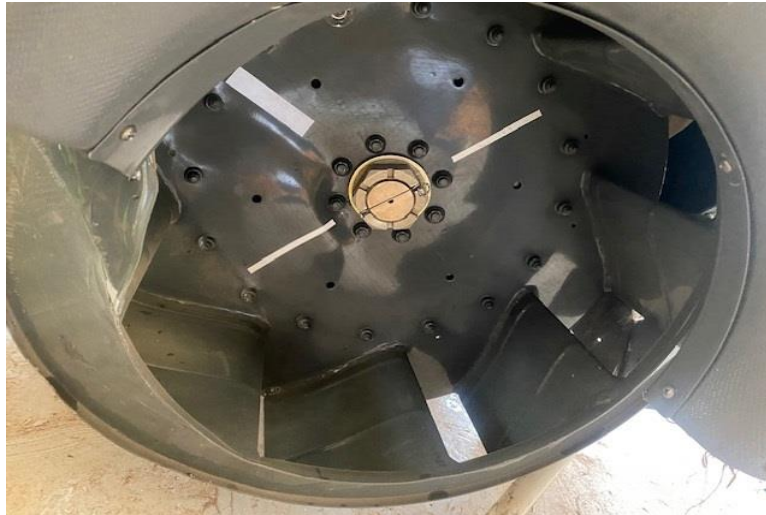
1.12.10 The white markings inside the engine cooling fan were aligned, and there was no slippage to the cooling fan retention nut alignment mark which indicated that the engine was producing little to no power at the time of impact.

Figure 9: The engine cooling fan.

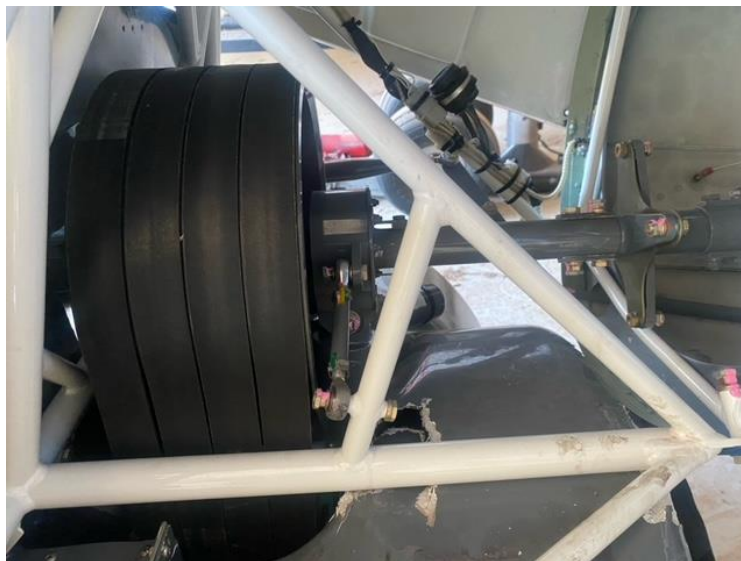
1.12.11 The V-belts on the engine output shaft were in place and intact. The long tail rotor drive shaft was severed; however, the tail rotor gearbox shaft was intact and it rotated freely. The tail rotor gearbox housing was also intact. The inspection sight gauge (glass) indicated a sufficient lubrication oil level.

Figure 10: The V-Belts on the engine output shaft.

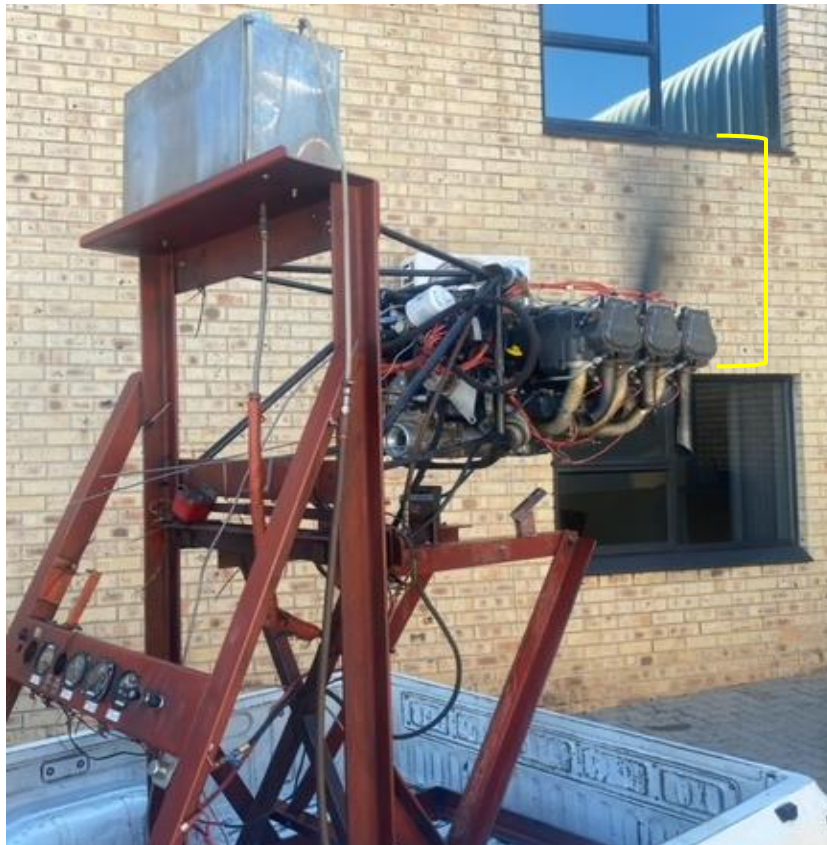
1.16.7 The FCU was later removed from the test rig and refitted to the engine. The engine output shaft was removed from the engine to allow the fitment of a three-blade propeller. The engine was later secured to a test cell for examination. The ignition key was turned on and the engine started without difficulty. The engine was warmed up before power was increased in stages. No adjustments or troubleshooting/s were performed during the engine test run. The engine met all the parameters IAW the engine maintenance manual (EMM). A hot engine start was also performed, and no irregularities were found. The magneto check was conducted during the tests and the engine RPM remained the same. No evidence of pre-existing defects was noticed that would have prevented the engine from operating normally.

Figure 11: The engine during a test run.
