AIRCRAFT ACCIDENT REPORT AND EXECUTIVE SUMMARY

Reference:		CA18/2/3/10392	
Aircraft Registration	ZS-CZR	Date of Accident	23 November 2023		Time of Accident	1430Z	
Type of Aircraft	Piper, PA 28-180			Type of Operation	Training (Part 141)		
Pilot-in-command Licence Type	Commercial Pilot Licence (CPL)		Age	26	Licence Valid	Yes	
Pilot-in-command Flying Experience	Total Flying Hours			1763.5	Hours on Type	229.3	
Last Point of Departure	Vereeniging Airport (FAVV), Gauteng Province						
Next Point of Intended Landing	Vereeniging Airport (FAVV), Gauteng Province						
Damage to Aircraft	Substantial						
Location of the accident site with reference to easily defined geographical points (GPS readings if possible)

Reference Number : CA18/2/3/10392
Occurrence Category : Accident (Category 1)
Type of Operation : Training (Part 141)
Name of Operator : Uitas Flying School
Aircraft Registration : ZS-CZR
Aircraft Make and Model : Piper, PA-28-180
Nationality : Egyptian
Place : Near Vereeniging, Gauteng Province
Date and Time : 23 November 2023 at 1430Z
Injuries : None
Damage : Substantial

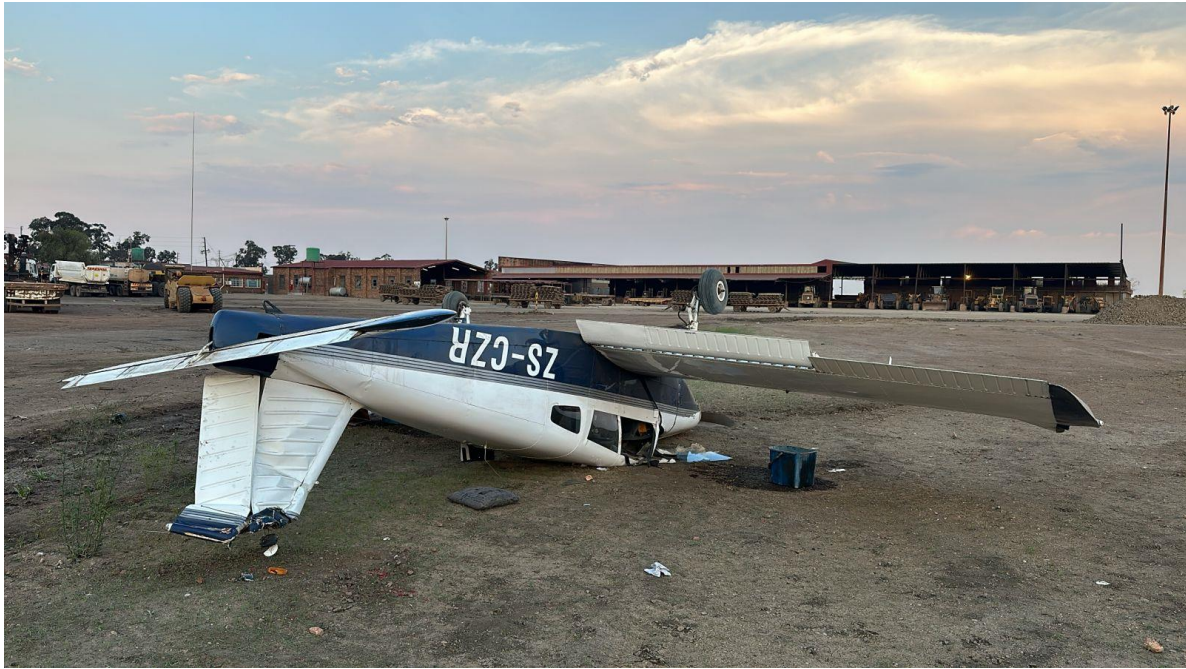
1.3.1. The aircraft sustained substantial damage to the nose wheel assembly, vertical stabiliser, propeller blades, both wings, cabin area and both fuel tanks.

Figure 2: The aircraft as it came to rest. (Source: Pilot)

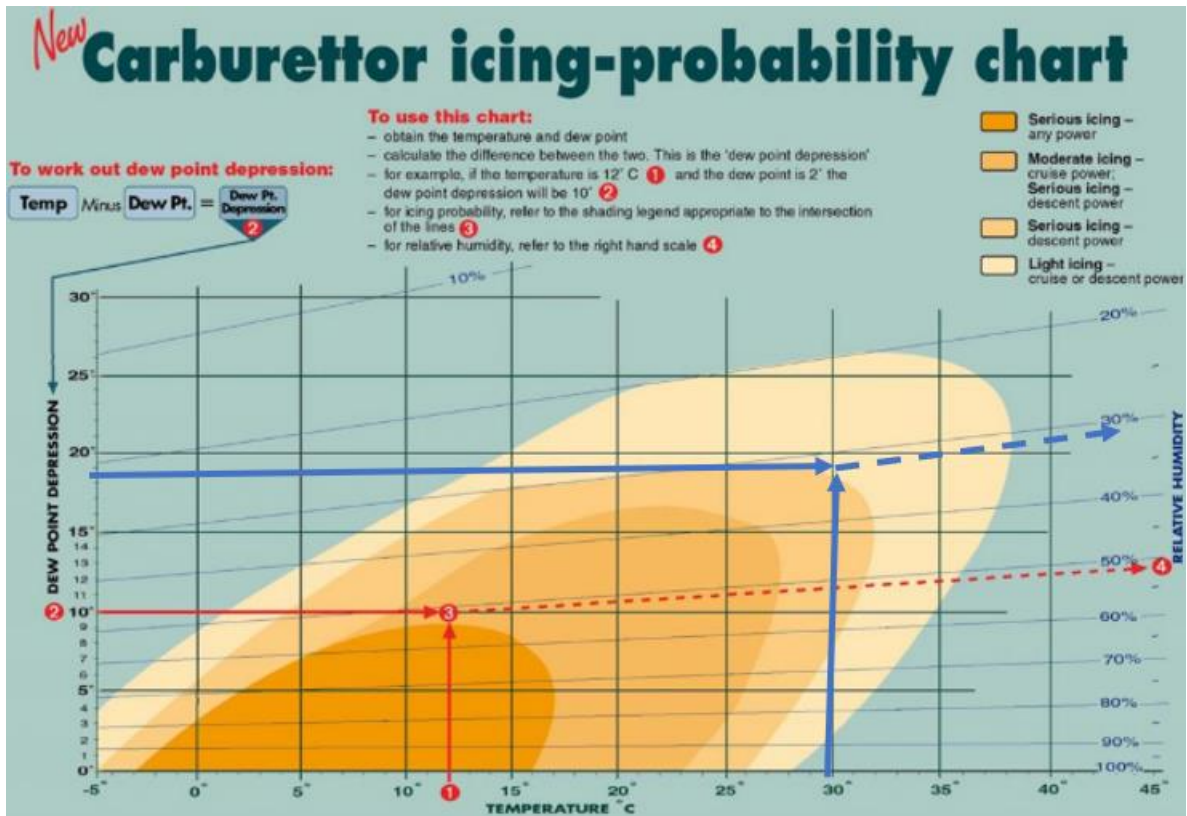
Figure 3: The carburettor icing probability chart.

1.7.3 The carburettor icing chart above indicates the dew point depreciation of 18°C at a temperature of 30°C which resulted in a relative humidity of 30% and a serious icing probability at descent engine power setting.

2.2.4 The investigation determined that there was a probability of serious carburettor icing during descent and the pilots only reported reduced engine power followed by complete loss of engine power.

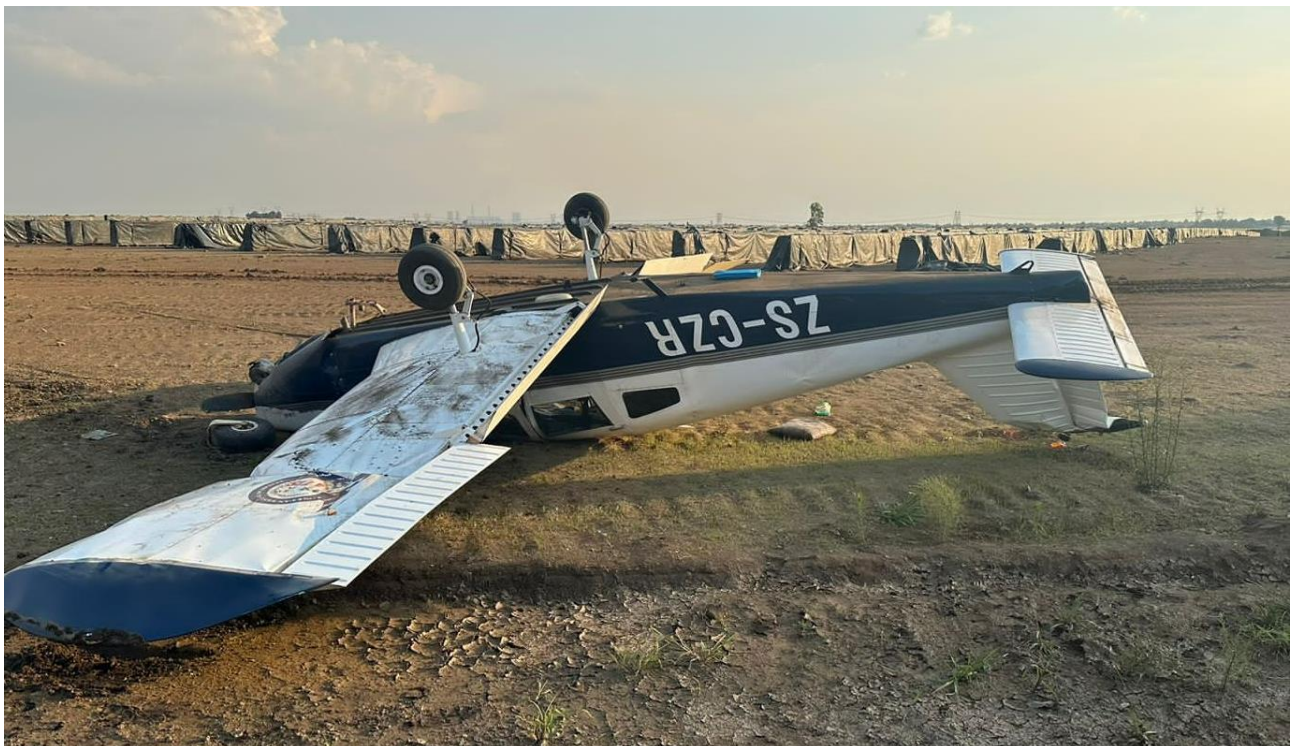
1.12.1 The wreckage was located within the parameters of a brick factory which was located approximately 1.38 nautical miles from the threshold of Runway 03. The aircraft was found in an inverted position. The nose gear had detached during the accident sequence.

Figure 4: The aircraft in an inverted position post-accident.

1.12.2 Both wings sustained damage during the impact sequence.

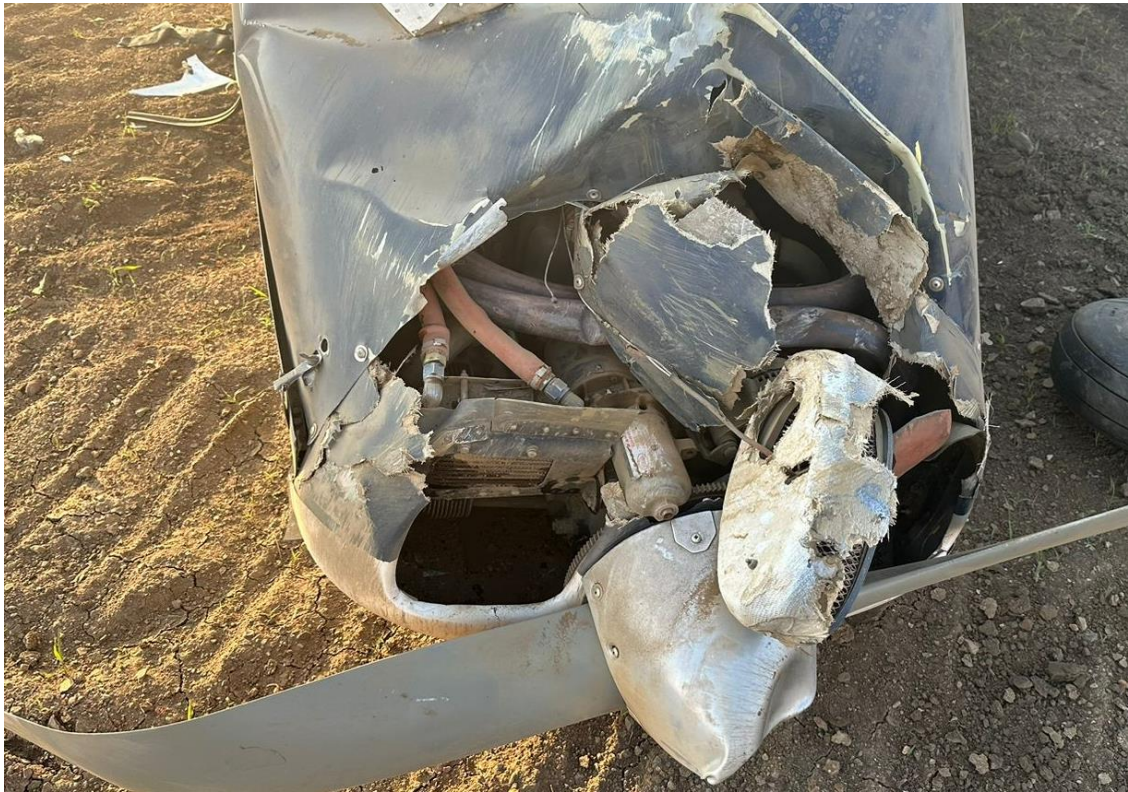
1.12.3 One of the propeller blades was found bent whilst the other blade was intact. The front section of the nose cone was damaged from the underside, an indication of impact with the ground.

Figure 5: Damage to the nose cone.

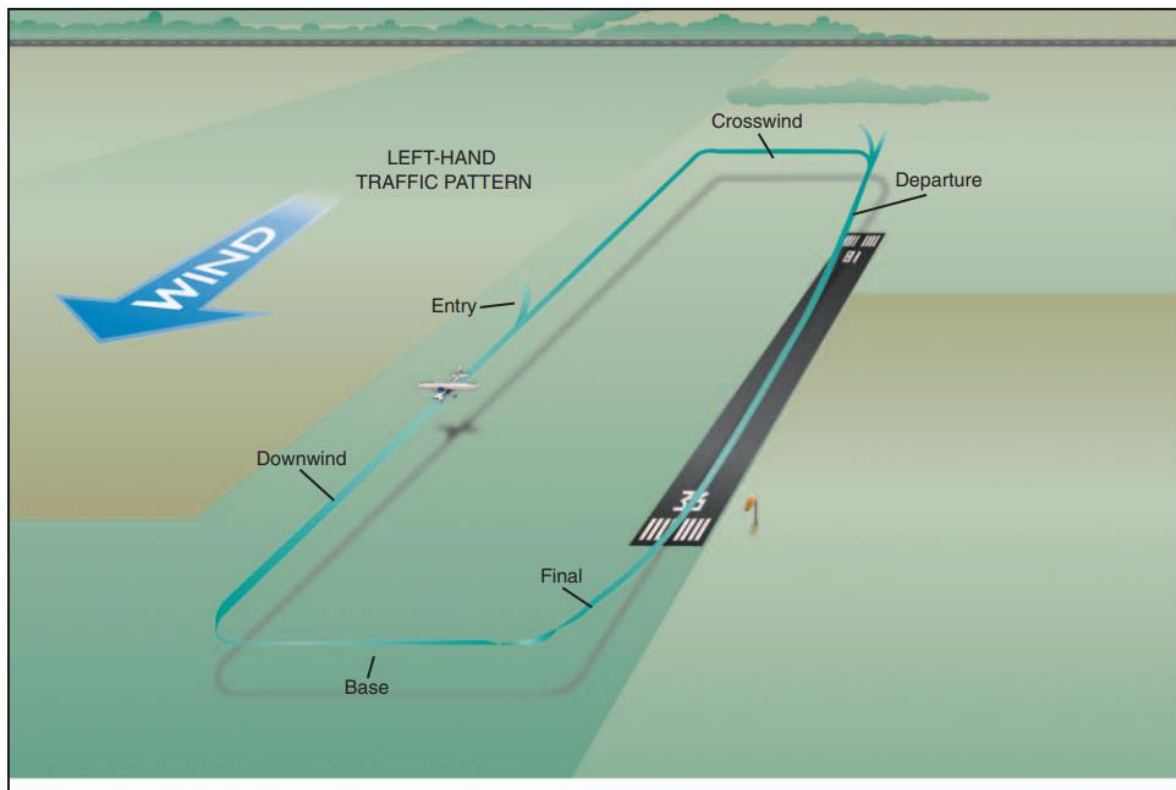
Figure 6: Standard pattern of a circuit.

- If the pilot extends the downwind leg while the carburettor heat is off, icing can start to set due to low power setting.
- The flight instructor and the pilot were focused on the exercises and, thus, did not notice the signs preceding the carburettor icing/engine failure.
- If the crew had flown a normal circuit, the aircraft would have reached the runway as they had stated that the aircraft was approximately 600ft AGL.
(aircraft height 5400 feet – elevation 4855 = 545 AGL which is approximately 600ft).
- The teardown inspection was performed without the investigator present to witness the procedure. The AMO indicated that the engine did not sustain any mechanical damage.
- There was enough fuel on-board the aircraft to complete all the planned circuit (take-off and landing) exercises.
