AIRCRAFT ACCIDENT REPORT AND EXECUTIVE SUMMARY

Reference:		CA18/2/3/10393	
Aircraft Registration	ZU-XCO	Date of Accident	26 November 2023		Time of Accident	0545Z	
Type of Aircraft	Bat Hawk			Type of Operation	Private (Part 94)		
Pilot-in-command Licence Type	Private Pilot Licence (PPL)		Age	57	Licence Valid	Yes	
Pilot-in-command Flying Experience	Total Flying Hours		106.9		Hours on Type	100.7	
Last Point of Departure	Aviator's Paradise Airfield (FAAP), North West Province						
Next Point of Intended Landing	Grasslands Airfield, Centurion, Gauteng Province						
Damage to Aircraft	Destroyed						
Location of the accident site with reference to easily defined geographical points (GPS readings if possible)							
Grasslands Airfield at GPS position: 25° 49' 38.0" South 028°05' 43" East; elevation at 4 530 feet							
Meteorological Information	Surface wind: 020°/ 8 kt; temperature: 25°C; dew point: 16°C; CAVOK						
Number of People On-board	1 + 1	Number of People Injured	0	Number of People Killed	2	Other (On Ground)	0

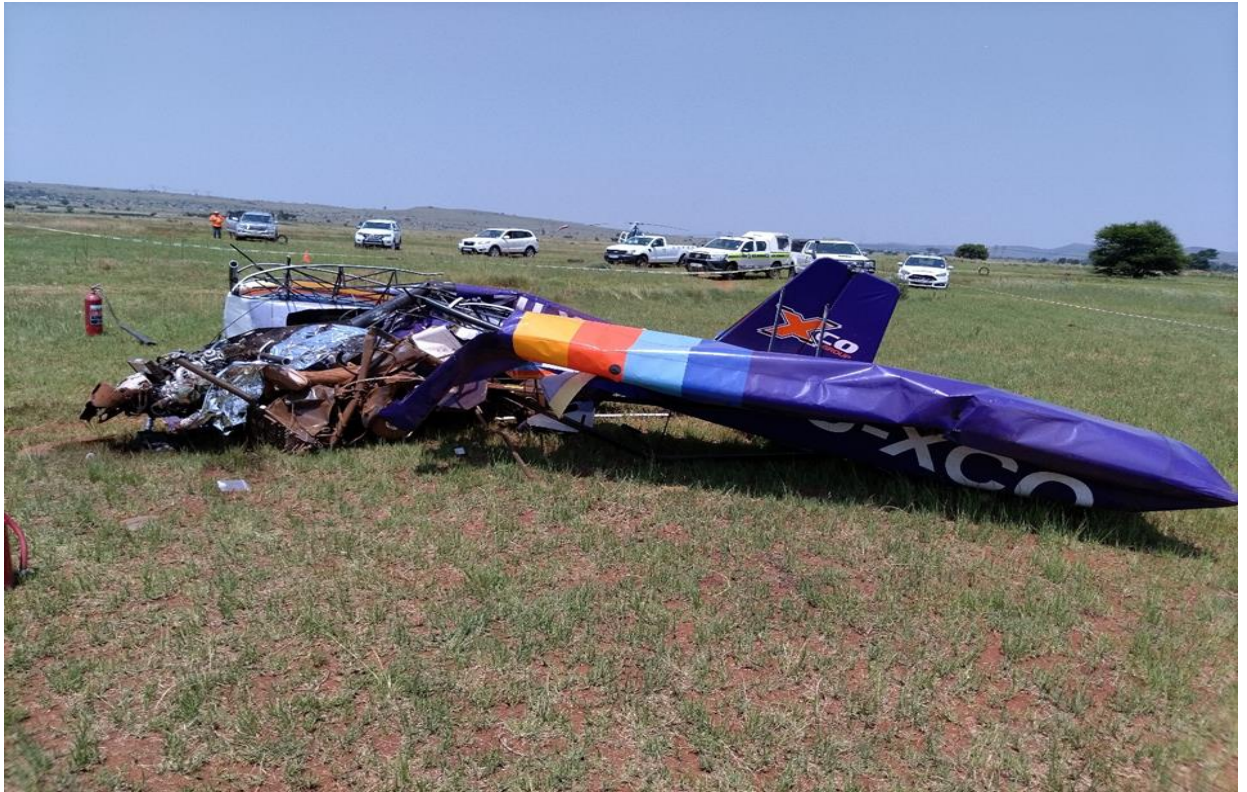
1.3.1. The aircraft was destroyed during the accident.

Figure 2: The aircraft's resting position post-accident.

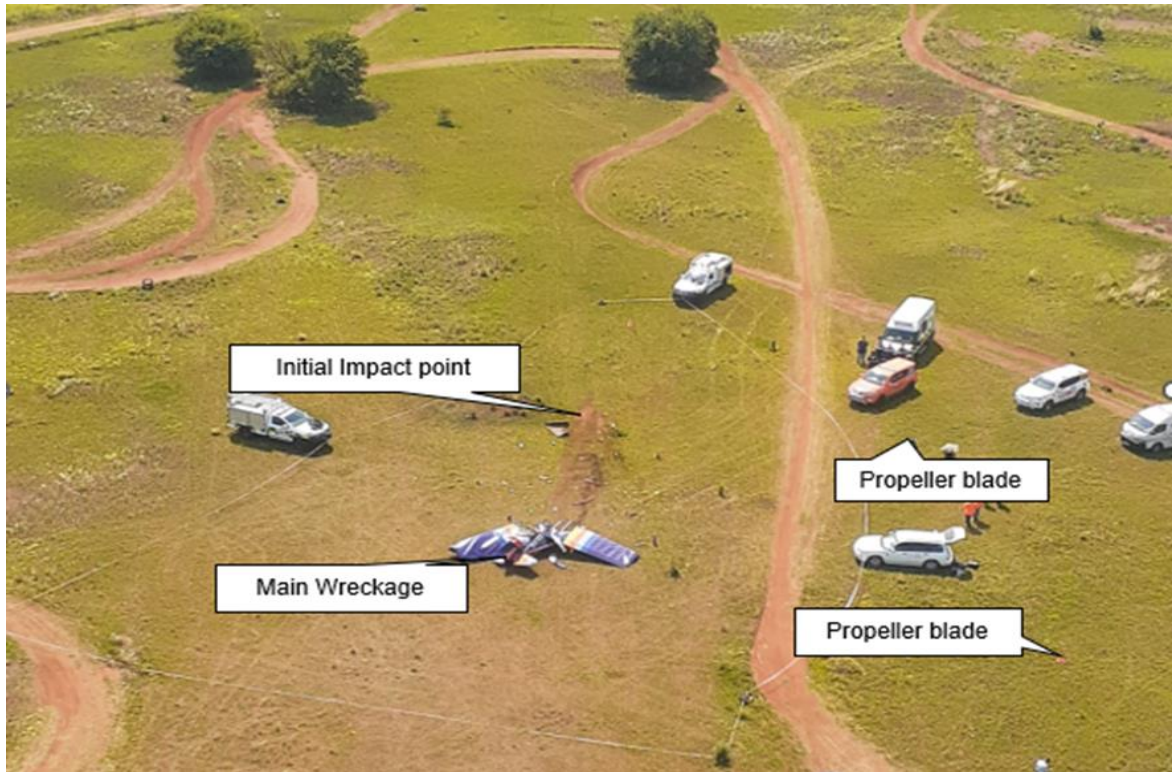
1.12.1. The accident occurred on an open area in Grasslands Airfield, approximately 500 metres (m) from the runway. The wreckage was localised within a radius of approximately 20m.

Figure 5: The accident site. (Source: SAPS Air-Wing)

1.12.2. The wreckage was found 10m from the point of impact. After impact, the aircraft skidded in the opposite direction of approach, scrapping the ground in its path. The nose section and the windshield fragments were found near the impact point. The structural integrity of the cockpit area was compromised.

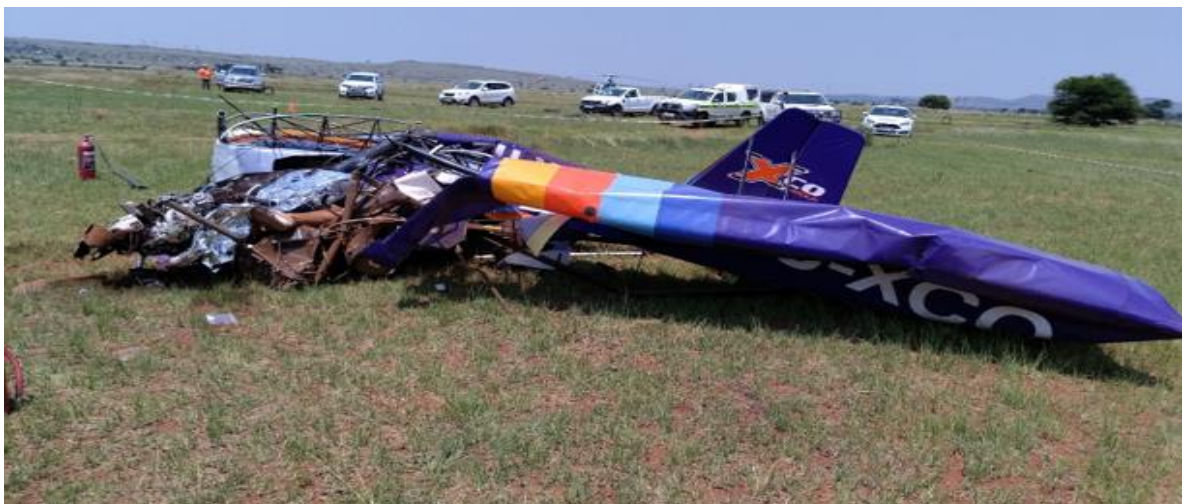
Figure 6: Damage to the left-wing tip.

1.12.3. The aircraft's left-wing tip portion of the leading edge towards the inner part was bent, indicative of impact forces mostly on the left side. The left side of the nose section and the cockpit sustained extensive damage. The right wing was still intact with not much visible damage.

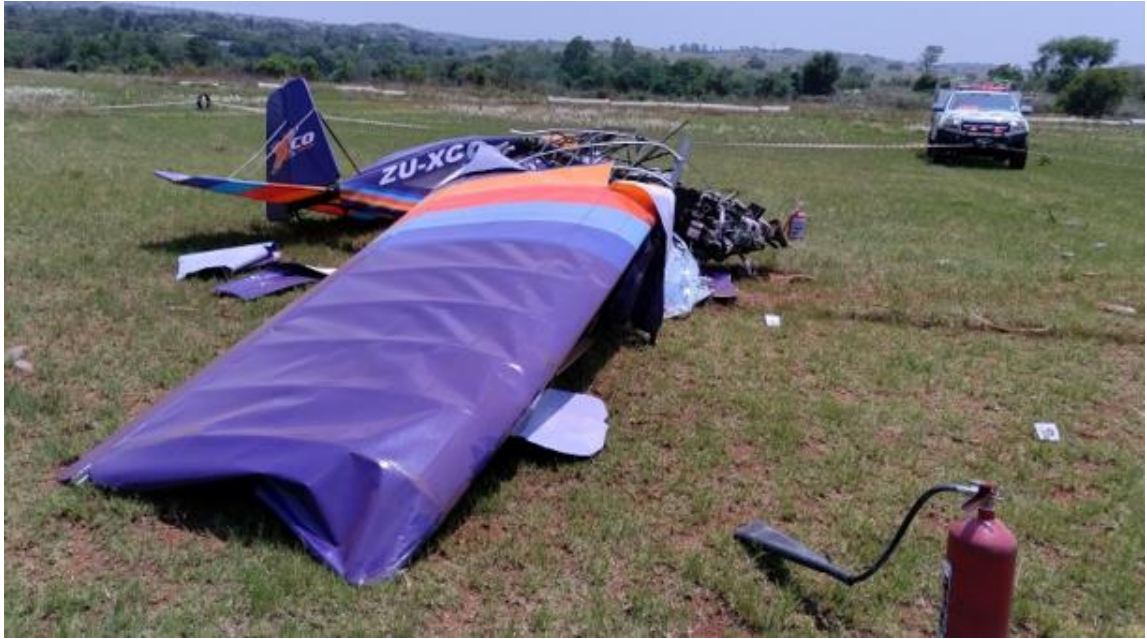
Figure 7: The right wing was found intact.
