LIMITED OCCURRENCE INVESTIGATION REPORT – FINAL

Reference Number	CA18/2/3/10394						
Classification	Accident	Date	15 November 2023		Time	0540Z	
Type of Operation	Private (Part 94)						
Location							
Place of Departure	Grantham Private Airfield, Western Cape Province		Place of Intended Landing		Grantham Private Airfield, Western Cape Province		
Place of Occurrence	Rietvlei in the Karoo National Park, Western Cape Province						
GPS Co-ordinates	Latitude	32°36'34" S	Longitude	022°54'12" E	Elevation	2 708 ft	
Aircraft Information							
Registration	ZU-FMV						
Make; Model; S/N	Bantam; B22J (Serial Number: 11-0349)						
Damage to Aircraft	Substantial			Total Aircraft Hours	Unknown		
Pilot-in-command							
Licence Type	Private Pilot Licence (PPL)		Gender	Male		Age	51
Licence Valid	Yes	Total Hours	435.2		Total Hours on Type	308.6	
Total Hours 30 Days	7.0		Total Flying on Type Past 90 Days			8.2	
People On-board	1+1	Injuries	0	Fatalities	0	Other (on ground)	0

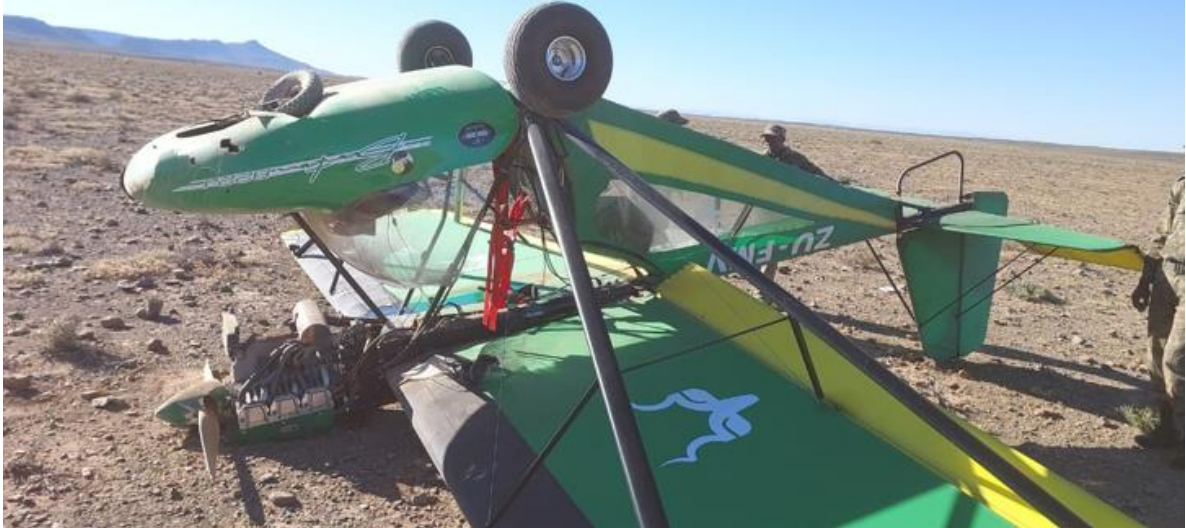
50 knots (kt). During the landing roll, the nose gear broke off, which resulted in the aircraft nosing over; it rested in an inverted position. Both occupants were not injured.

Figure 2: Aircraft after the accident. (Source: Pilot)

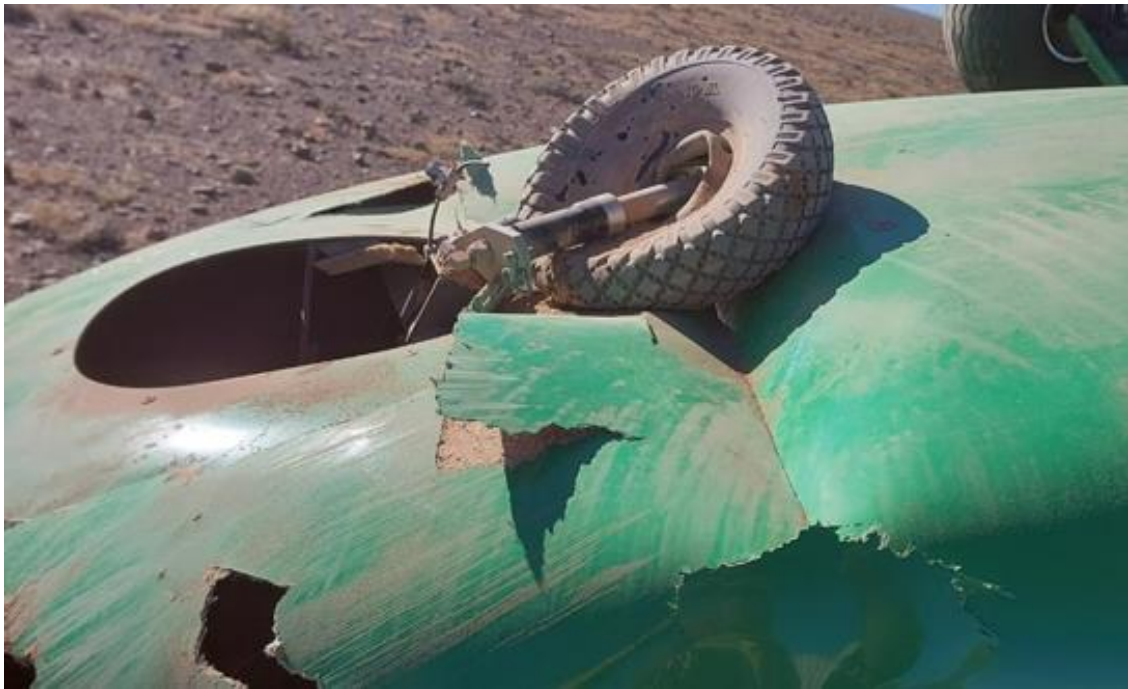
Figure 3: Damage sustained to the nose gear. (Source: Pilot)

6. During landing on a rocky open field, the nose gear broke off which caused the aircraft to nose over.
7. The aircraft landed in an area that was not intended for take-off or landing of aircraft, thus, contravening the CAR Part 91.07.25 (1)(n)(i) read together with Part 91.02.7 (1)(n)(i).

Probable Cause(s)
During landing in an area that was not authorised for take-offs and landings, the nose gear broke off which cause the aircraft to nose over.
Contributing Factor(s)
<ul style="list-style-type: none"> • Failure to adhere to the regulatory and manufacturer's prescripts.
Safety Action(s)
None.
Safety Message
In the interest of safety, pilots are urged to always adhere to the regulatory and manufacturer prescripts.
About this Report
<p><i>The decision to conduct a limited investigation is based on factors including whether the cause is known and the evidence supporting the cause is clear, the level of safety benefit likely to be obtained from an investigation and that will determine the scope of an investigation. For this occurrence, a limited investigation has been conducted, and the Accident and Incident Investigations Division (AIID) has relied on the information submitted by the affected person/s and organisation/s to compile this limited report. The report has been compiled using information supplied in the initial notification, as well as from follow-up desk top enquiries to bring awareness of potential safety issues to the industry in respect of this occurrence, as well as possible safety action/s that the industry might want to consider in preventing a recurrence of a similar occurrence.</i></p> <p><i>All times given in this report are Co-ordinated Universal Time (UTC) and will be denoted by (Z). South African Standard Time is UTC plus 2 hours.</i></p>

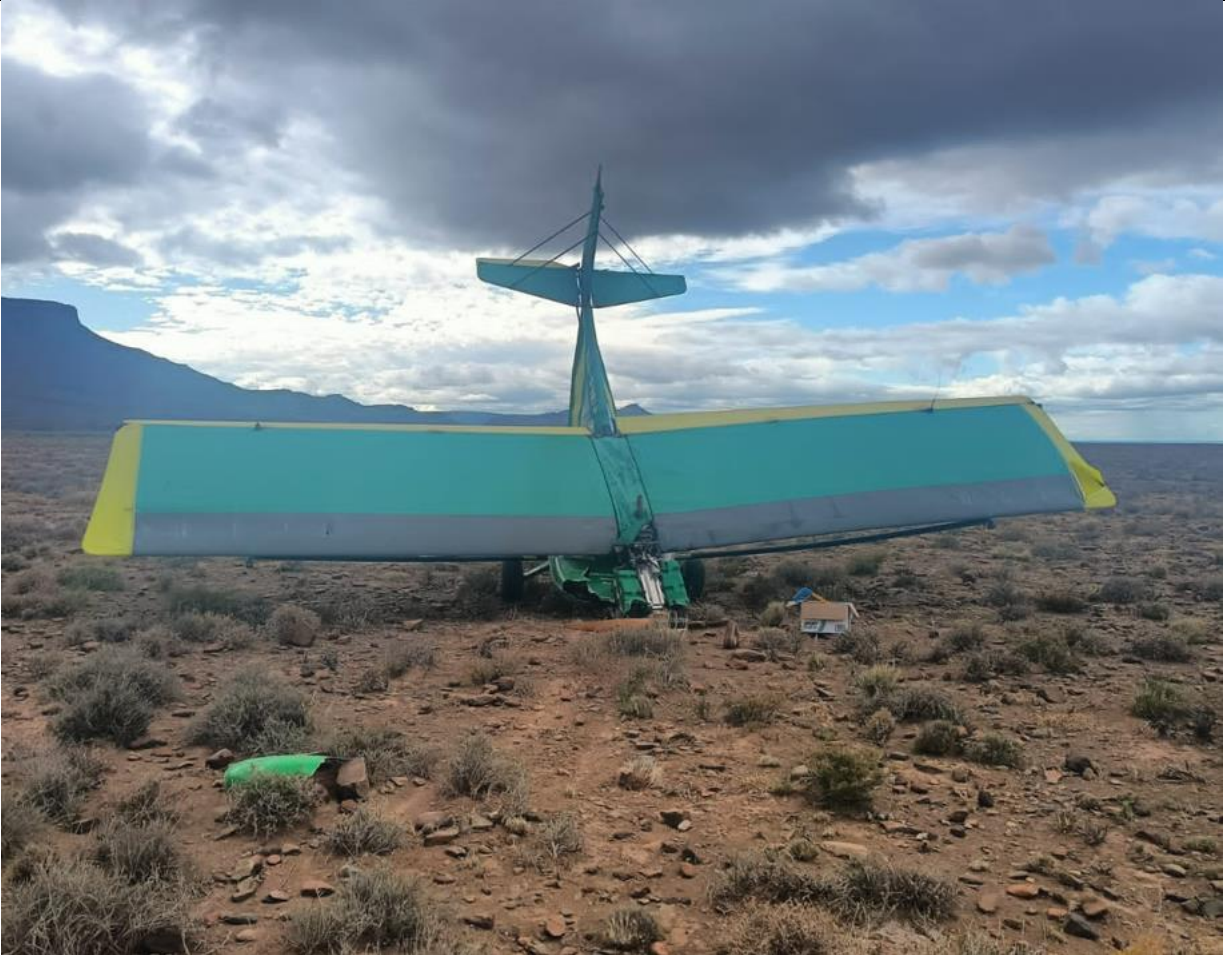
Figure 4: The microlight after it was positioned upright after the accident. (Source: Operator)
