LIMITED OCCURRENCE INVESTIGATION REPORT – FINAL

Reference Number	CA18/2/3/10395					
Classification	Accident	Date	27 November 2023	Time	1528Z	
Type of Operation	Training (Part 141)					
Location						
Place of Departure	New Tempe Aerodrome (FATP), Free State Province		Place of Intended Landing	New Tempe Aerodrome (FATP), Free State Province		
Place of Occurrence	Open field near Krugersdrift Dam, approximately 10 nautical miles (nm) north-west of FATP					
GPS Co-ordinates	Latitude	28° 49' 25" S	Longitude	025° 57' 07.4" E	Elevation	4247 ft
Aircraft Information						
Registration	ZU-IIL					
Make; Model; S/N	The Airplane Factory, Sling 2 (Serial Number: 212)					
Damage to Aircraft	Substantial		Total Aircraft Hours	2675.9		
Pilot-in-command						
Licence Type	Student Pilot Licence (SPL)		Gender	Male	Age	40
Licence Valid	Yes	Total Hours	34.9	Total Hours on Type	34.9	
Total Hours 30 Days	9.9		Total Flying on Type Past 90 Days		19.7	
People On-board	1+0	Injuries	0	Fatalities	0	Other (on ground) 0

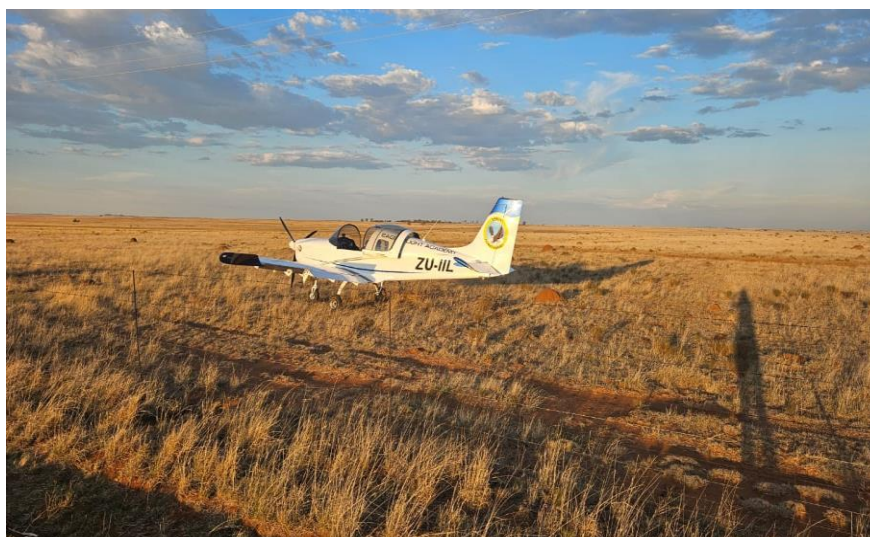
Figure 1: The aircraft at the accident site. (Source: Pilot)

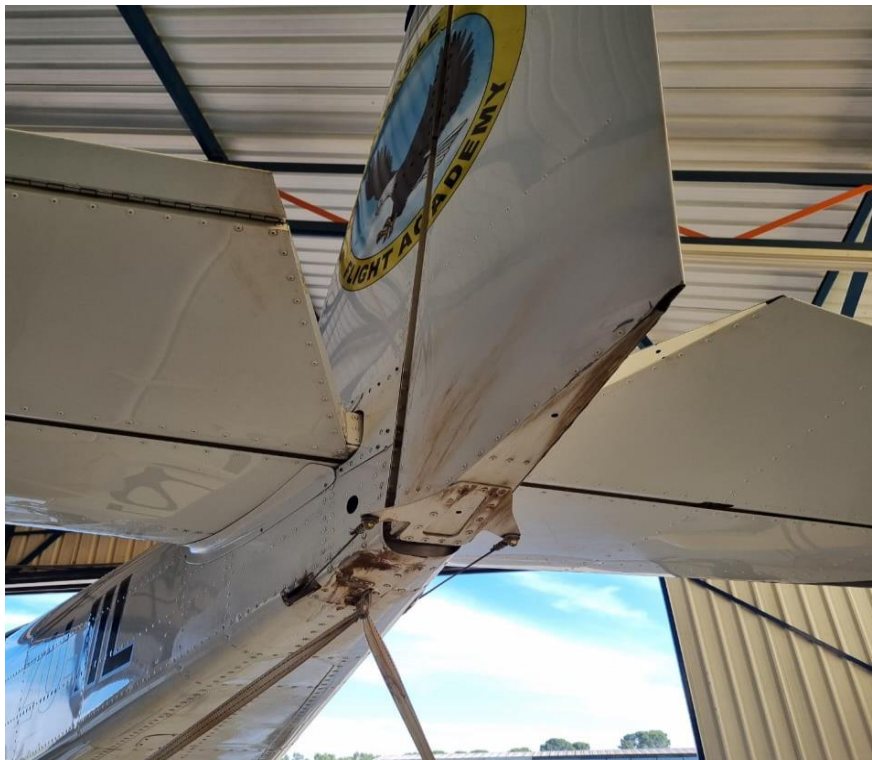
Figure 3: Scrape marks on the under skin of the tail section. (Source: Pilot)

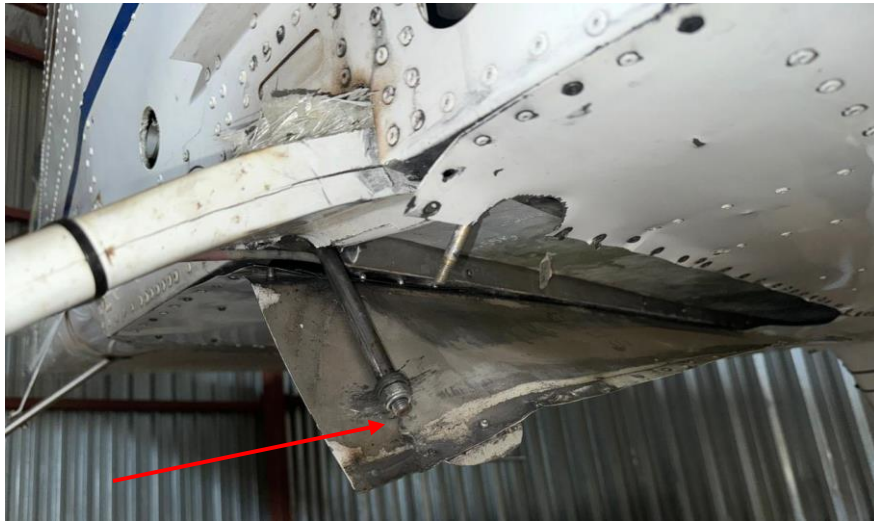
Figure 4: The landing gear attachment bolt that dislodged from the landing gear assembly and the damaged landing gear strut. (Source: Operator)

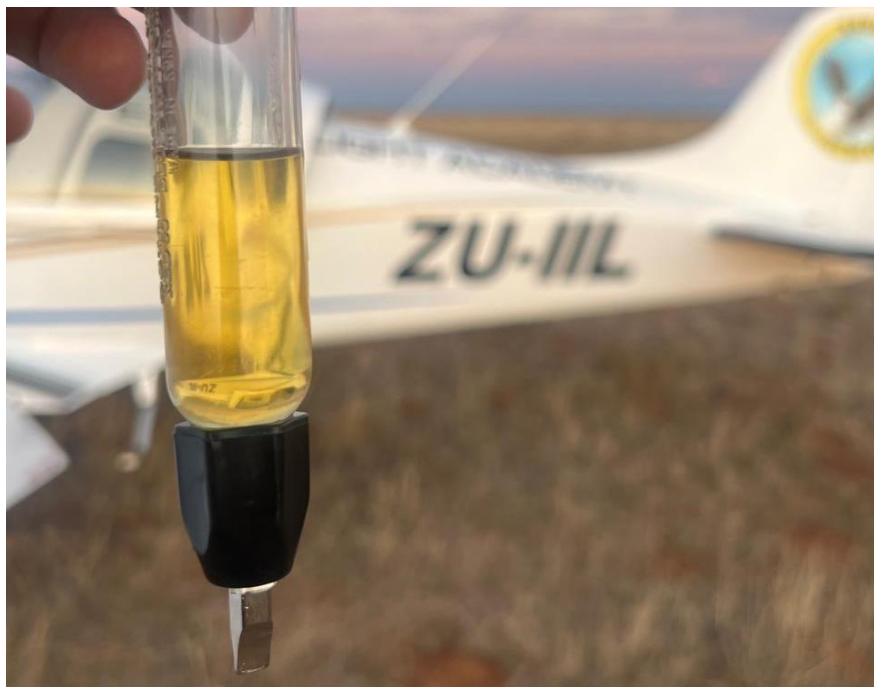
An aircraft maintenance engineer (AME) conducted an inspection on the fuel system at the accident site and nothing abnormal was noted. The student pilot stated that the aircraft had 90 litres of fuel when he took off and, after the accident, there was 81 litres remaining; thus, the aircraft had adequate fuel in the tanks. A small amount of fuel was strained from the aircraft, which was gold-yellow in colour. The fuel was inspected, and it was found free of dirt.

Figure 5: The fuel sample drained from the left-wing port. (Source: Operator)
