LIMITED OCCURRENCE INVESTIGATION REPORT – FINAL

Reference Number	CA18/2/3/10396						
Classification	Accident	Date	2 December 2023		Time	0722Z	
Type of Operation	Private (Part 141)						
Location							
Place of Departure	Klerksdorp Airfield (FAKD), Gauteng Province		Place of Intended Landing		Klerksdorp Airfield (FAKD), Gauteng Province		
Place of Occurrence	Private farm, 7 nautical miles from Klerksdorp Airfield (FAKD)						
GPS Co-ordinates	Latitude	26°45'57.6"S	Longitude	26°39'42.2"E	Elevation	4 444ft	
Aircraft Information							
Registration	ZS-ESW						
Make; Model; S/N	Piper Aircraft Corporation; PA 28-140 Cherokee (Serial Number: 28-22004)						
Damage to Aircraft	Substantial		Total Aircraft Hours	6434.5			
Pilot-in-command							
Licence Type	Commercial Pilot Licence (CPL)		Gender	Female		Age	24
Licence Valid	Yes	Total Hours	364		Total Hours on Type	202	
Total Hours 30 Days	0.5		Total Flying on Type Past 90 Days	5.5			
People On-board	2+0	Injuries	0	Fatalities	0	Other (on ground)	0

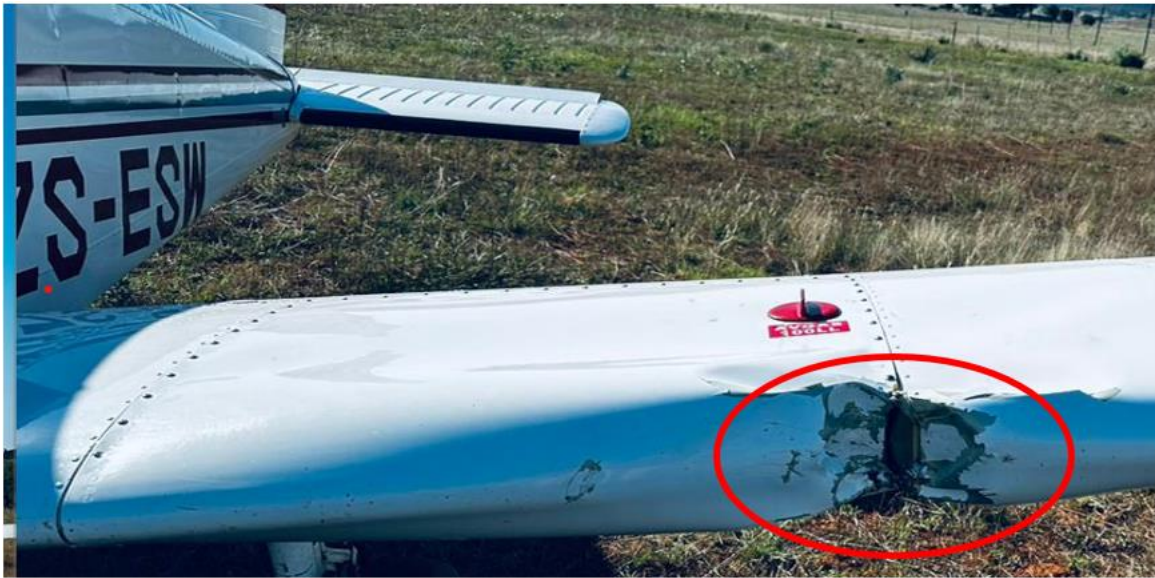
A visual inspection was conducted post-accident, and the following damage was recorded: the left- and the right-wing leading edges were dented in the mid-section, and the propeller blades had scratch marks.

Figure 1: The dented left-wing leading edge. (Source: Operator)

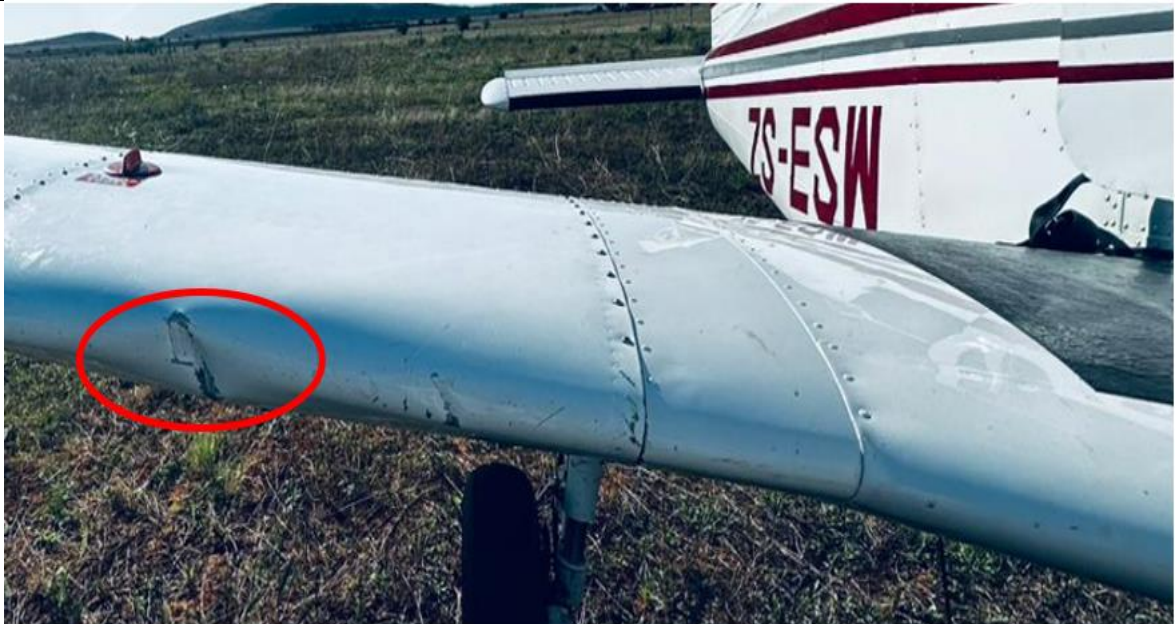
Figure 2: The dented right-wing leading edge. (Source: Operator)

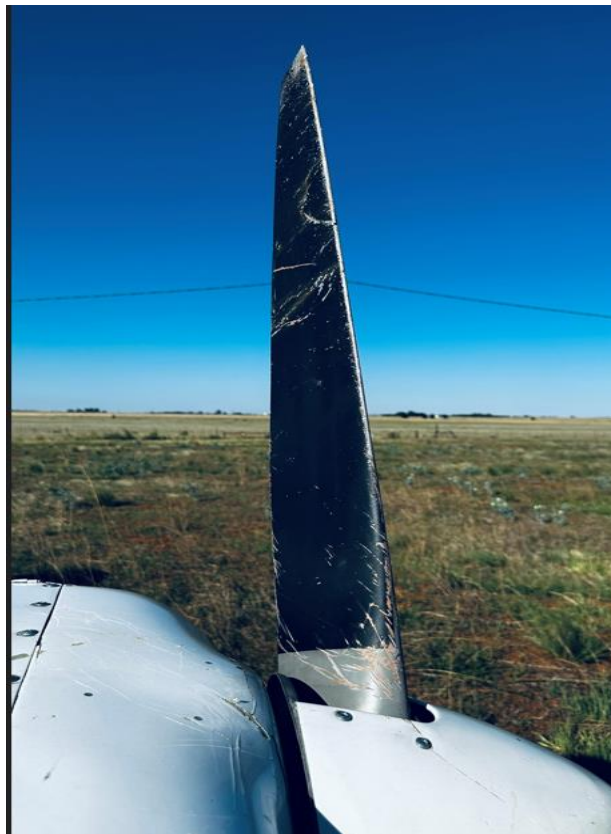
Figure 3: The propeller blade with scratch marks. (Source: Operator)
