LIMITED OCCURRENCE INVESTIGATION REPORT – FINAL

Reference Number	CA18/2/3/10397						
Classification	Accident	Date	2 December 2023	Time	1550Z		
Type of Operation	Private (Part 91)						
Location							
Place of Departure	Koppie-Alleen Farm near Perdekop, Mpumalanga Province		Place of Intended Landing	Klipfontein Farm near Ermelo, Mpumalanga Province			
Place of Occurrence	Klipfontein Farm, Mpumalanga Province						
GPS Co-ordinates	Latitude	26°39'09.05" S	Longitude	030°00'55.89" E	Elevation	5 471ft	
Aircraft Information							
Registration	ZS-OCW						
Make; Model; S/N	Cessna Aircraft Company; 182S (Serial Number: 182-80087)						
Damage to Aircraft	Substantial			Total Airframe Hours	2 471.3		
Pilot-in-command							
Licence Type	Private Pilot Licence		Gender	Male		Age	65
Licence Valid	Yes	Total Hours	896.0		Total Hours on Type	896.0	
Total Hours 90 Days	11.0		Total Flying Hours on Type Past 90 Days	11.0			
People On-board	1 + 1	Injuries	0	Fatalities	0	Other (on ground)	0

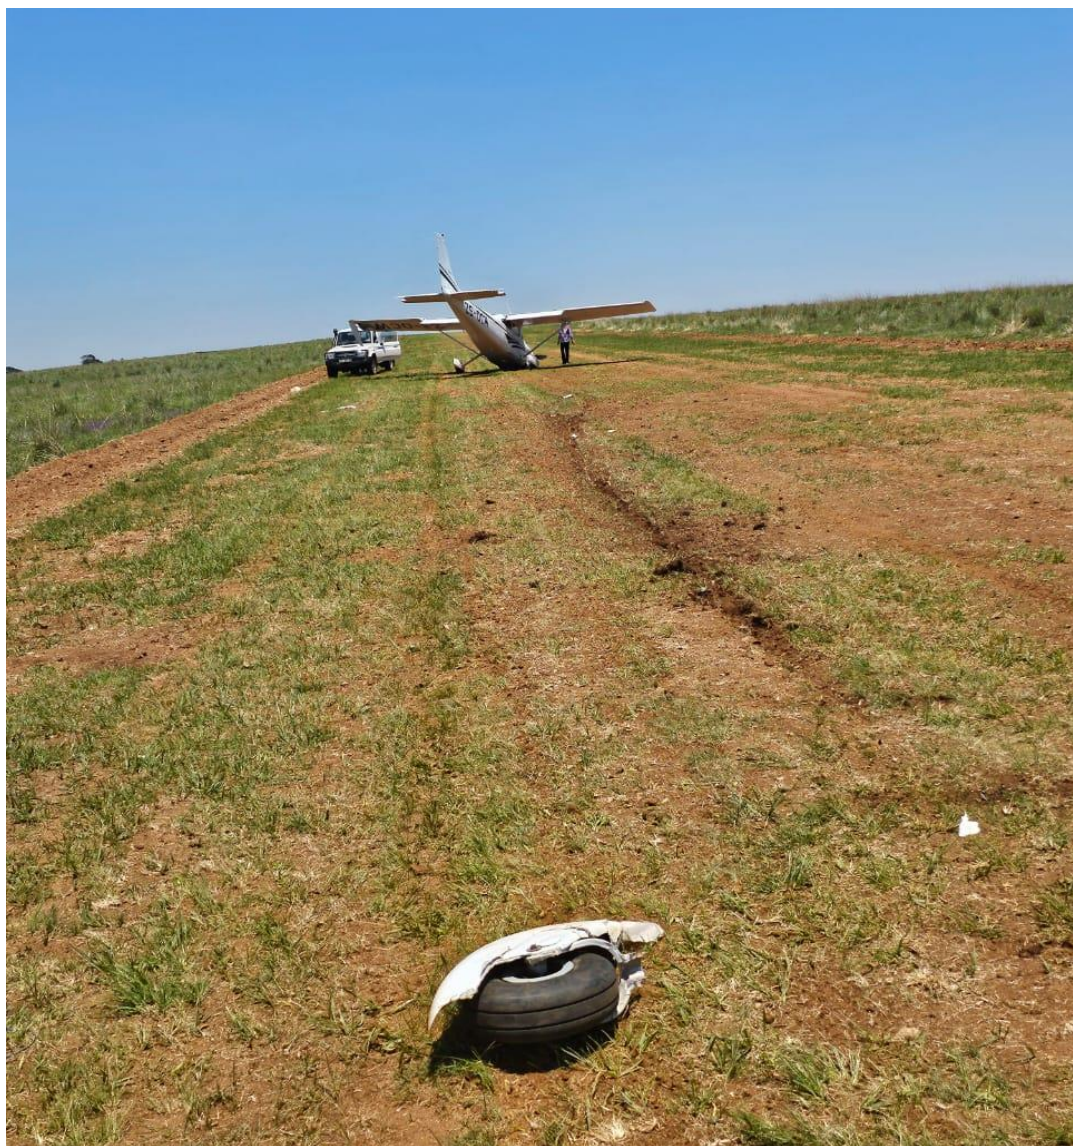
Figure 1: The aircraft as it came to rest with the severed nose gear fork in the foreground. (Source: Pilot)

2.4	The aircraft was issued a Certificate of Release to Service (CRS) on 23 March 2023 with an expiry date of 22 March 2024 or at 2 524.5 airframe hours, whichever occurs first.
Probable Cause	
The pilot applied an incorrect landing technique on an upslope runway, which led to the nose wheel contacting the runway first and was severed. The aircraft came to rest in a nose-down attitude on the runway.	
Contributing Factors

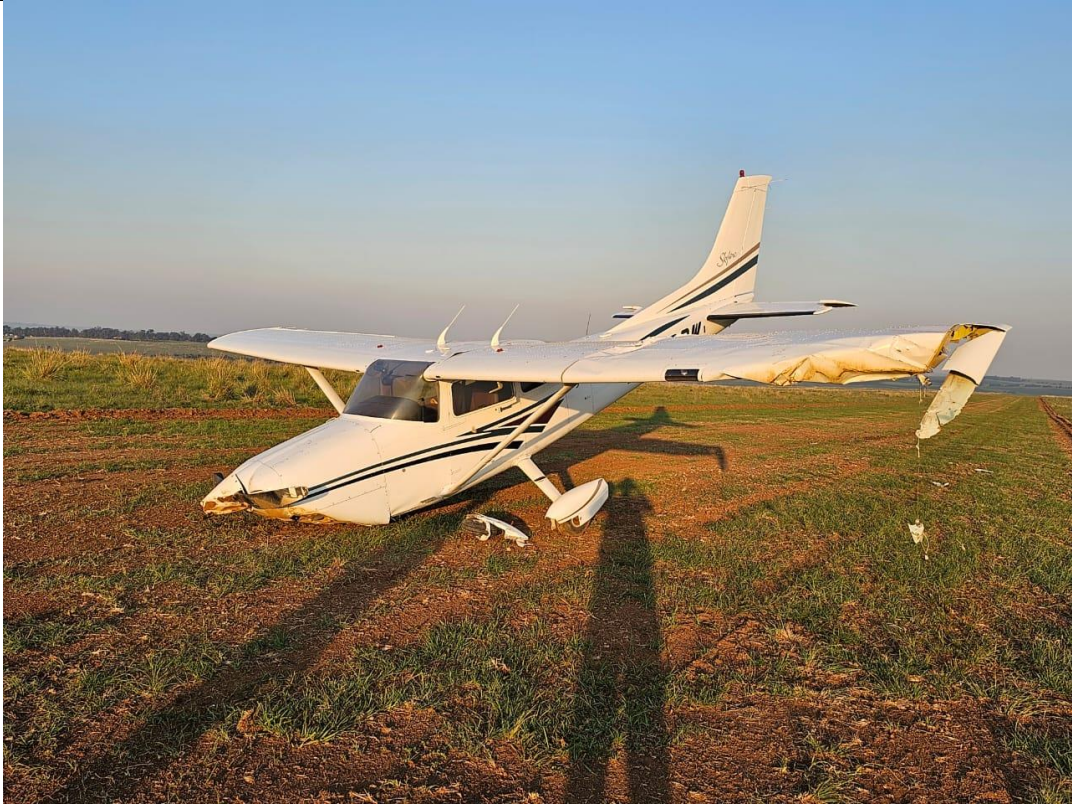
Figure 2: A view of the aircraft and the upslope runway. (Source: Pilot)

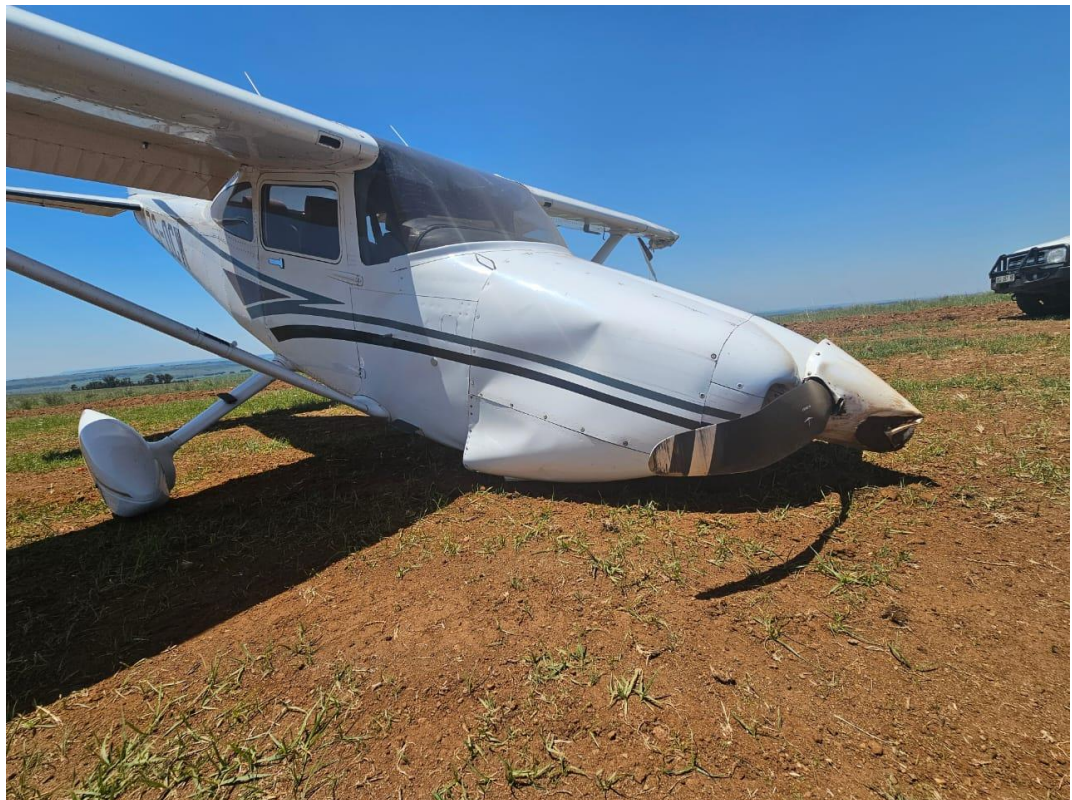
Figure 3: A closer view of the damage to the propeller and the lower fuselage. (Source: Pilot)
