LIMITED OCCURRENCE INVESTIGATION REPORT – FINAL

Reference Number	CA18/2/3/10398						
Classification	Accident	Date	9 December 2023	Time	0600Z		
Type of Operation	Training (Part 141)						
Location							
Place of Departure	Wonderboom Aerodrome (FAWB), Gauteng Province		Place of Intended Landing	Wonderboom Aerodrome (FAWB), Gauteng Province			
Place of Occurrence	Runway 06 at Wonderboom Aerodrome (FAWB)						
GPS Co-ordinates	Latitude	25°39'19.11" S	Longitude	028°13'16.81" E	Elevation	4 095 feet (ft)	
Aircraft Information							
Registration	ZS-SDA						
Make; Model; S/N	Cessna Aircraft Company; C172P Skyhawk (Serial Number: 17276251)						
Damage to Aircraft	Substantial		Total Aircraft Hours	15 250.9			
Pilot-in-command							
Licence Type	Student Pilot Licence (SPL)		Gender	Female		Age	20
Licence Valid	Yes	Total Hours	37		Total Hours on Type	37	
Total Hours 30 Days	3.7		Total Flying on Type Past 90 Days	10.8			
People On-board	1+0	Injuries	0	Fatalities	0	Other (on ground)	0

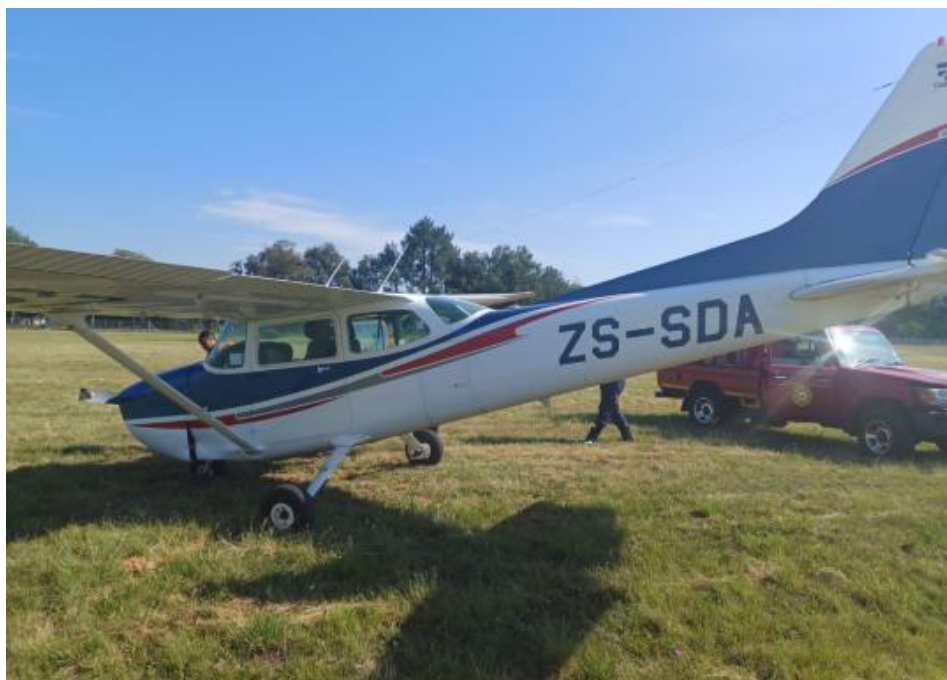
over the threshold of Runway 29, the SP reduced power before initiating a round out. The aircraft ballooned and touched down hard on its main wheels and bounced. It touched down for the second time and bounced (this time the touchdown was harder and the bounce was higher than the previous one). The SP applied power to initiate a go-around and the aircraft's nose pitched up. *The aircraft's indicated air speed (IAS) was approaching the stalling speed at this time.* The aircraft touched down for the third time, this time with the nose gear first. The nose gear broke and the propeller impacted the runway. The aircraft skidded on its nose and veered off to the left of the runway. It came to a stop a few metres from the edge of the runway. The SP turned off all the electrical switches and exited the aircraft unassisted. The Airport Firefighting and Rescue Service (ARFFS) responded to the accident scene. The aircraft sustained substantial damage to the propeller, nose gear and nose section. No person was injured during the accident.

Figure 1: The aircraft after it came to a stop. (Source: Operator)

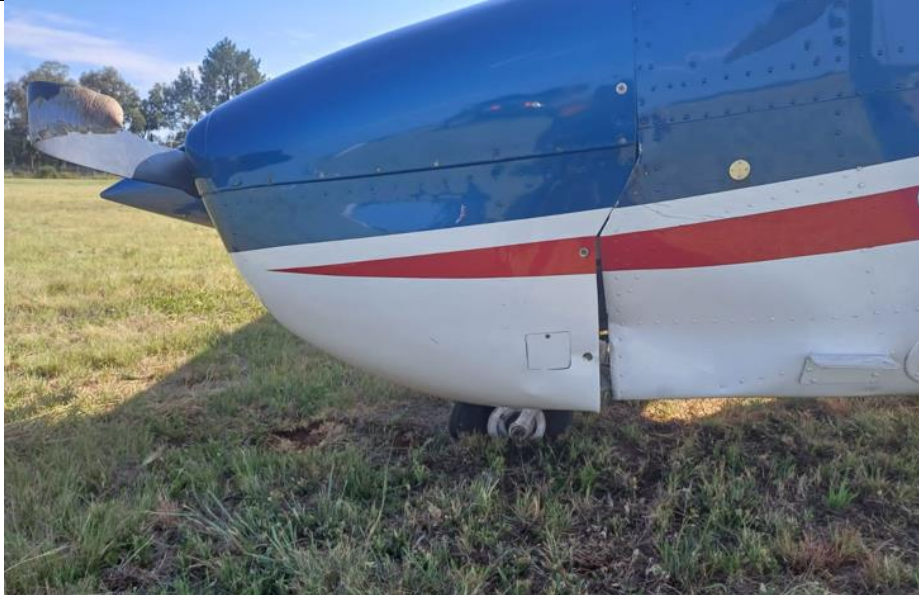
Figure 2: The damaged nose gear. (Source: Operator)

14. The approach speed was too high which caused the aircraft to float above the runway and touched down hard and deep, this was followed by two bounces. The SP attempted to execute a go-around, but the aircraft stalled and touched down with the nose gear which broke before the aircraft veered off to the left of the runway.

The aircraft’s airspeed was too high on approach for landing which caused it to float before it touched down hard, followed by two bounces. The aircraft stalled and, thereafter, touched down hard with the nose landing gear which broke; the aircraft veered off to the left of the runway.

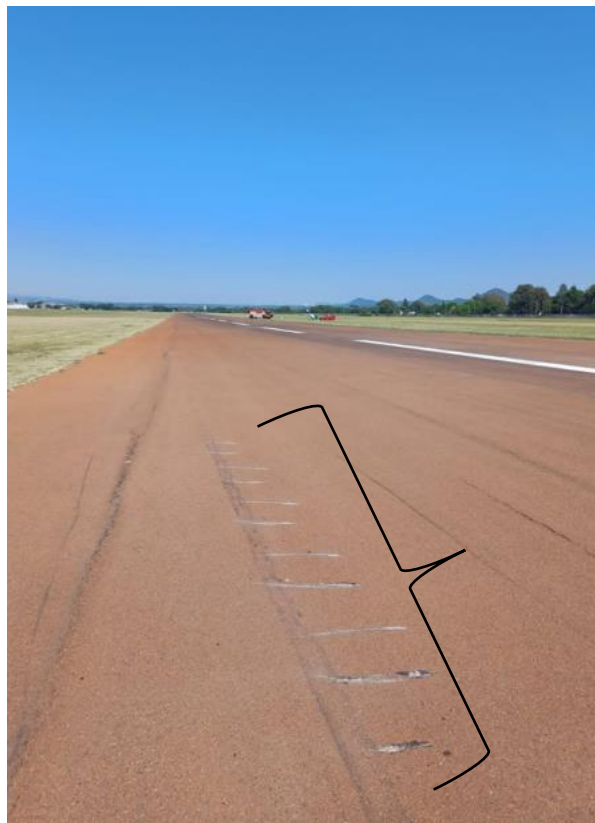
Figure 3: The propeller strike marks on the runway. (Source: Operator)

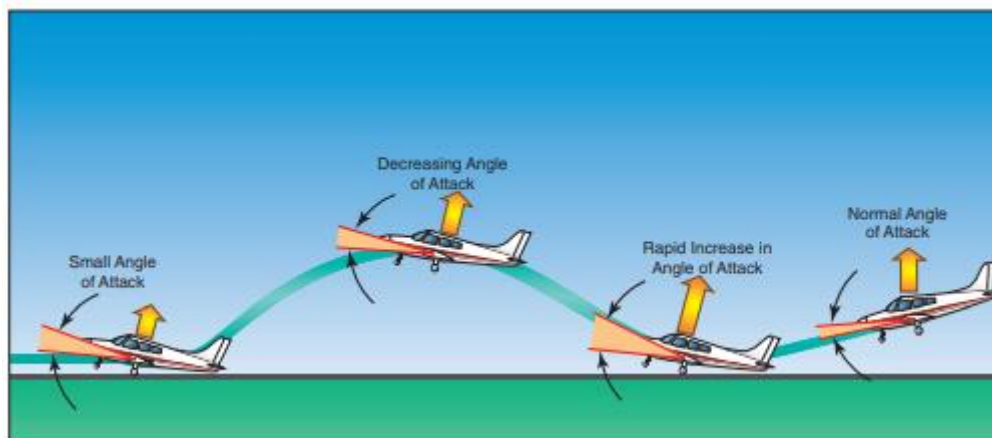
If the airspeed on final approach is excessive, it will usually result in the airplane floating. [Figure 4] Before touchdown can be made, the airplane may be well past the desired landing point and the available runway may be insufficient. When diving an airplane on final approach to land at the proper point, there will be an appreciable increase in airspeed. The proper touchdown attitude cannot be established without producing an excessive angle of attack and lift. This will cause the airplane to gain altitude or balloon. Any time the airplane floats, judgment of speed, height, and rate of sink must be especially acute. The pilot must smoothly and gradually adjust the pitch attitude as the airplane decelerates to touchdown speed and starts to settle, so the proper landing attitude is attained at the moment of touchdown. The slightest error in judgment and timing will result in either ballooning or bouncing. The recovery from floating will depend on the amount of floating and the effect of any crosswind, as well as the amount of runway remaining. Since prolonged floating utilizes considerable runway length, it should be avoided especially on short runways or in strong crosswinds. If a landing cannot be made on the first third of the runway, or the airplane drifts sideways, the pilot should **execute a go-around**.

Illustration 1: An aircraft bounces during touchdown. (Source: Airplane Flying Handbook FAA-8083-3A)

1. *Throttle – FULL OPEN*
2. *Carburettor Heat – COLD*
3. *Wing Flaps -- 20°*
4. *Climb Speed – 55 KIAS*
5. *Wing Flaps -- 10° (until obstacles are cleared). RETRACT (after reaching a safe altitude and 60 KIAS)*
