LIMITED OCCURRENCE INVESTIGATION REPORT – FINAL

Reference Number	CA18/2/3/10399						
Classification	Accident	Date	9 December 2023	Time	0730Z		
Type of Operation	Private (Part 94)						
Location							
Place of Departure	Yorkville Airstrip in Kamberg, KwaZulu-Natal Province		Place of Intended Landing	Farm near Ladysmith, KwaZulu-Natal Province			
Place of Occurrence	Hill side, Nottingham, KwaZulu-Natal Province						
GPS Co-ordinates	Latitude	29°27'41.21" S	Longitude	029°52'59.87" E	Elevation	5 632 feet (ft)	
Aircraft Information							
Registration	ZU-IVW						
Make; Model; S/N	Savanna S (Serial Number: 21-06-54-0792)						
Damage to Aircraft	Substantial		Total Aircraft Hours	210			
Pilot-in-command							
Licence Type	National Pilot Licence (NPL)		Gender	Male	Age	64	
Licence Valid	Yes	Total Hours	903.7	Total Hours on Type	457		
Total Hours Past 30 Days	13		Total Flying Hours on Type Past 90 Days	37			
People On-board	1 + 1	Injuries	2	Fatalities	0	Other (on ground)	0

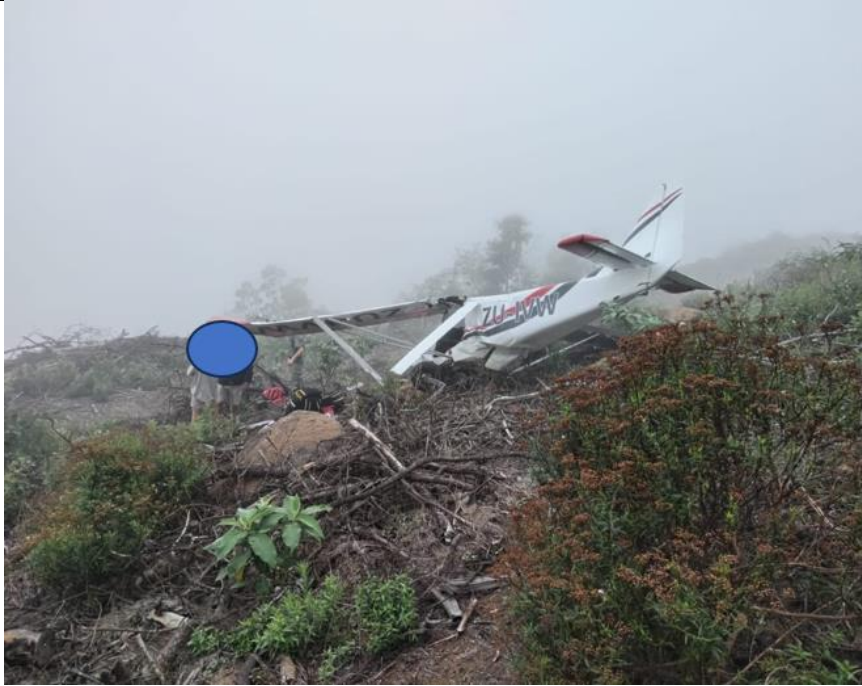
The pilot was seriously injured and was taken to a hospital in Pietermaritzburg; the passenger sustained minor injuries. The aircraft was substantially damaged during the accident.

Figure 3: The resting position of the aircraft post-accident. (Source: SAPS)

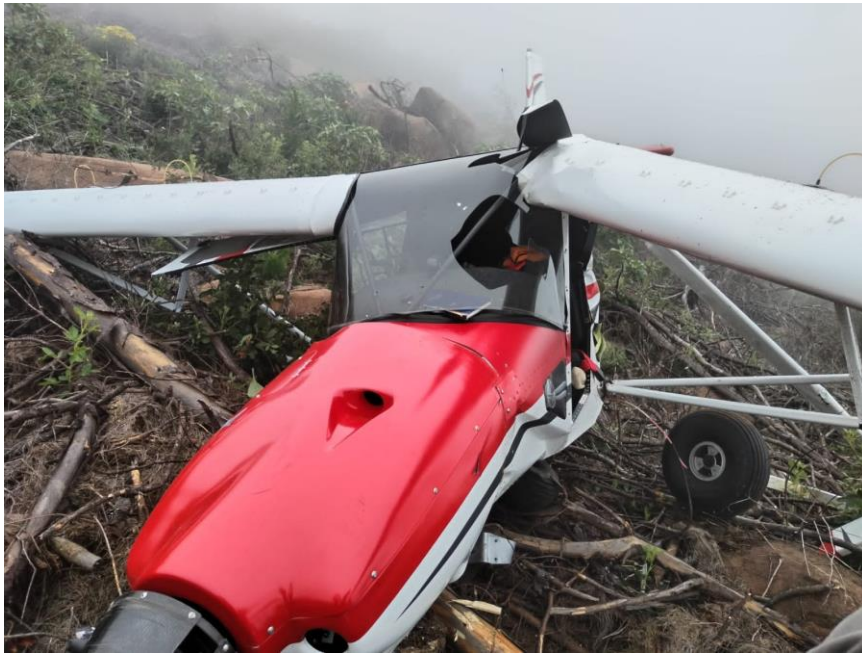
Figure 4: Close-up view of the damage post-accident. (Source: SAPS)

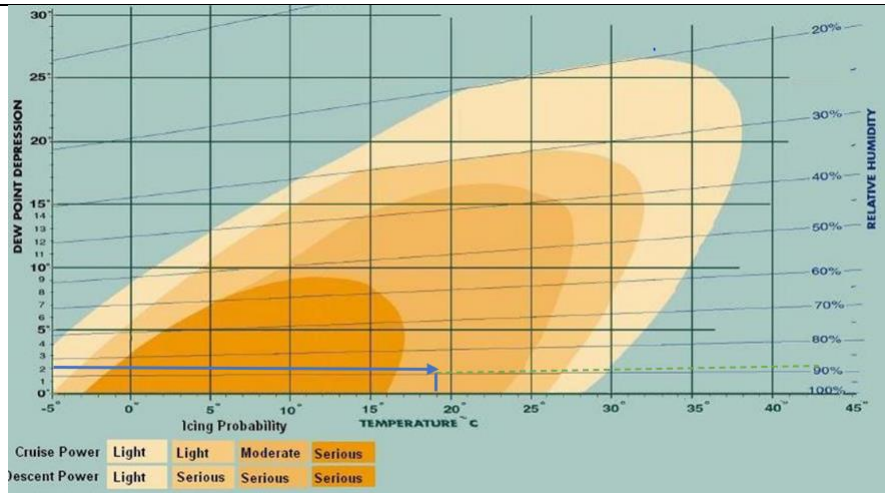
Figure 6: Carburettor Icing Probability Chart.

Although carburettor icing was not a factor in this accident, there was 89% relative humidity and a moderate icing probability at cruise power setting with a serious icing probability at descent power setting.
