**LIMITED OCCURRENCE INVESTIGATION REPORT – FINAL**

<b>Reference Number</b>	CA18/2/3/10400						
<b>Classification</b>	Accident	<b>Date</b>	13 December 2023	<b>Time</b>	1510Z		
<b>Type of Operation</b>	Private (Part 94)						
<b>Location</b>							
Place of Departure	Rhino Park Airfield, Gauteng Province		Place of Intended Landing	Rhino Park Airfield, Gauteng Province			
Place of Occurrence	Rhino Park Airfield Runway 09						
GPS Co-ordinates	Latitude	25°49'58.49" S	Longitude	028°32'39.11" E	Elevation	4 757 feet	
<b>Aircraft Information</b>							
Registration	ZU-TSM						
Make; Model; S/N	Jabiru; J430 (Serial Number: 989)						
Damage to Aircraft	Substantial		Total Aircraft Hours	71.7			
<b>Pilot-in-command</b>							
Licence Type	Private Pilot Licence (PPL) (Aeroplane)		Gender	Male		Age	43
Licence Valid	Yes	Total Hours	86		Total Hours on Type	66.6	
Total Hours 30 Days	17		Total Flying on Type Past 90 Days	33.5			
<b>People On-board</b>	1 + 0	<b>Injuries</b>	0	<b>Fatalities</b>	0	<b>Other (on ground)</b>	0

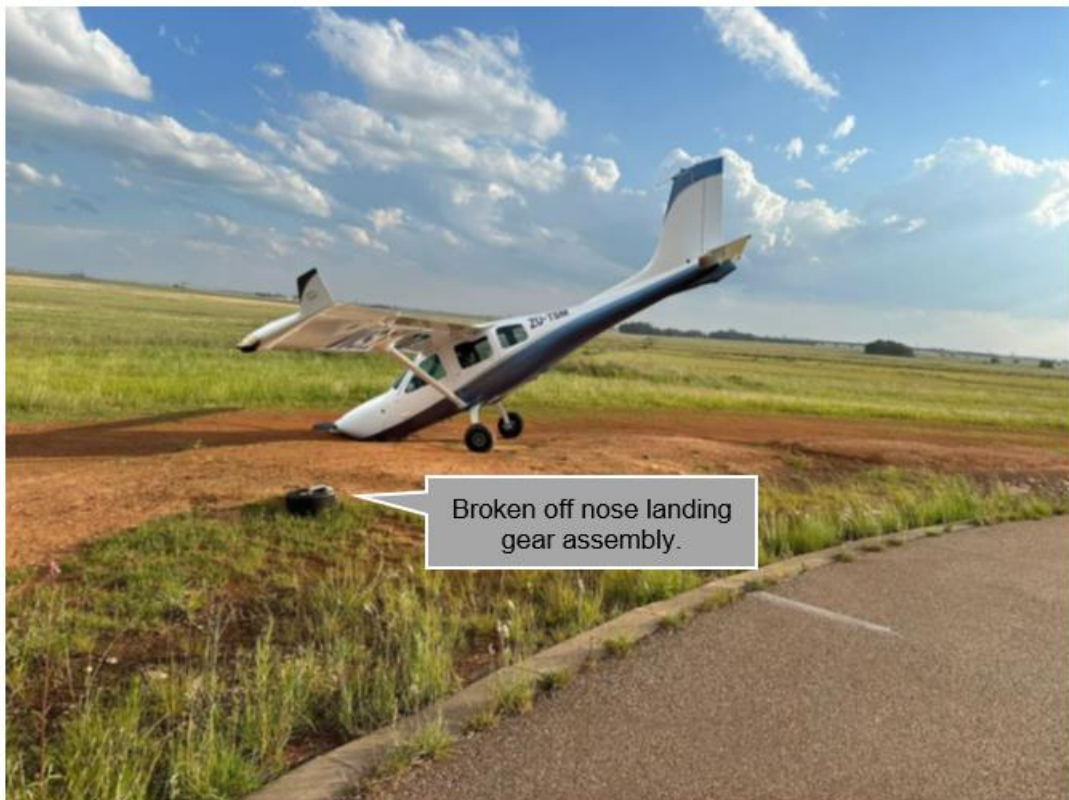
**Figure 2:** The aircraft as it came to rest on the right side of Runway 09 near the threshold of RWY 27. The nose gear strut that broke off is in the foreground. (Source: Pilot)

5. The aircraft touched down at a speed of 77 kts and with the flaps set at 10°. According to the Jabiru Owner's Manual, the aircraft's landing speed is 65 kts with the wing flaps full down. The aircraft landed too deep and at a high speed on RWY 09 which left the aircraft with insufficient surface to safely stop and, thus, overshoot the runway. The aircraft came to a stop on the right side of RWY 09 near the threshold of RWY 27.
