LIMITED OCCURRENCE INVESTIGATION REPORT – FINAL

Reference Number	CA18/2/3/10402						
Classification	Accident	Date	20 December 2023		Time	1533Z	
Type of Operation	Aerial Work Operations (Part 137)						
Location							
Place of Departure	Noods Hulp Private Farm, Ottosdal, North West Province		Place of Intended Landing			Noods Hulp Private Farm, Ottosdal, North West Province	
Place of Occurrence	On the prepared runway strip						
GPS Co-ordinates	Latitude	26°41'37.38"S	Longitude	025°51'29.56"E	Elevation	4 595 ft	
Aircraft Information							
Registration	ZS-FDT						
Make; Model; S/N	Piper Aircraft Corporation; PA25-235 (Serial Number: 25-4429)						
Damage to Aircraft	Substantial			Total Aircraft Hours	10 545.9		
Pilot-in-command							
Licence Type	Commercial Pilot Licence (CPL)		Gender	Male	Age	43	
Licence Valid	Yes	Total Hours	545.7	Total Hours on Type	64.5		
Total Hours 30 Days	17.6		Total Flying on Type Past 90 Days			30.7	
People On-board	1+0	Injuries	0	Fatalities	0	Other (on ground)	0

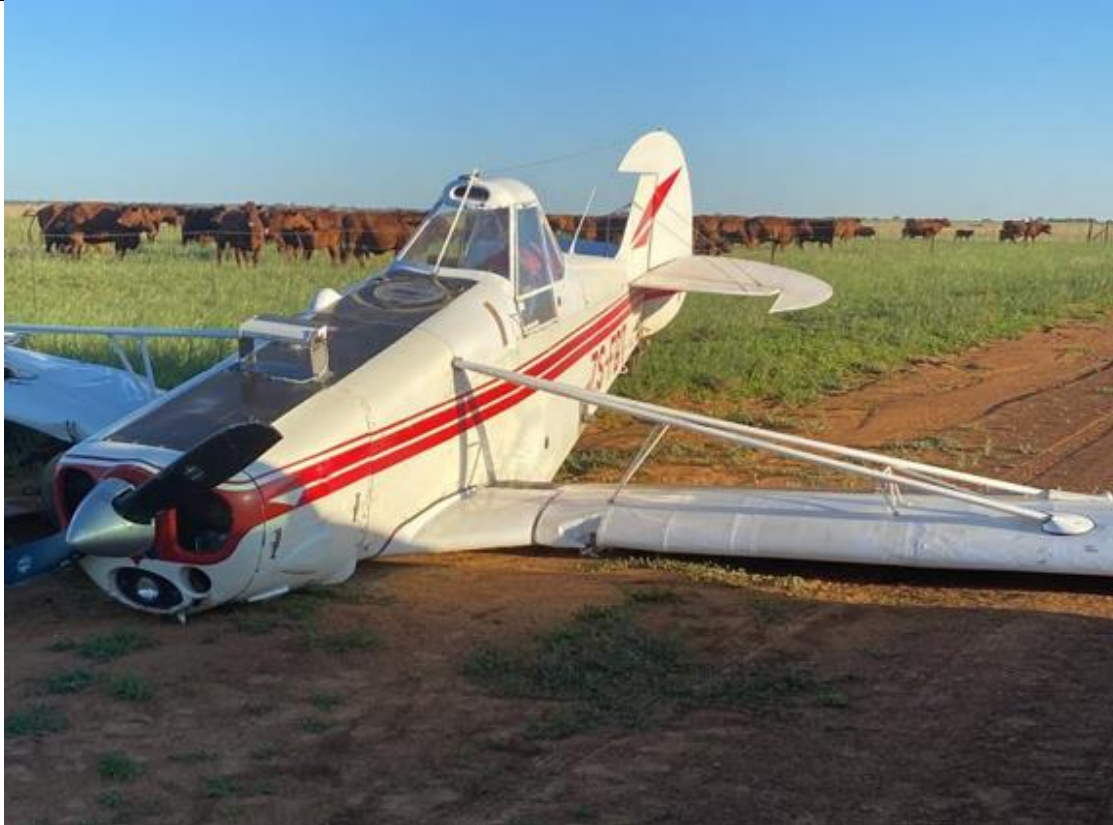
After the aircraft had come to a stop, the pilot disembarked unassisted and with no injuries. The aircraft sustained substantial damage to the main landing gears that broke off, both wings' leading edges, and the propeller blades. Also, the crop-spraying apparatus was destroyed.

Figure 2: The aircraft after the accident. (Source: The pilot)

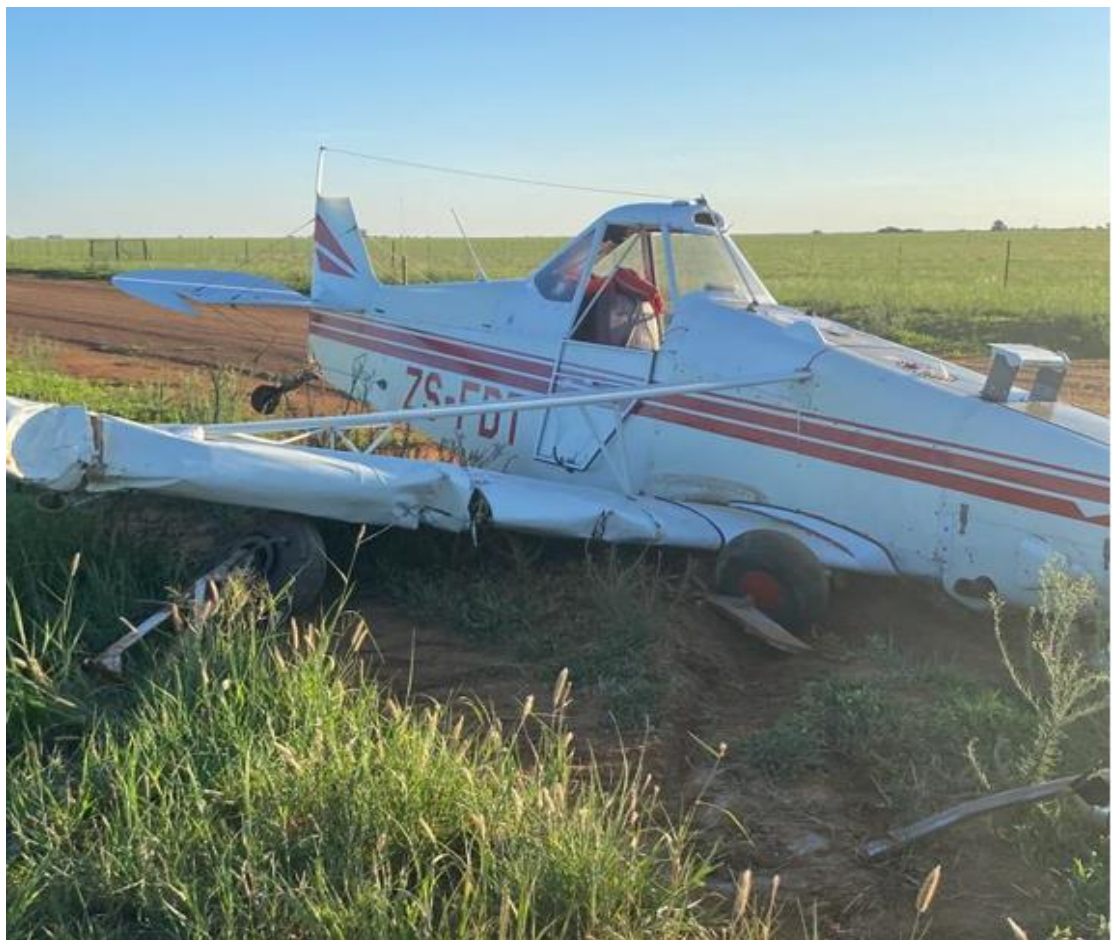
landing gear came into contact with the soft sand and the aircraft veered off to the right of the runway. The pilot attempted to steer the aircraft to the left and was unsuccessful. The aircraft pivoted 180 degrees and skidded sideways towards the left of the runway, which exacerbated the damage to the main landing gears which broke off. In addition, whilst the aircraft skidded, it impacted the perimeter fence which led to damage to both wings and the propeller blades.

Figure 3: Damage on the right side of the aircraft and the severed undercarriage.

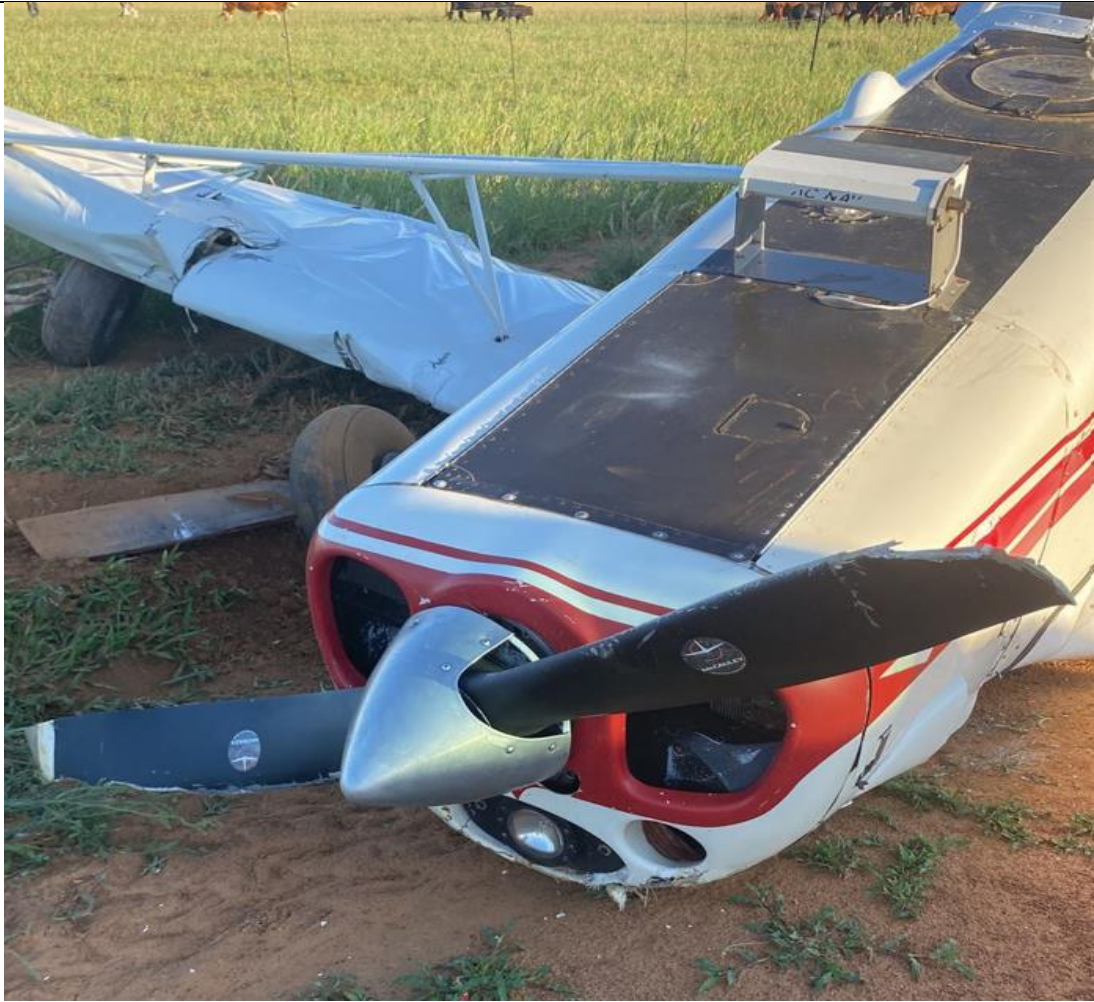
Figure 4: Damage to the propeller and the right wing.

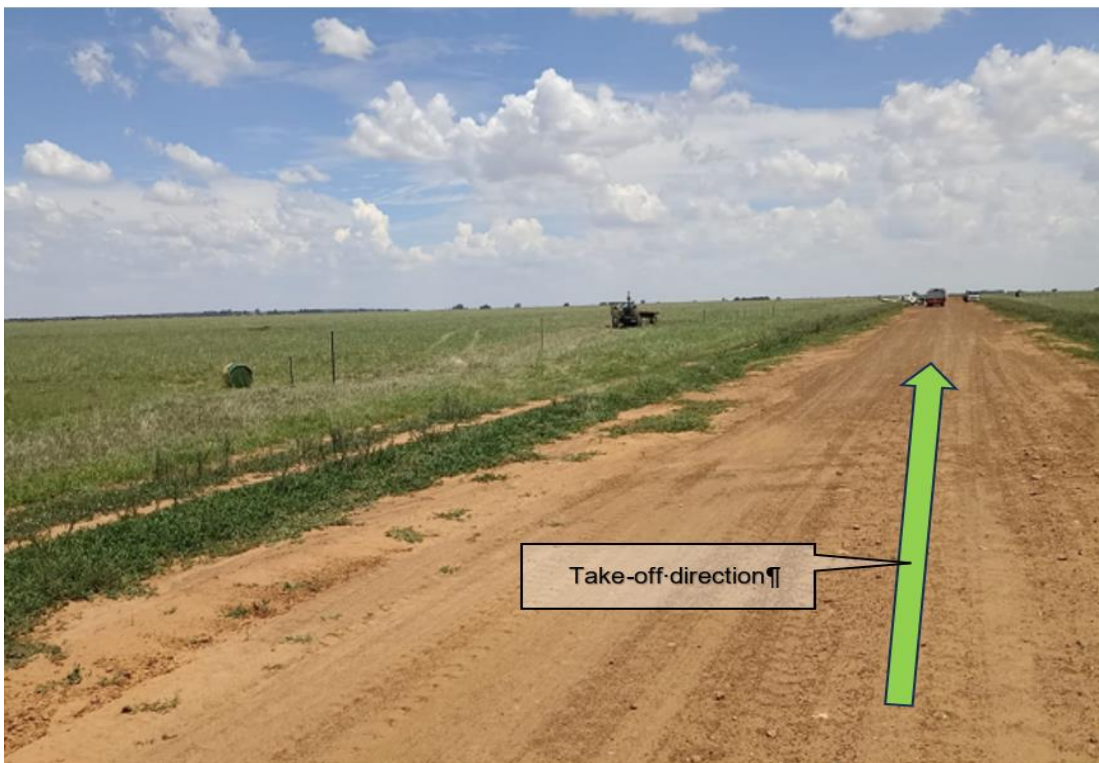
Figure 5: The green arrow shows the direction of flight.
