**LIMITED OCCURRENCE INVESTIGATION REPORT – FINAL**

<b>Reference Number</b>	CA18/2/3/10403						
<b>Classification</b>	Accident	<b>Date</b>	22 December 2023	<b>Time</b>	0535Z		
<b>Type of Operation</b>	Crop-spraying (Part 137)						
<b>Location</b>							
Place of Departure	Long Hill Farm near Dalton, KwaZulu-Natal Province	Place of Intended Landing	Long Hill Farm near Dalton, KwaZulu-Natal Province				
Place of Occurrence	Seven Oaks Farm near Dalton, KwaZulu-Natal Province						
GPS Co-ordinates	Latitude	29° 11' 23" S	Longitude	030° 31' 45.2" E	Elevation	3311ft	
<b>Helicopter Information</b>							
Registration	ZS-RTJ						
Make; Model; S/N	Robbinson R44 Raven II (Serial Number:10283)						
Damage to Helicopter	Substantial	Total Helicopter Hours	4137.7				
<b>Pilot-in-command</b>							
Licence Type	Commercial Pilot Licence (CPL)	Gender	Male	Age	36		
Licence Valid	Yes	Total Hours	4769.10	Total Hours on Type	3352.14		
Total Hours 30 Days	34.00		Total Flying on Type Past 90 Days	79.12

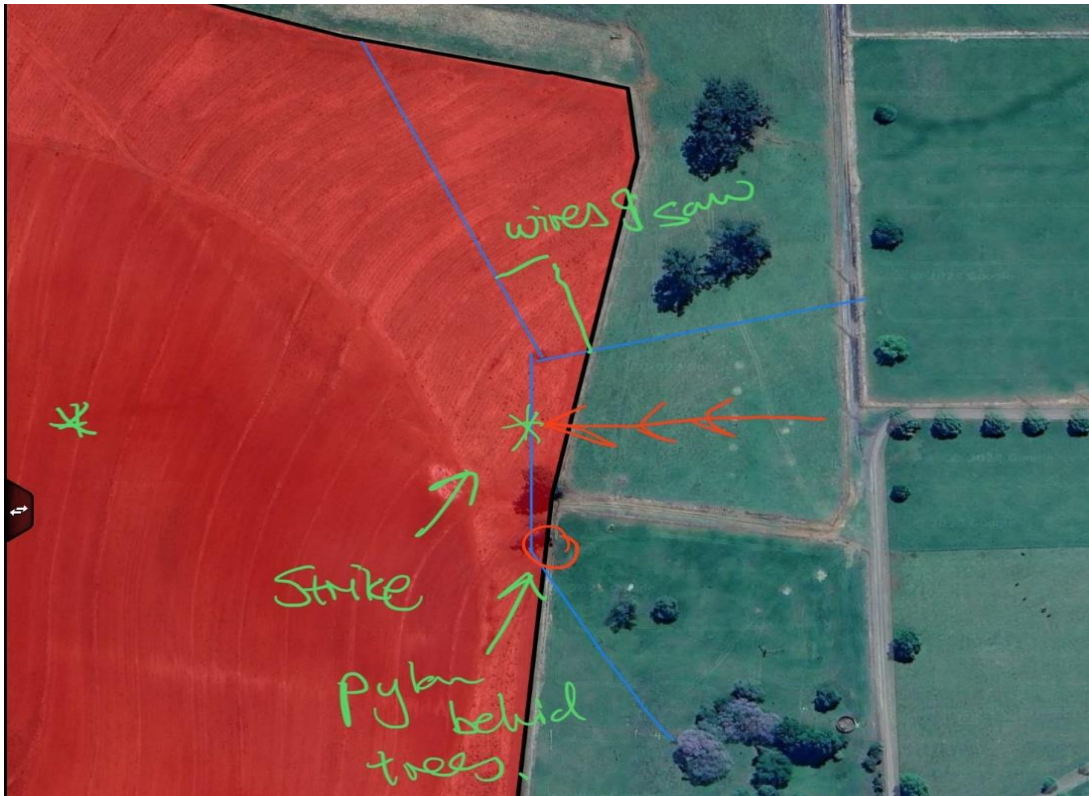
**Figure 1:** Sketch of the accident site. (Source: Pitot)

The pilot reported that he conducted a risk analysis prior to the crop-spraying operation. He was aware of the power lines to the right of the helicopter's flight path but did not notice the power lines which spanned across the flight path as the trees obscured the pylon from his view. This led to the helicopter impacting the power lines. The pilot stated that it was not his first time conducting a crop-spraying operation at this farm.

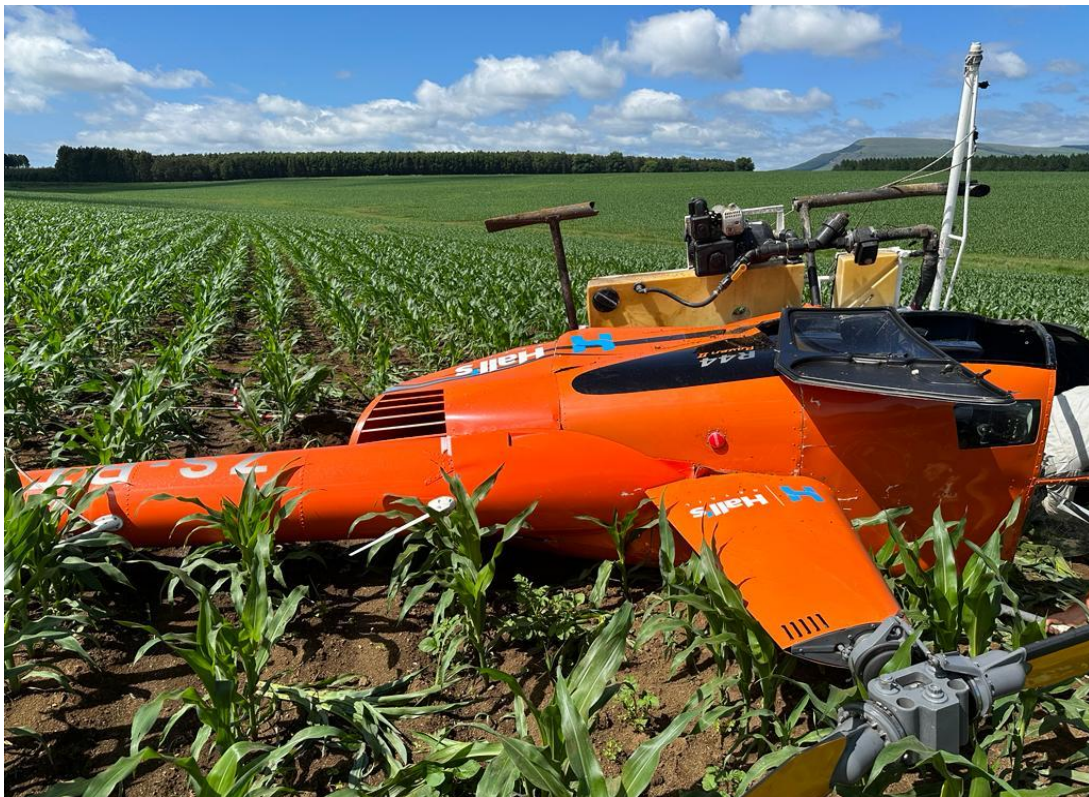
The helicopter sustained substantial damage to the windshield, tail boom, fuselage, landing skids, spray boom and the main rotor blades.

**Figure 2:** The helicopter after the accident. (Source: Operator)

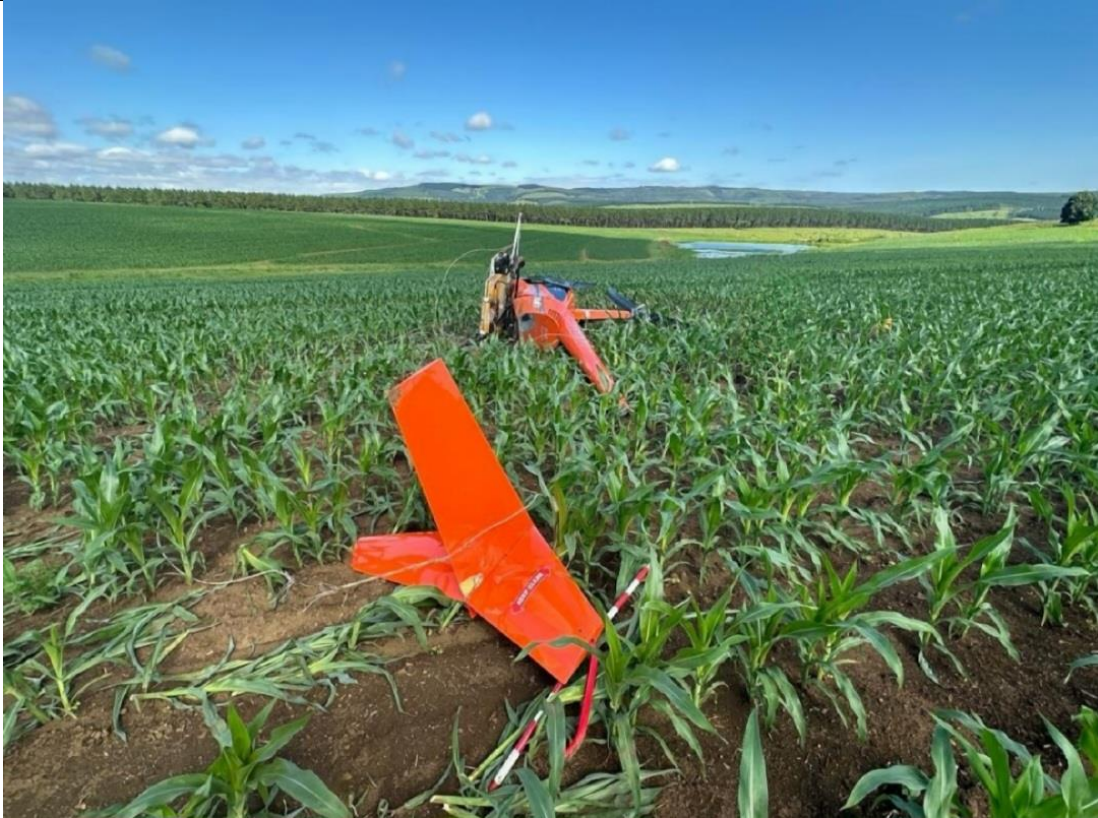
**Figure 3:** The severed tail rotor at the accident site. (Source: Operator)

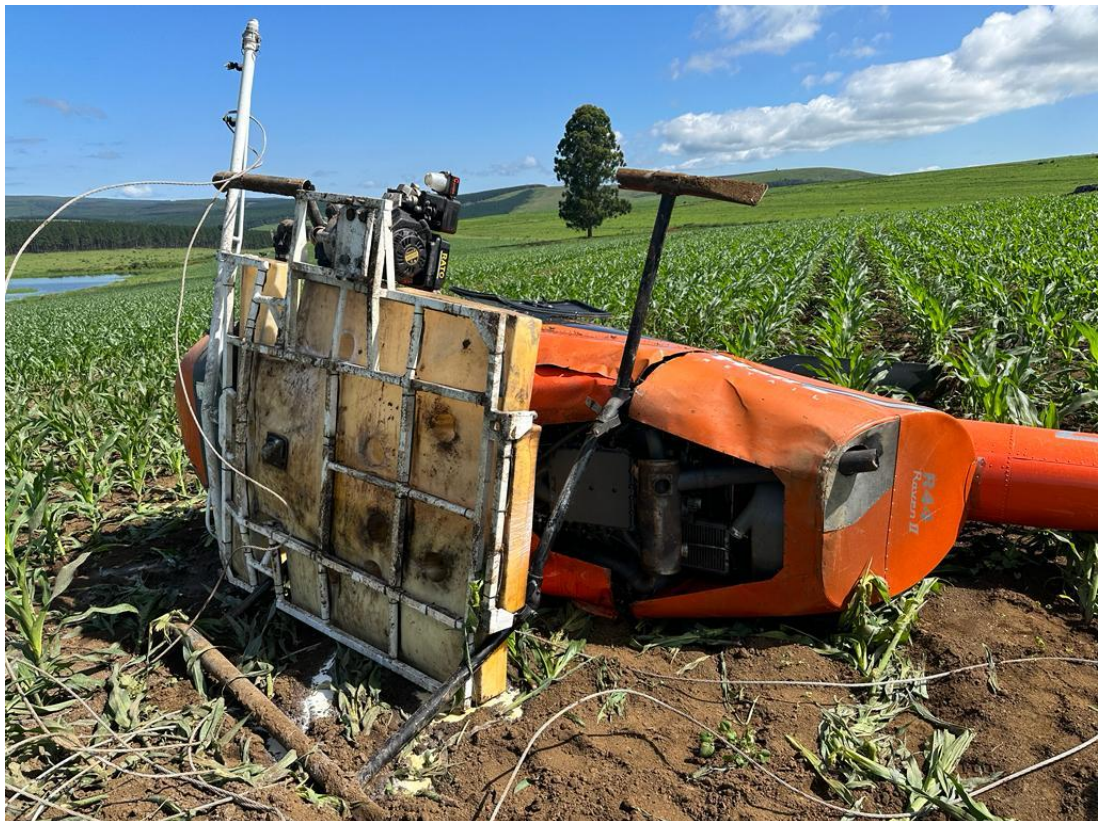
**Figure 4:** Damaged skids, spray boom and fuselage. (Source: Operator)
