LIMITED OCCURRENCE INVESTIGATION REPORT – FINAL

Reference Number	CA18/2/3/10404						
Classification	Accident	Date	22 December 2023		Time	0830Z	
Type of Operation	Private (Part 94)						
Location							
Place of Departure	Farm Elands near Marble Hall, Limpopo Province		Place of Intended Landing		Farm Yzervark near Bapsfontein, Gauteng Province		
Place of Occurrence	Private Farm near Bapsfontein, Gauteng Province						
GPS Co-ordinates	Latitude	26°02'59.55" S	Longitude	028°33'05.36" E	Elevation	5 203 ft	
Aircraft Information							
Registration	ZU-EZA						
Make; Model; S/N	Sky Ranger (Serial Number: 831)						
Damage to Aircraft	Substantial			Total Aircraft Hours	698.5		
Pilot-in-command							
Licence Type	National Pilot Licence (NPL)		Gender	Male		Age	79
Licence Valid	Yes	Total Hours	1128		Total Hours on Type	52.2	
Total Hours Past 30 Days	8		Total Flying Hours on Type Past 90 Days		28		
People On-board	1 + 0	Injuries	0	Fatalities	0	Other (on ground)	0

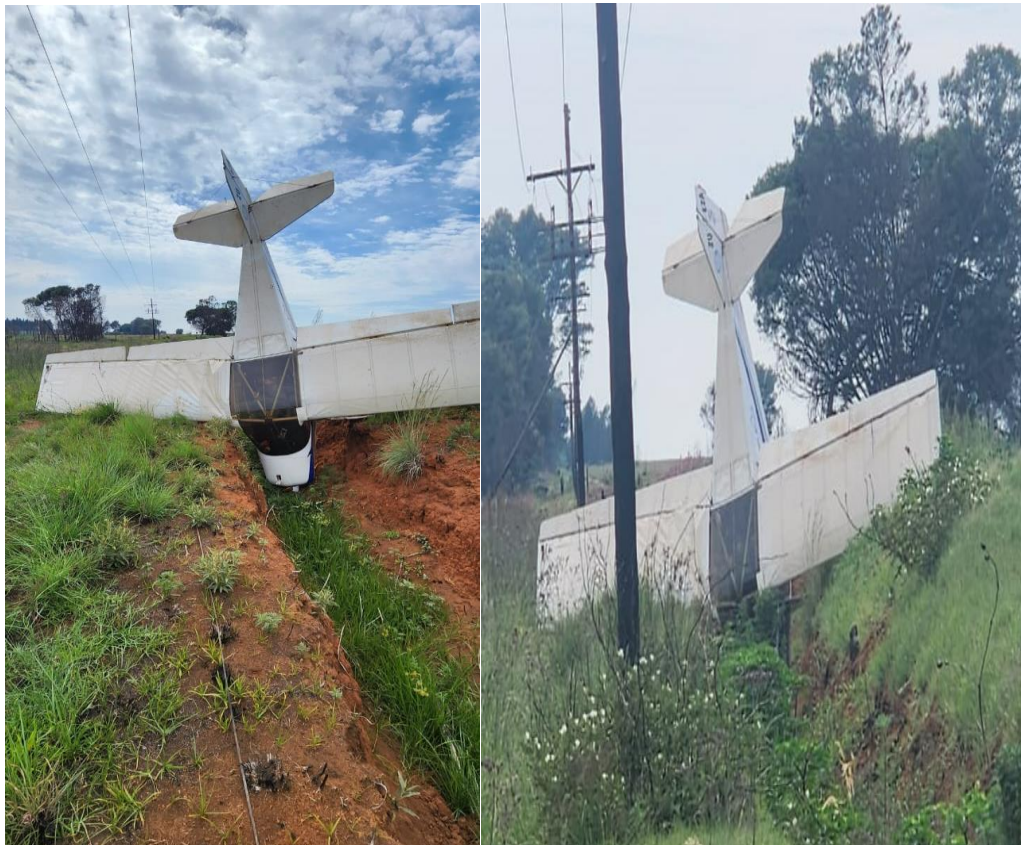
Figure 2: The aircraft as it came to rest after the accident. (Source: Pilot)

6. It is likely that the aircraft's airspeed was too high on approach and landing, which resulted in the aircraft landing deep and overshooting the runway before it came to a stop in a ditch beyond the runway.

It is likely that the aircraft's airspeed was too high on approach, and during the landing phase, the aircraft landed deep and overshoot the runway before it came to a stop in a ditch beyond the runway.
