**LIMITED OCCURRENCE INVESTIGATION REPORT – FINAL**

<b>Reference Number</b>	CA18/2/3/10405						
<b>Classification</b>	Accident	<b>Date</b>	27 December 2023	<b>Time</b>	0720Z		
<b>Type of Operation</b>	Private (Part 94)						
<b>Location</b>							
Place of Departure	Morningstar Aerodrome, Western Cape Province			Place of Intended Landing	Craigcor Private Airstrip, Western Cape Province		
Place of Occurrence	Runway 20 at Craigcor Private Airstrip, 33 nautical miles north-east of FACT						
GPS Co-ordinates	Latitude	33° 29'31.67" S	Longitude	018° 57'46.89" E	Elevation	306 feet	
<b>Aircraft Information</b>							
Registration	ZU-ITJ						
Make; Model; S/N	Rans Aircraft; S-21 (Serial Number: 05190048)						
Damage to Aircraft	Substantial			Total Aircraft Hours	176.4		
<b>Pilot-in-command</b>							
Licence Type	Private Pilot Licence (PPL) A		Gender	Male		Age	67
Licence Valid	Yes	Total Hours	1 199.3		Total Hours on Type	176.4	
Total Hours 30 Days	12.3		Total Flying on Type Past 90 Days	12.3

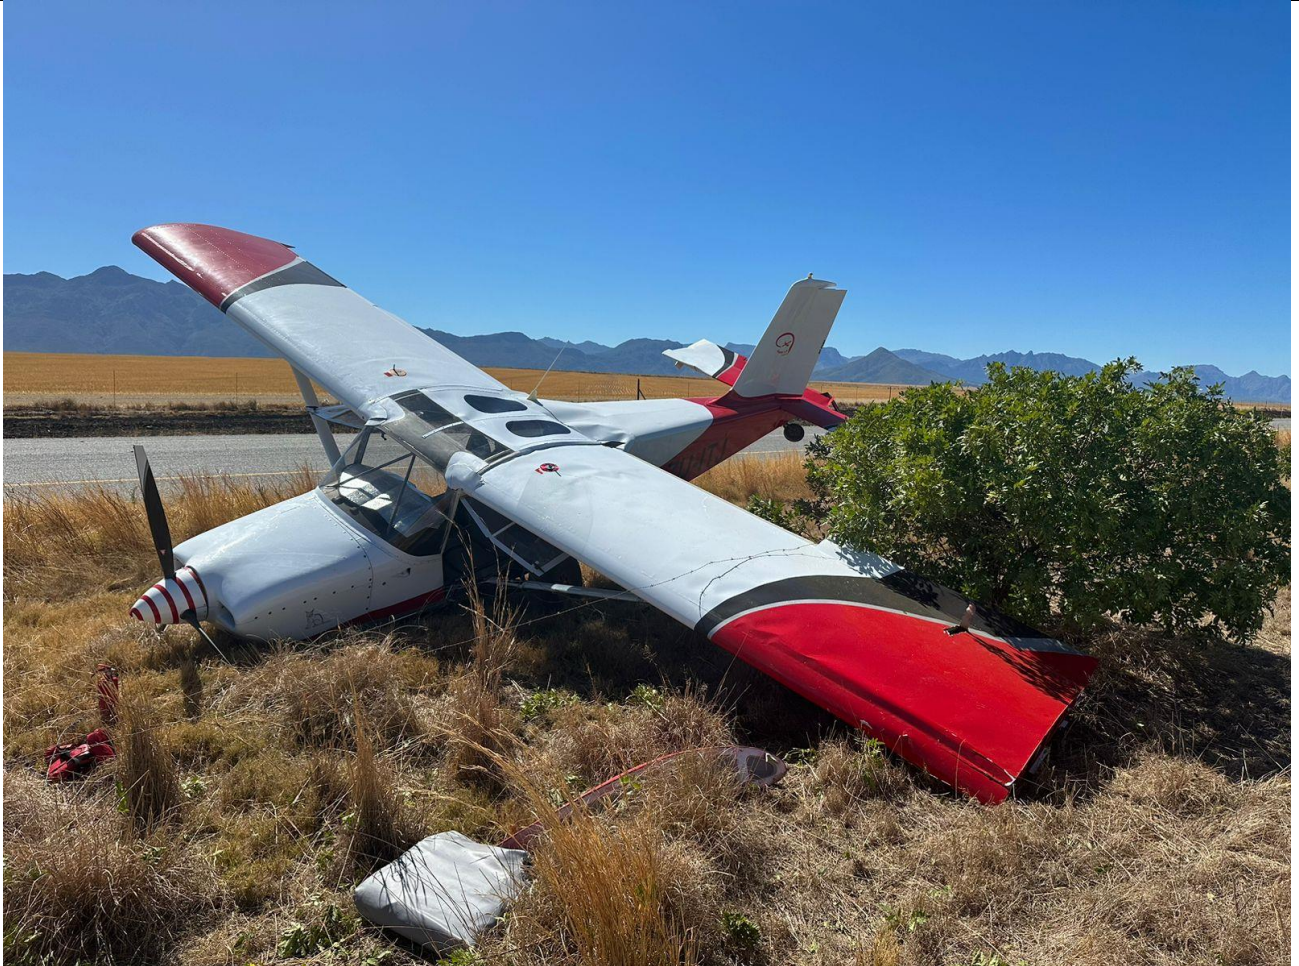
According to the pilot, whilst flying over the runway threshold, the aircraft experienced a sudden sharp drop of the left wing, which resulted in the left wing scrapping the runway surface. The pilot elected to execute a go-around and, thus, applied power to take-off and initiate a climb whilst maintaining the runway heading. The aircraft rolled to the left, prompting correction by inputting opposite rudder and aileron. Despite these corrective actions, the pilot lost control of the aircraft and it impacted the runway, and veered off to the left. It rolled through a perimeter fence before it stopped in the bushes approximately 100 metres from the initial impact (with the perimeter fence). The propeller, left wing, left elevator and fuselage were substantially damaged. Both the pilot and the passenger disembarked from the aircraft unscathed.

**Figure 2:** The aircraft at the accident site. (Source: Pilot)

6. Following a slower-than-recommended approach speed, the left wing dropped and scrapped the ground which caused the aircraft to drift to the left, depart the runway and roll through a perimeter fence due to loss of directional control. The pilot and the passenger were not injured during the accident sequence. The aircraft sustained substantial damage to the landing gear, propeller, fuselage, left wing and horizontal stabiliser.

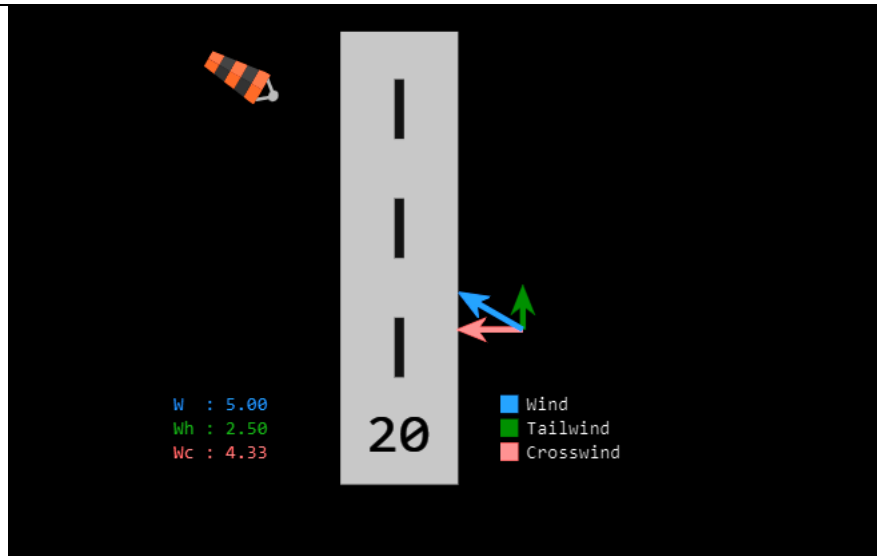
**Figure 3:** Crosswind component calculation. (Source: E6BX.com)

According to the crosswind calculation in Figure 3, there was a right crosswind component of 4.33 kt at the time of landing.
