LIMITED OCCURRENCE INVESTIGATION REPORT – FINAL

Reference Number	CA18/2/3/10406						
Classification	Serious Incident	Date	20 December 2023	Time	1130Z		
Type of Operation	Aerial Operation (Part 127)						
Location							
Place of Departure	Landing Zone T306 at Majuba Venus, KwaZulu-Natal Province		Place of Intended Landing	Landing Zone T306 at Majuba Venus, KwaZulu-Natal Province			
Place of Occurrence	T299 Majuba Venus, 20.2nm north of Ladysmith Airfield (FALY), in KwaZulu-Natal Province						
GPS Co-ordinates	Latitude	28°15'01.58" S	Longitude	29°50'11.00" E	Elevation	4 160 ft	
Aircraft Information							
Registration	ZS-RXO						
Make; Model; S/N	Bell 407 (Serial Number: 53927)						
Damage to Aircraft	Minor		Total Aircraft Hours	8 092.3			
Pilot-in-command							
Licence Type	Commercial Pilot Licence (CPL)		Gender	Female		Age	34
Licence Valid	Yes	Total Hours	3 847.0		Total Hours on Type	1 368.3	
Total Hours 30 Days	15.8		Total Flying on Type Past 90 Days	75.8

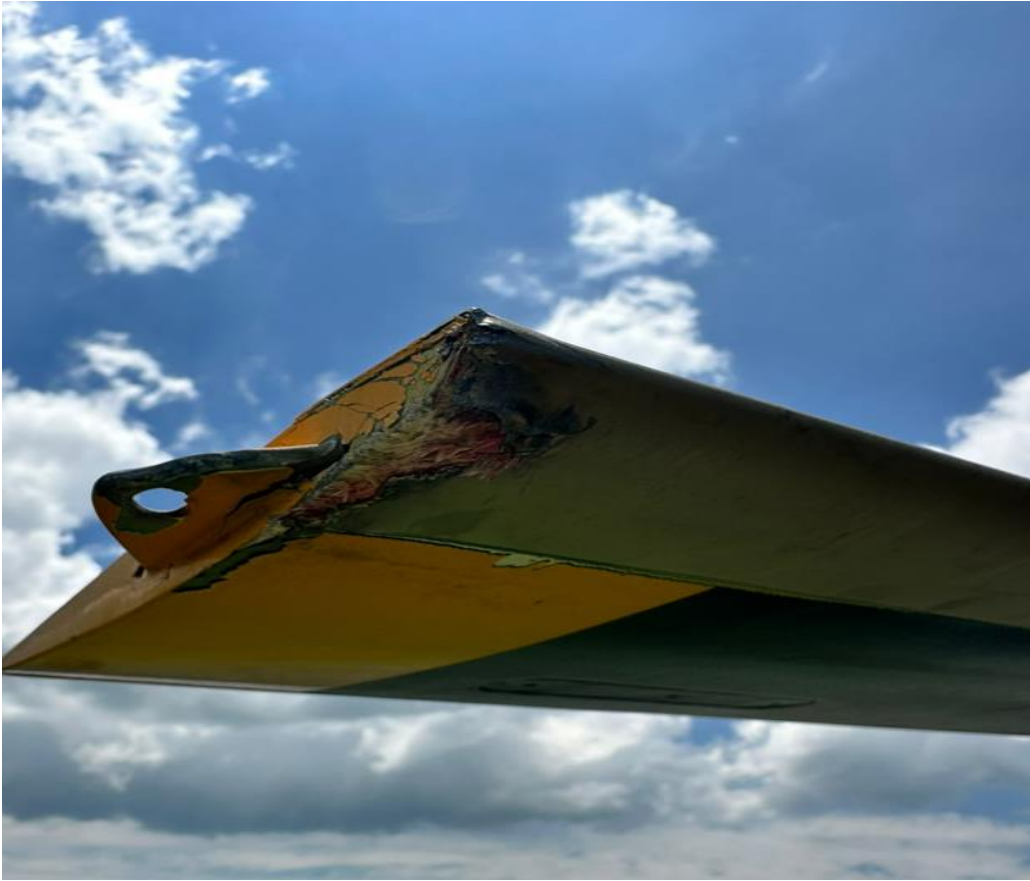
Post-landing, an inspection was conducted, and the pilot noticed that the main rotor blade tips were damaged; they had contacted the earth conductor during the bird diverters installation. As a result, the earth conductor wire strands protruded from the loom.

After the incident, the helicopter was loaded on a flatbed truck and recovered to an approved maintenance organisation (AMO) for thorough inspection. It was determined during the inspection that all four blade tips had sustained damage.

Figure 4: The damaged rotor blade. (Source: Pilot)

9. During the hover out-of-ground effect whilst the transmission line worker was installing the bird diverter, the retreating main rotor blades contacted the earth conductor. The pilot had misjudged the distance between the rotor blades and the down-sloping earth conductor.

The helicopter's main rotor blades in advertently contacted the earth conductor during installation of the bird diverters on the power lines.
