AIRCRAFT ACCIDENT REPORT AND EXECUTIVE SUMMARY

Reference:		CA18/2/3/10407	
Aircraft Registration	ZS-XPC & ZS-STD	Date of Accident	29 December 2023			Time of Accident	0908Z
Type of Aircraft	Air Tractor AT-502A and Cessna T182T		Type of Operation			Agricultural Spraying (Part 137); and Private (Part 91)	
Pilot-in-command Licence Type	Commercial Pilot Licence (CPL) & Private Pilot Licence (PPL)		Age	63 & 53		Licence Valid	Yes
Pilot-in-command Flying Experience	Total Flying Hours			14 369.4 & 386.7	Hours on Type	3 941.1 & 386.7	
Last Point of Departure	Potchefstroom Aerodrome (FAPS) North West Province						
Next Point of Intended Landing	Potchefstroom Aerodrome (FAPS), North West Province						
Damage to Aircraft	Both aircraft were destroyed						
Location of the accident site with reference to easily defined geographical points (GPS readings if possible)							
Arena Farm, Carletonville District (GPS position: 26°08'21.53" South 027°26'27.62" East), elevation 5 106 feet

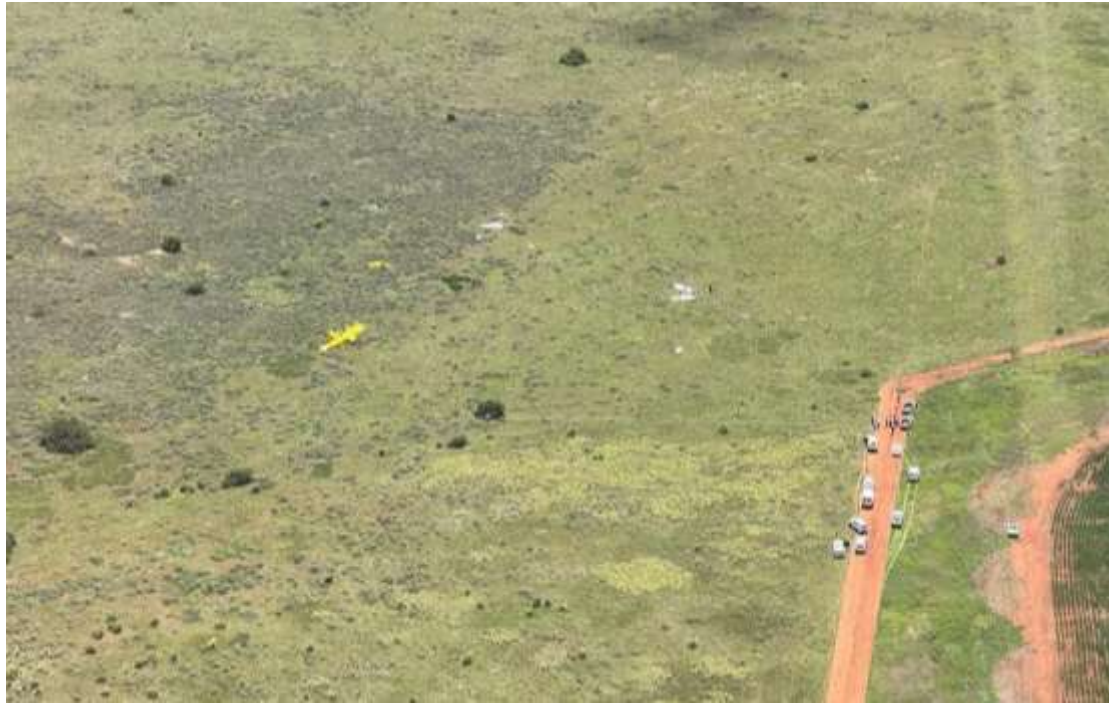
- 1.12.1 The debris covered the radius of approximately 110 metres (m). The main wreckage of ZS-STD which came to rest in an inverted attitude and faced north-easterly. The entire left wing had separated from the fuselage and was found approximately 40m from the main wreckage. The pilot's (left front) seat was found next to the right wing, and the second seat was still in the cockpit/cabin area. The aircraft was destroyed.

- 1.12.2 The main wreckage of ZS-XPC also came to rest in an inverted attitude facing south, approximately 100m from the main wreckage of ZS-STD. The empennage of the aircraft was found separated from the main fuselage. The vertical stabiliser and rudder were found separated from the aft fuselage. One of the four propeller blades was severed from the hub assembly, with the three remaining blades sustaining extensive deformation. The deep groove mark on the ground indicated that the propeller was turning under power on impact. The cockpit/cabin area of the aircraft was also severed from the fuselage. The pilot seat and the floor structure it was attached to had ripped off of the fuselage. The pilot seat was found next to the right wing of the main wreckage of ZS-STD. The propeller gear drive, which is part of the engine, had separated from the rest of the engine and was still secured to the propeller hub assembly; the rest of the engine was undamaged and still secured to the fuselage. The spraying equipment, although deformed, had remained attached to the fuselage. The aircraft was equipped with an emergency locator transmitter (ELT); the unit remained intact and was flung off of the fuselage during the impact sequence.

Figure 4: An aerial view of the accident site. (Source: A person on-board another aircraft flying in the vicinity)

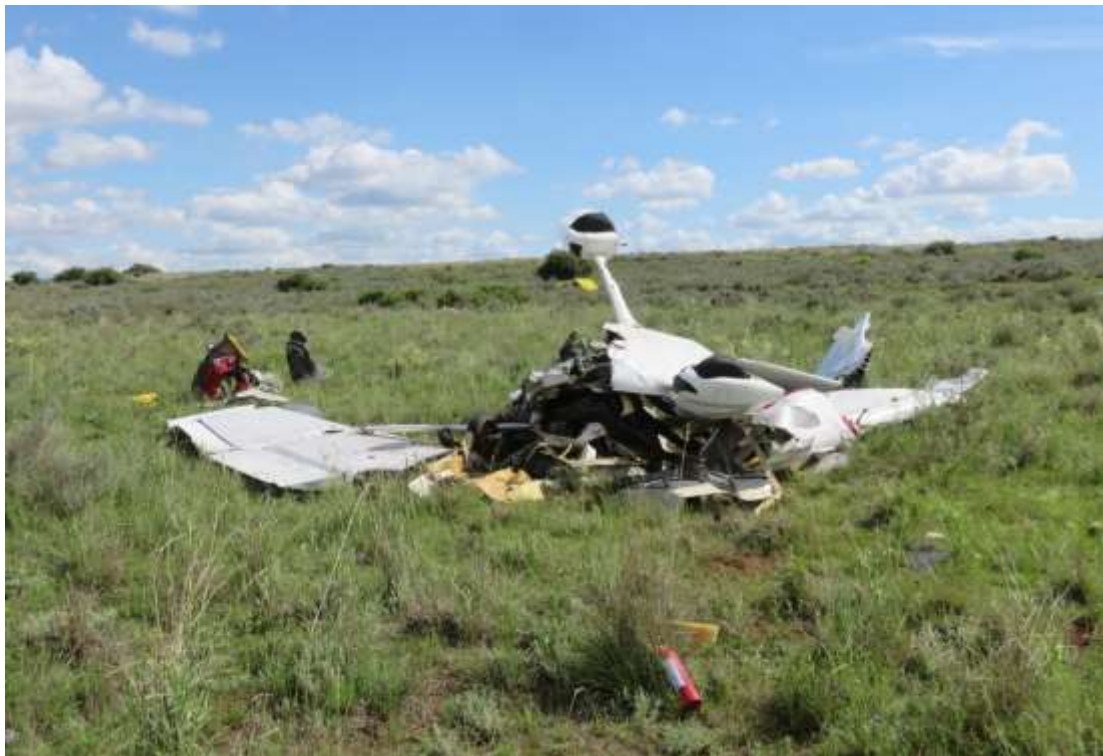
Figure 5: The main wreckage of ZS-STD.

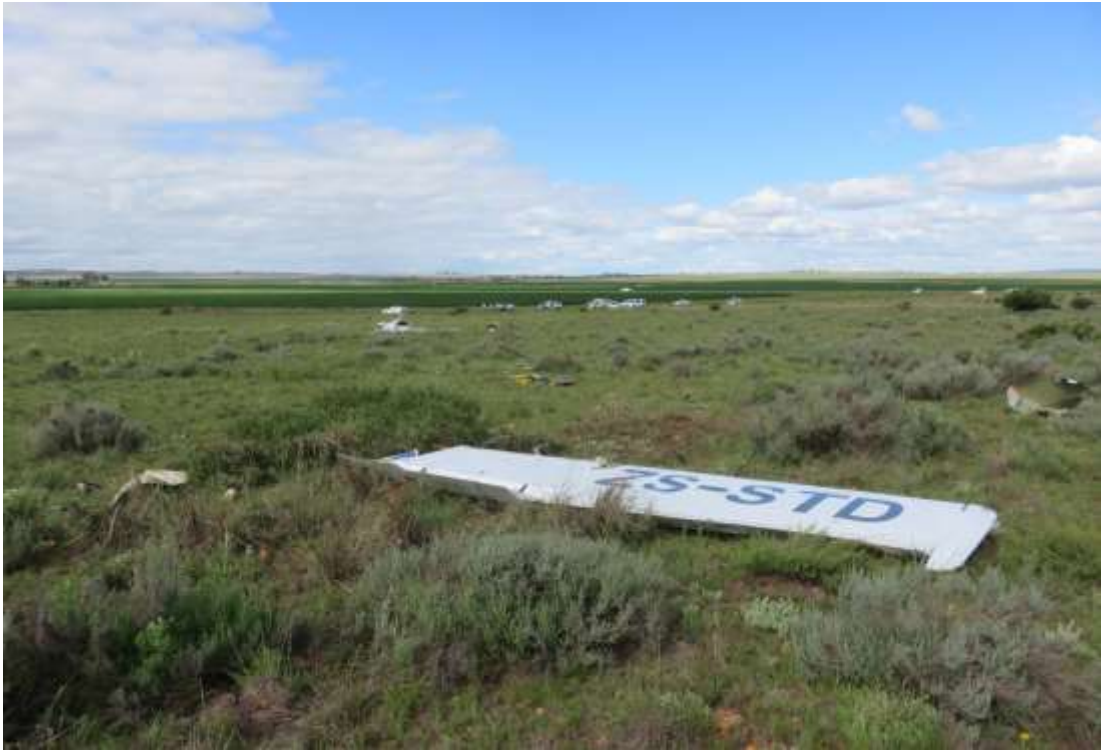
Figure 6: The left wing of ZS-STD.

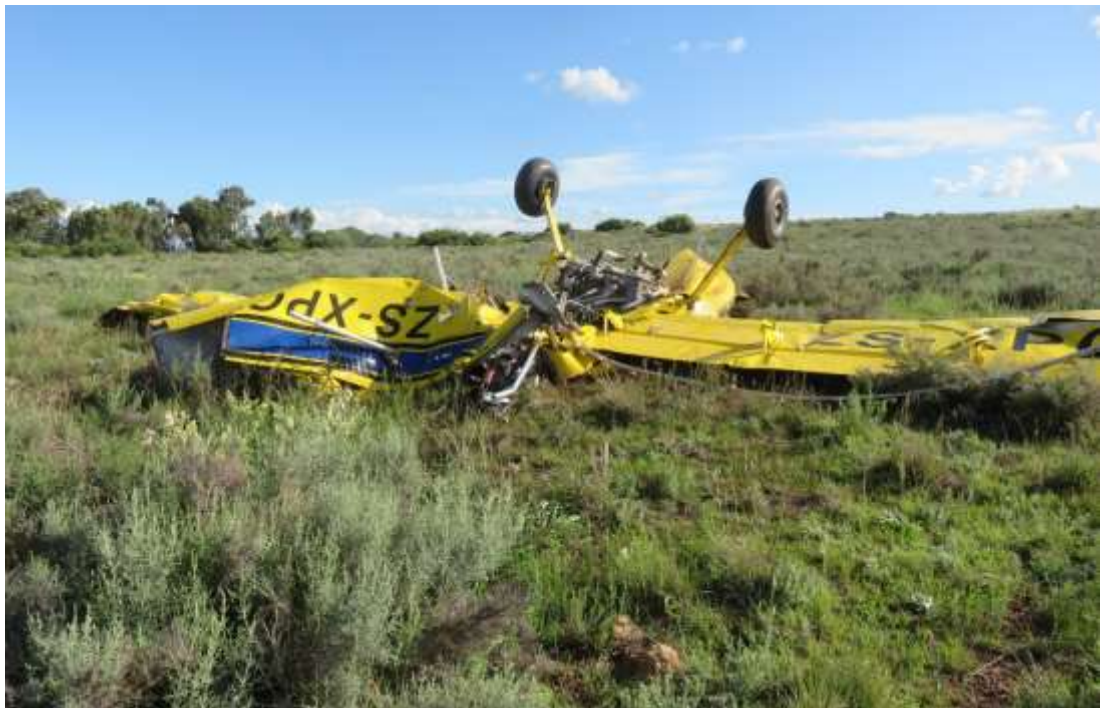
Figure 7: The main wreckage of ZS-XPC.

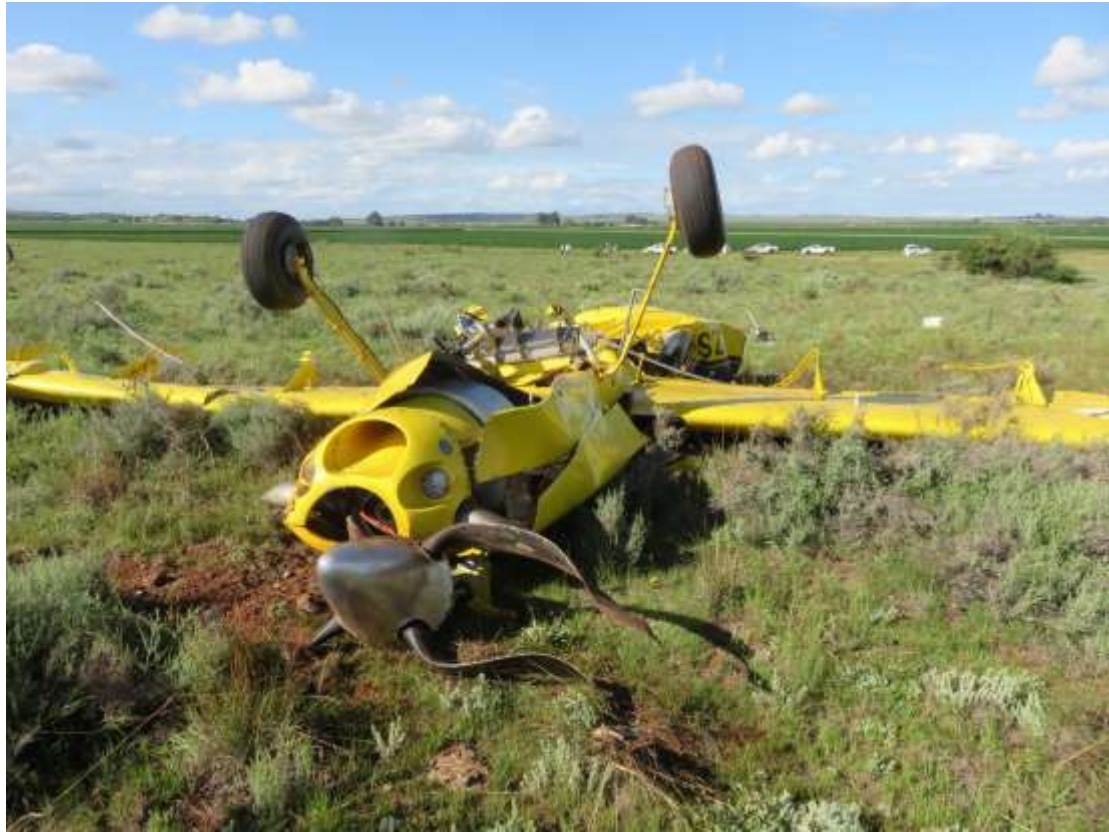
Figure 8: Deformed propeller blades, with one broken off.

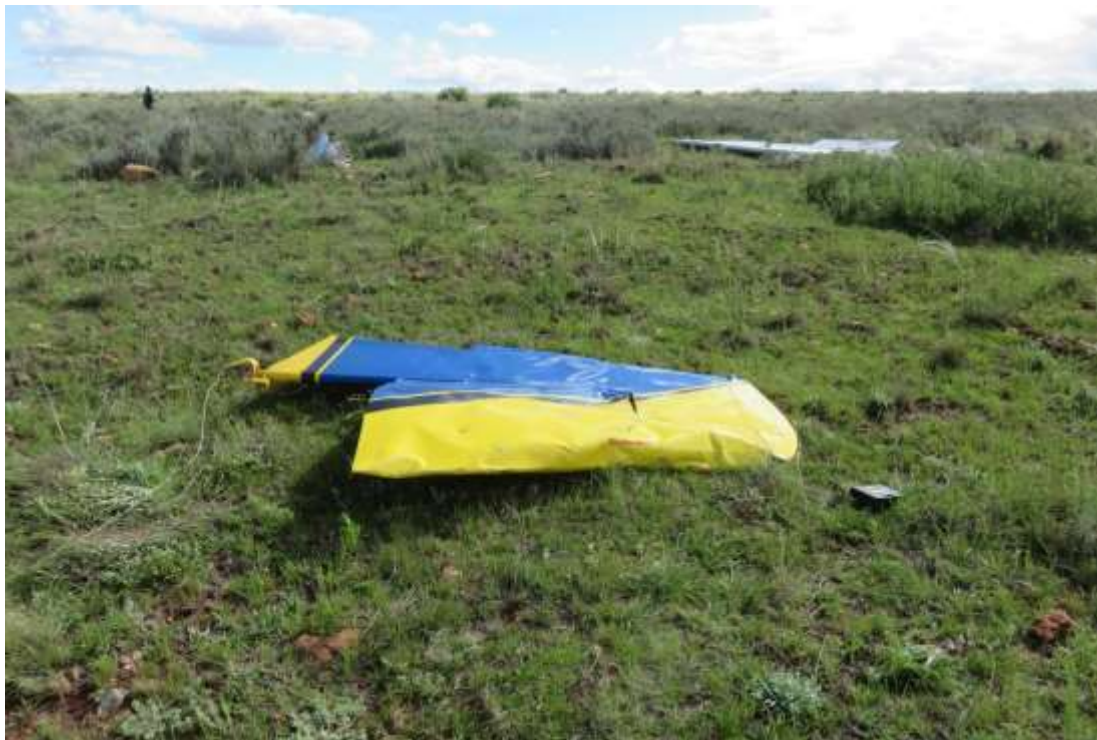
Figure 9: The vertical stabiliser and rudder assembly near the left wing of ZS-STD.

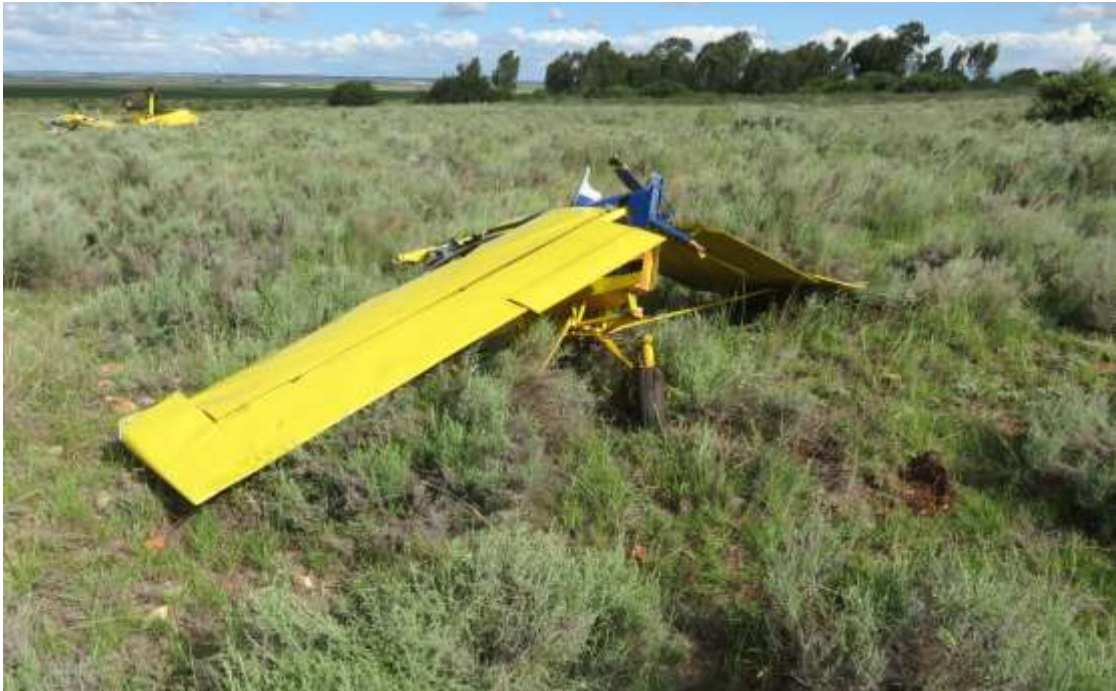
Figure 10: The aft fuselage and empennage with the two horizontal stabilisers still attached.

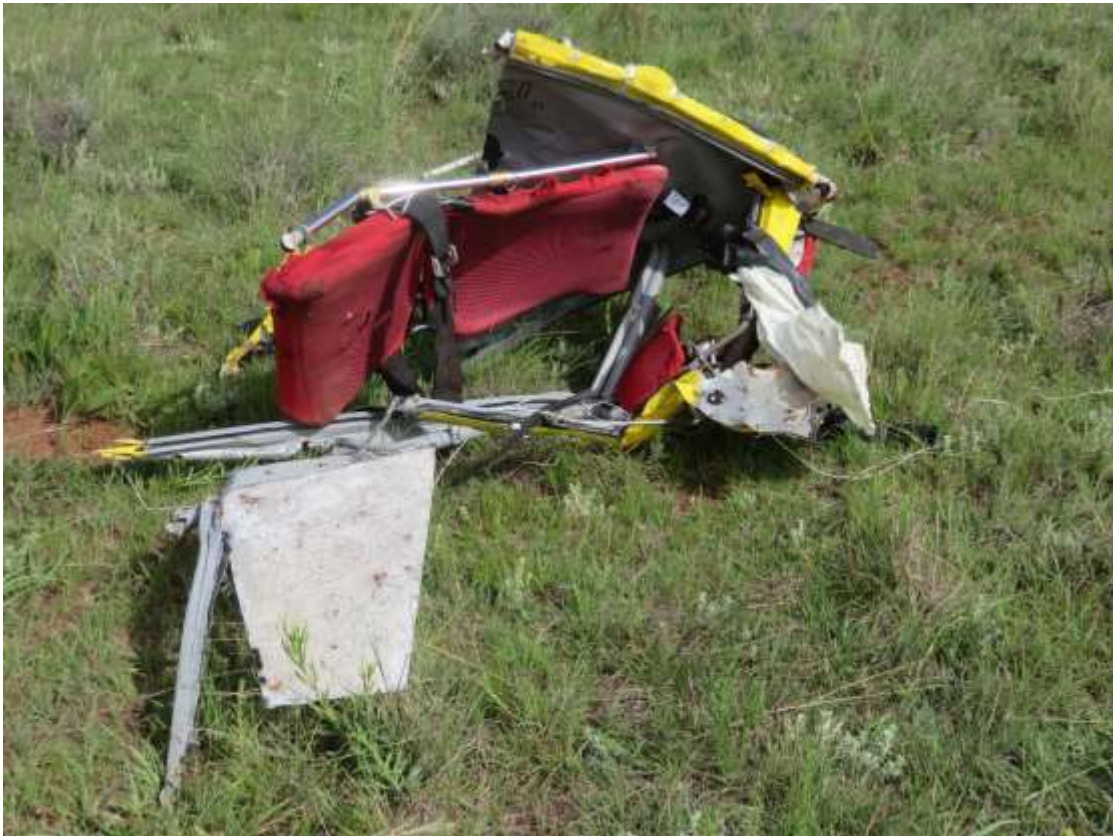
Figure 11: The pilot's seat and floor structure of ZS-XPC.

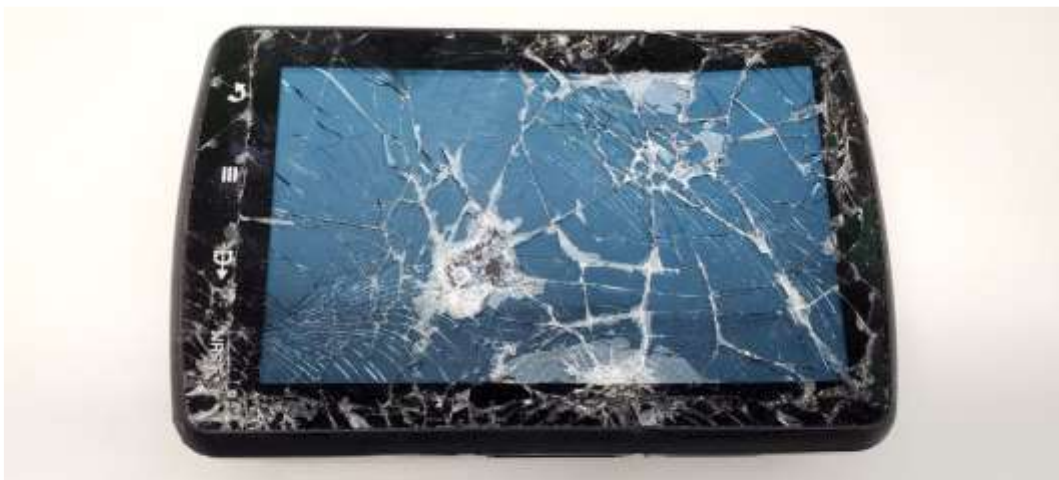
1.16.1. The ZS-STD aircraft was equipped with a Garmin Aera 795 GPS receiver; it was recovered from the accident site and was sent to the Transportation Safety Board of Canada (TSB) Engineering Laboratory to extract data that might be relevant to the accident. The GPS with serial number 2D0004741 was examined by the TSB. The substantially damaged screen and the outer casing were removed to check the circuitry, which was not damaged. It was determined that it was safe to power on the circuitry. The unit powered up but could not communicate with the laboratory computer. Thereafter, the memory chip (see Figure 13) was removed from the motherboard, cleaned and reballed. The memory chip was then placed on an adapter to be read, but there was no communication between the chip and the computer. Radiographs and computer tomography scan of the chip were completed to examine for internal damage to the chip. There was no damage found. It was likely that there was damage to the memory chip which the scans could not identify. Therefore, it was not possible to extract data from the GPS.

Figure 12: The recovered GPS unit.

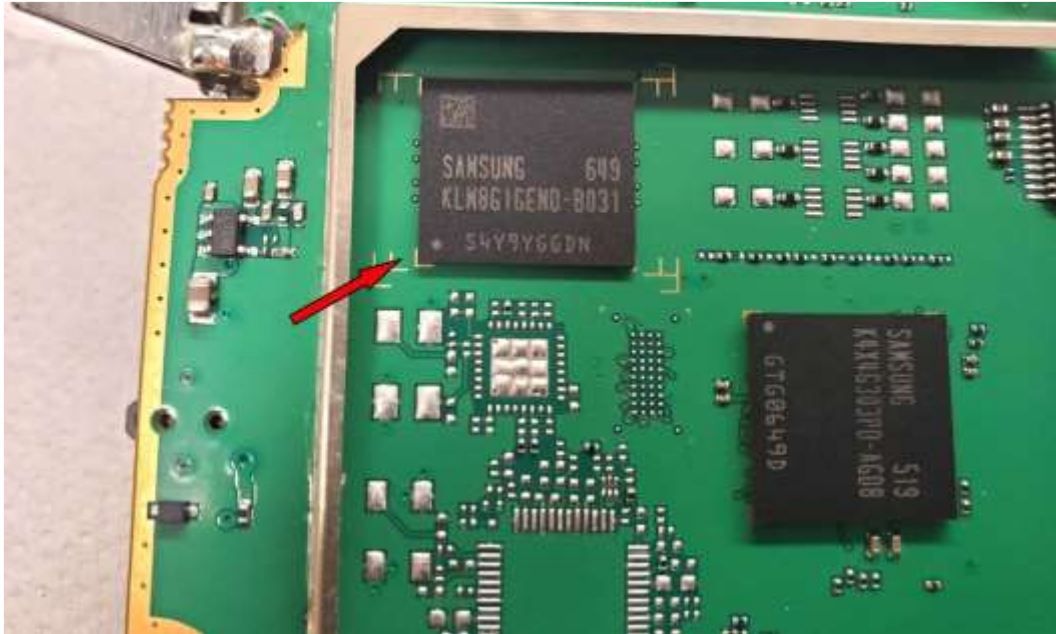
Figure 13: The undamaged memory card. (Source: Honeywell)

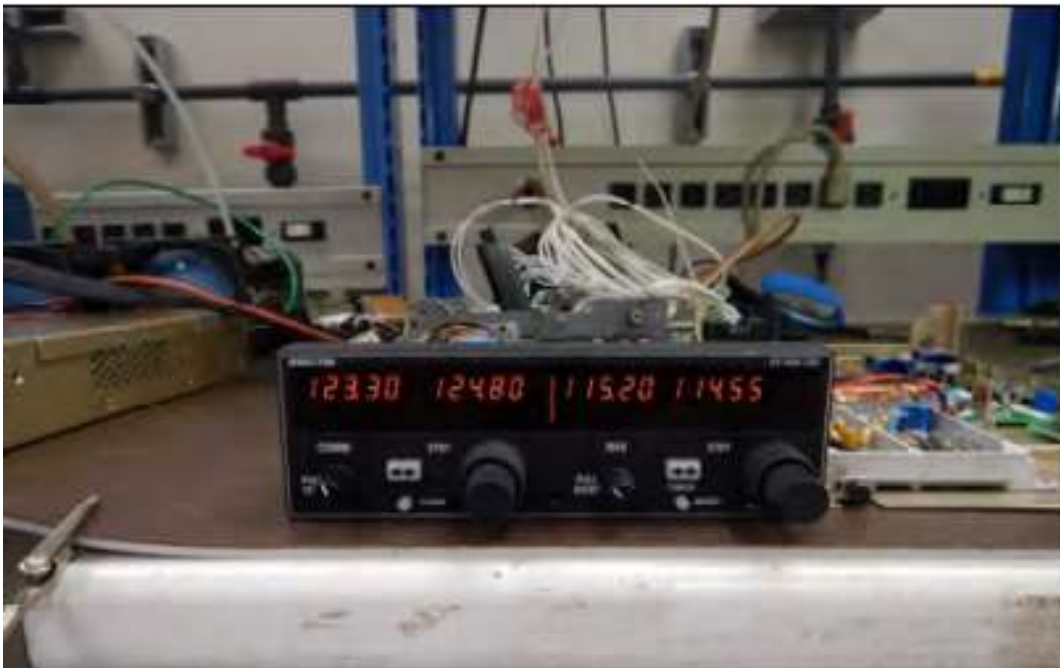
1.16.2. The ZS-STD aircraft was equipped with a Honeywell KX155A Navigation/Communication unit (Part number: 069-01032-0101, Serial number: 22916) and KT76C ATC Transponder (Part number: 066-01156-0101, serial number: 12674). These units were both sent to Honeywell in the United States of America where both memory chips were removed and installed to slave components. The last tuned frequencies were confirmed as follows: COMM 123.30 (active), 124.80 (Standby), NAV: 115.20 (active) and 114.55 (standby) [see Figure 14]. The transponder squawk code was 2000.

Figure 14: Radio frequencies displayed during testing. (Source: Honeywell)

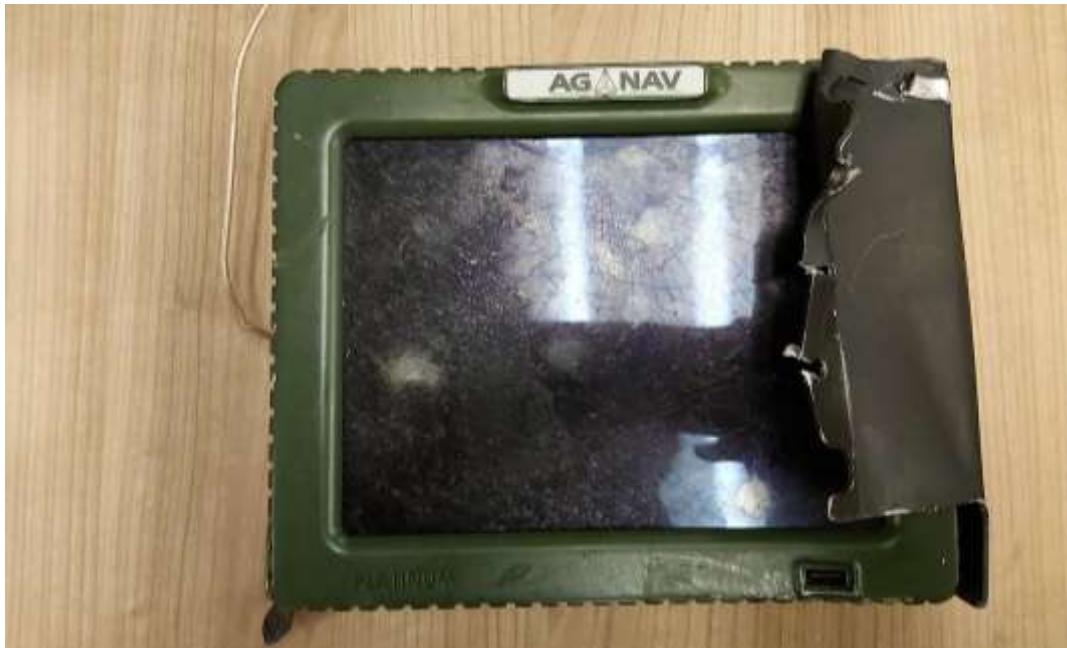
1.16.3. The ZS-XPC aircraft was equipped with an Ag-Nav Platinum, model number P771 with serial number 771200025. This unit was recovered from the accident site as it was flung off from the instrument panel during the impact sequence. The unit was shipped to the original equipment manufacturer (OEM) in Canada. Oversight during the download of the data was provided by TSB Canada. The OEM was able to power up the unit and retrieve data.

Figure 15: The Ag-Nav unit had remained intact.

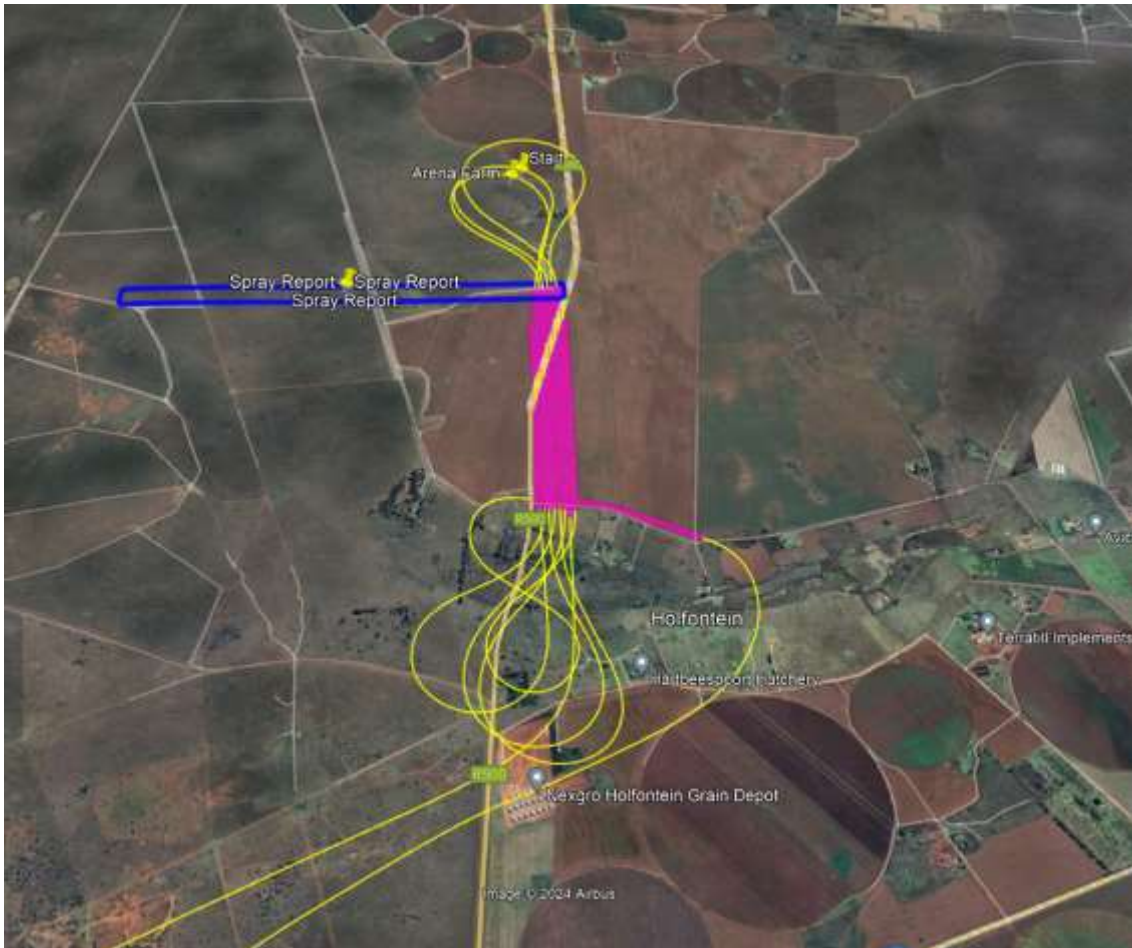
Before spraying the area, the pilot plotted a boundary of the area to be sprayed to see the guidelines to be followed. In this case, it is the area marked as a blue rectangle labelled spray report, see Figure 14.

The data recording starts from where the first spray data begins, there is no yellow line on top of that and the aircraft enters the spray area again from the bottom to the 2nd spray line and the last data that was in the unit was until the “last Ag-Nav position recorded”. There are only 6 spray enter and exit lines on the top and eight on the bottom; there is no exit for the first and last lines.

Figure 16: ZS-XPC spray track. (Source: AgNav)

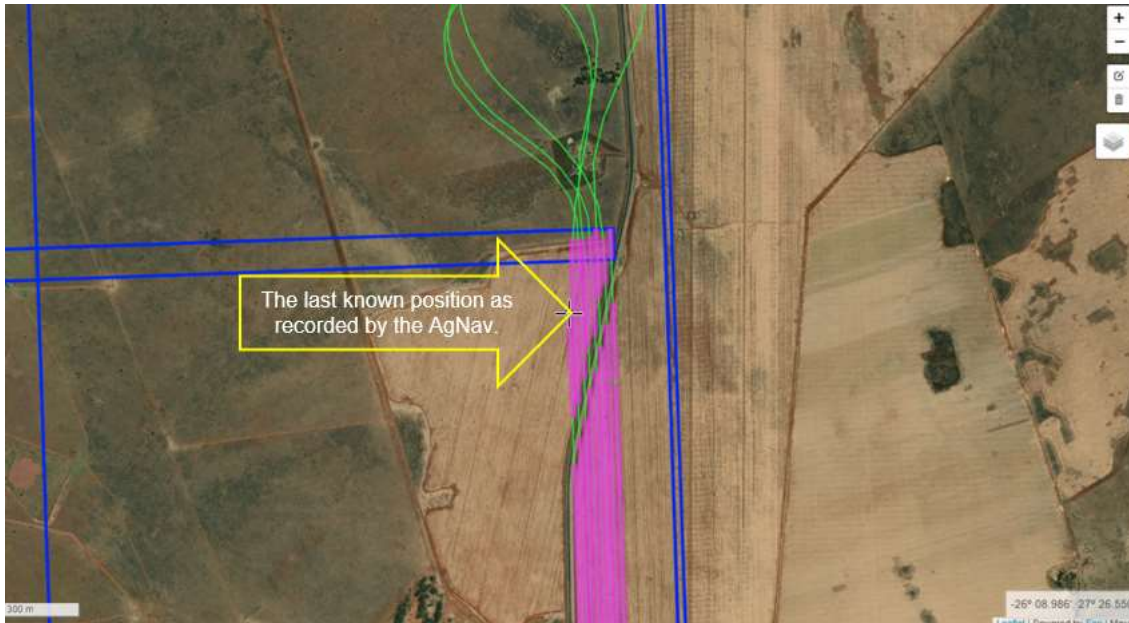
The unit powered off after the crash; it was not able to save the last few seconds of the accident data. The last data recorded was almost at the end of the spray line (flying in a northerly direction), see Figure 15.

The system writes the data records to temporary memory (RAM) for 20 seconds and then writes to the actual hard drive once the 20-second buffer is full. Since it is unknown when the aircraft lost power, the full 20 seconds could have been lost or just a part of the 20 seconds

was recorded. In this case, approximately 10 seconds of data before power loss could not be retrieved.

According to the technician's analysis, the general projection of the aircraft was that it would have made it to the final site within 10 seconds. The ZS-XPC did not deviated from its planned track.

Figure 17: The last known position of the aircraft recorded by the Ag-Nav unit. (Source: AgNav)

4.2.1. It is recommended to Ag-Nav that they consider upgrading the software of the unit to allow for shorter data-capturing intervals. The AIID acknowledges that the unit's sole purpose is to assist the pilot in accurate crop-spraying detail. The fact that the unit has a non-volatile memory that captures and stores data every 20 seconds is a bonus when these devices are retrieved for accident investigation purposes. It is, however, recommended that the OEM investigate the possibility of capturing and saving the flight track data every 1 second.

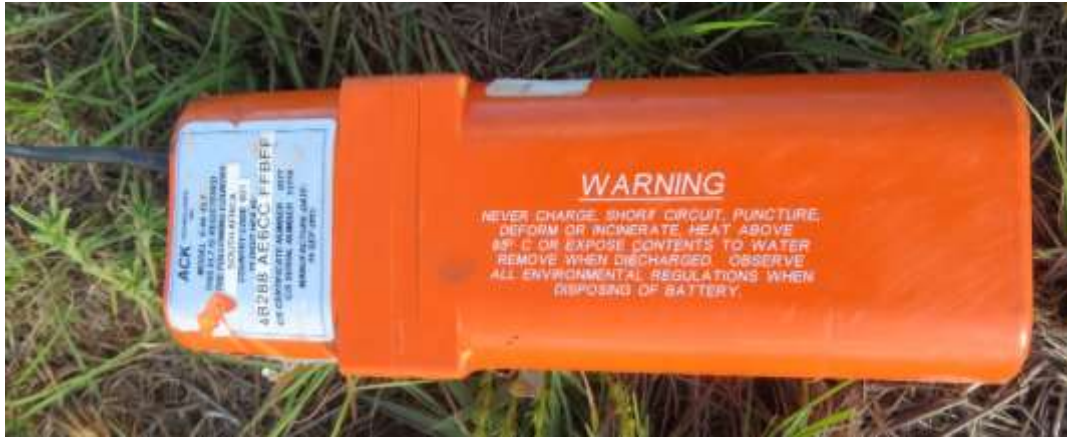
1.18.1 The ZS-XPC aircraft was equipped with a 406 MHz ELT. The unit, which remained intact and armed, was flung off of the fuselage during the accident sequence. The South African Mission Control Centre (ASMCC) in Cape Town did not receive any coded distress signal (HEX ID: 4B288 AE6CC FFBFF) for this aircraft.

Figure 18: ELT unit as it was found at the accident site.
