**LIMITED OCCURRENCE INVESTIGATION REPORT – FINAL**

<b>Reference Number</b>	CA18/2/3/10408						
<b>Classification</b>	Accident	<b>Date</b>	9 January 2024		<b>Time</b>	1430Z	
<b>Type of Operation</b>	Private (Part 94)						
<b>Location</b>							
<b>Place of Departure</b>	Robertsvale Airstrip in Gonubie, Eastern Cape Province		<b>Place of Intended Landing</b>		Rexfield Airstrip in East London, Eastern Cape Province		
<b>Place of Occurrence</b>	Runway 15 at Rexfield Airfield, East London						
<b>GPS Co-ordinates</b>	<b>Latitude</b>	32°41'86.5" S	<b>Longitude</b>	27°34'72.2" E	<b>Elevation</b>	4009 feet	
<b>Aircraft Information</b>							
<b>Registration</b>	ZU-ELC						
<b>Make; Model; S/N</b>	Kitplanes for Africa; Bushbaby Explorer (Serial Number: 1160506EX)						
<b>Damage to Aircraft</b>	Substantial		<b>Total Aircraft Hours</b>		877.5		
<b>Pilot-in-command</b>							
<b>Licence Type</b>	Private Pilot Licence (PPL)		<b>Gender</b>	Male		<b>Age</b>	60

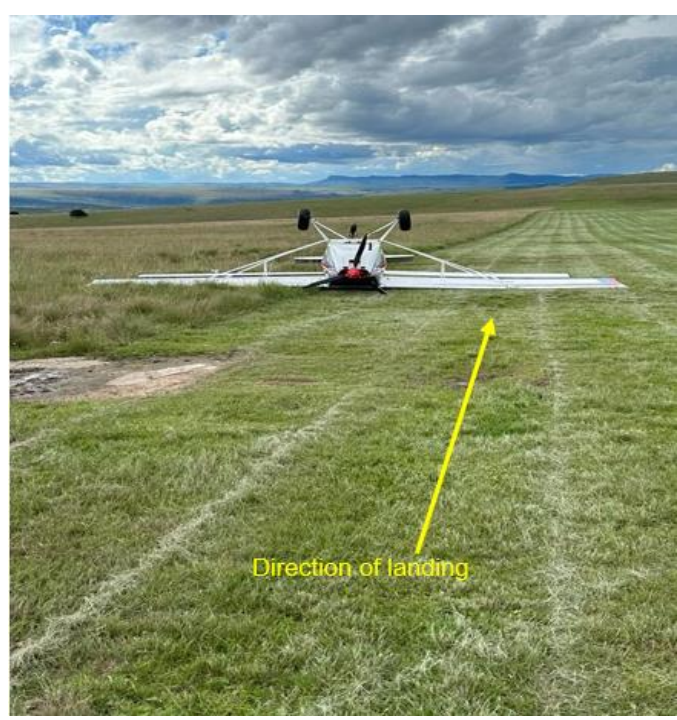
**Figure 2:** The aircraft at the accident site. (Source: Pilot)

<p>8. The aircraft's Certificate of Registration (C of R) was issued on 5 July 2016.</p> <p>9. The pilot lost directional control of the aircraft during landing and, in an attempt to recover, he applied excessive brakes which caused the aircraft to nose over.</p>
<p><b>Probable Cause</b></p> <p>The pilot lost directional control of the aircraft during the landing roll on Runway 15; in an attempt to recover, he applied excessive brakes which caused the aircraft to nose over.</p>
<p><b>Contributing Factors</b></p> <p>None.</p>
<p><b>Safety Action</b></p> <p>None.</p>
<p><b>Safety Message</b></p> <p>In the interest of safety and to avoid injury or damage to property, pilots are advised to be vigilant during the critical phases of flight such as take-off and landing.</p>
<p><b>About this Report</b></p> <p><i>The decision to conduct a limited investigation is based on factors including whether the cause is known and the evidence supporting the cause is clear, the level of safety benefit likely to be obtained from an investigation and that will determine the scope of an investigation. For this occurrence, a limited investigation has been conducted, and the Accident and Incident Investigations Division (AIID) has relied on the information submitted by the affected person/s and organisation/s to compile this limited report. The report has been compiled using information supplied in the initial notification, as well as from follow-up desk top enquiries to bring awareness of potential safety issues to the industry in respect of this occurrence, as well as possible safety action/s that the industry might want to consider in preventing a recurrence of a similar occurrence.</i></p> <p><i>All times given in this report are Co-ordinated Universal Time (UTC) and will be denoted by (Z). South African Standard Time is UTC plus 2 hours.</i></p>

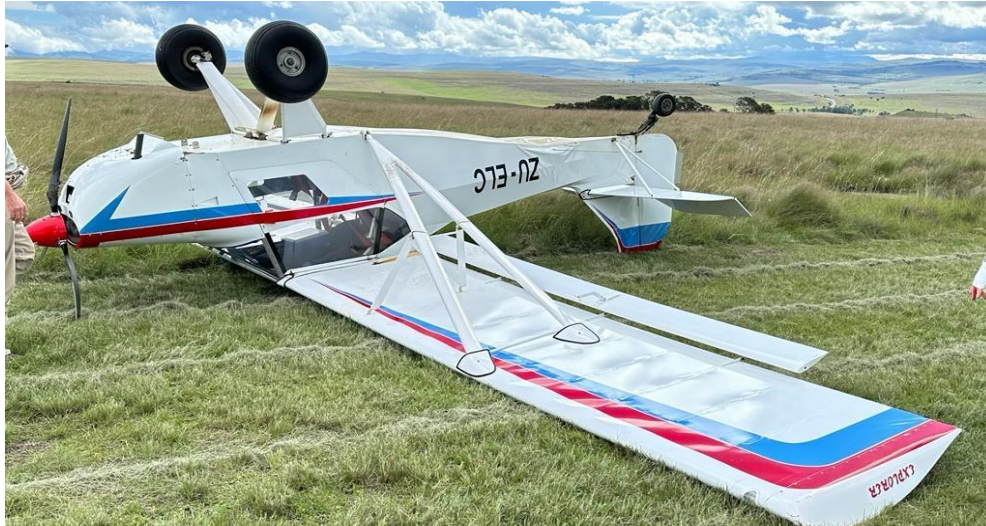
**Figure 3:** A close-up view of the aircraft at the accident site. (Source: Pilot)
