LIMITED OCCURRENCE INVESTIGATION REPORT – FINAL

Reference Number	CA18/2/3/10409						
Classification	Accident	Date	13 January 2024		Time	0627Z	
Type of Operation	Private (Part 94)						
Location							
Place of Departure	Riverside Private Airfield, Malalane, Mpumalanga Province			Place of Intended Landing	Riverside Private Airfield, Malalane, Mpumalanga Province		
Place of Occurrence	Sugarcane plantation in Malalane, Mpumalanga Province						
GPS Co-ordinates	Latitude	25°31'39.5" S	Longitude	031°23'23.3" E	Elevation	1043 ft	
Aircraft Information							
Registration	ZU-IWX						
Make; Model; S/N	Bat Hawk (Serial Number: 0102)						
Damage to Aircraft	Substantial			Total Aircraft Hours	319.1		
Pilot-in-command							
Licence Type	Private Pilot Licence (PPL)		Gender	Male		Age	53
Licence Valid	Yes	Total Hours	777.7		Total Hours on Type	777.7	
Total Hours 30 Days	4.3		Total Flying on Type Past 90 Days	58.8			
People On-board	1+1	Injuries	0	Fatalities	0	Other (on ground)	0

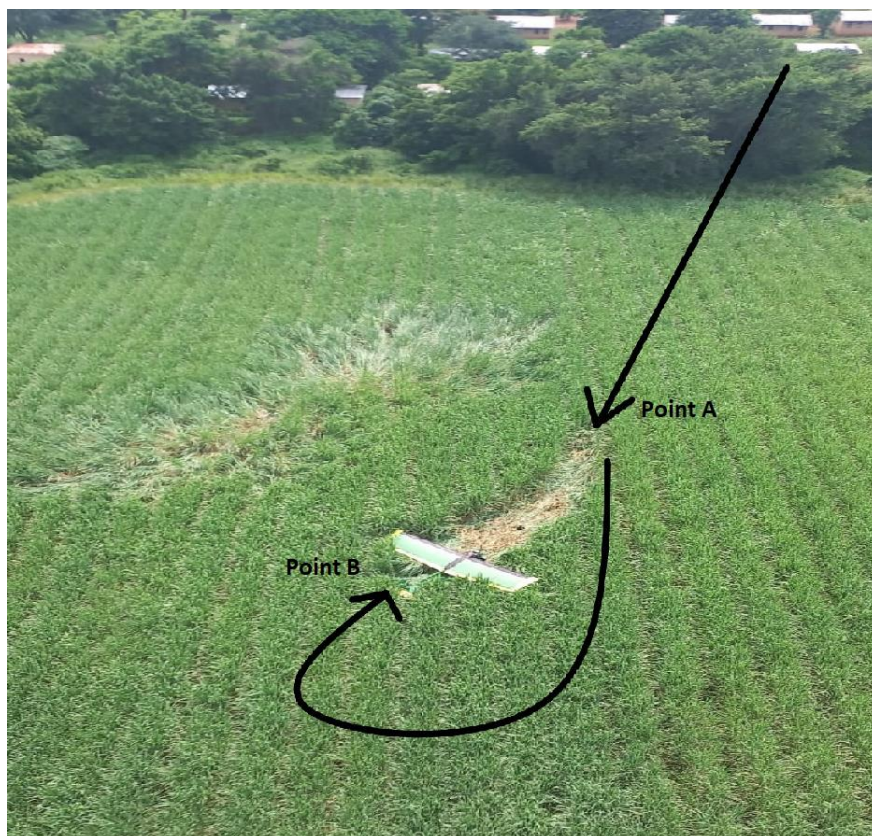
Figure 1: Point A is the initial impact. The distance between points A and B is 16 metres. (Source: Operator)

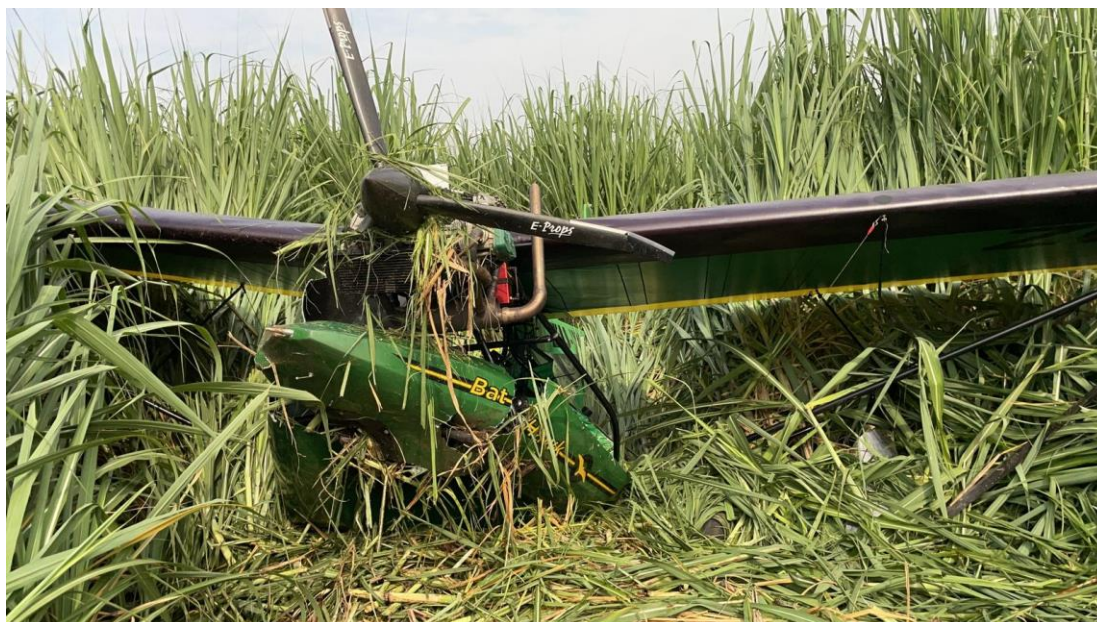
Figure 2: The microlight came to rest facing the landing direction. (Source: Operator)

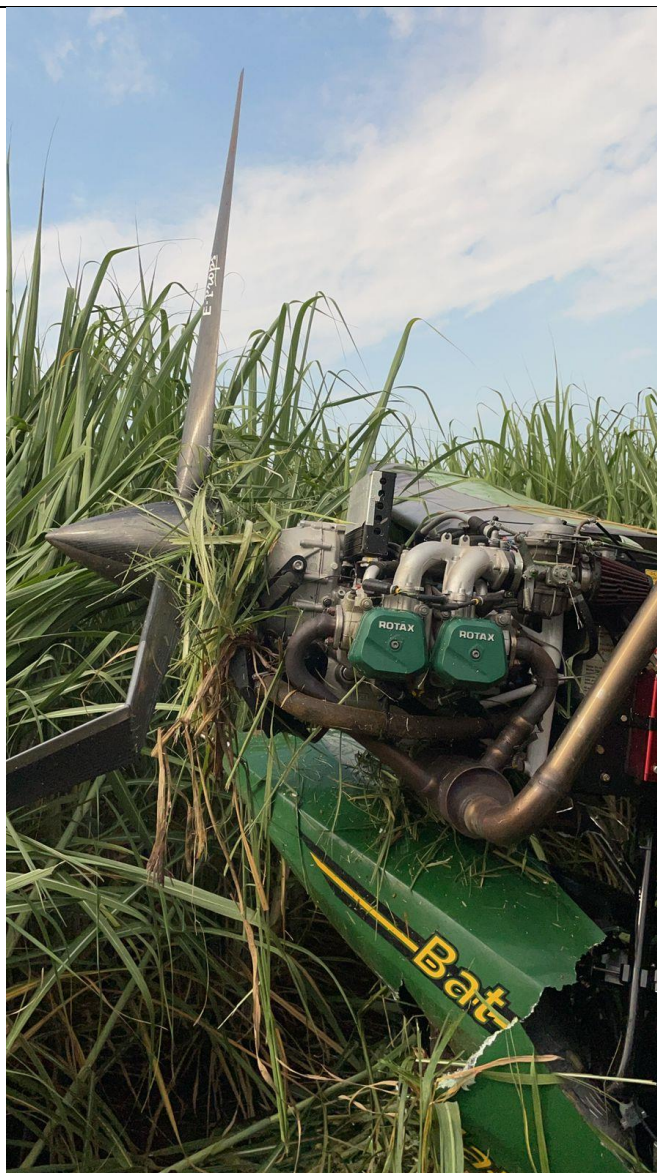
The undercarriage frame and the propellers were substantially damaged. The two occupants were unharmed.

Figure 3: The damaged airframe and propeller blade. (Source: Operator)

- *The propeller showed signs that it broke at high-speed rotation, an indication that the engine was spinning at the time of the accident.*
 - *The slightly bent axles and cracked undercarriage indicated high vertical speed.*
