LIMITED OCCURRENCE INVESTIGATION REPORT – FINAL

Reference Number	CA18/2/3/10410						
Classification	Accident	Date	11 January 2024		Time	1645Z	
Type of Operation	Private (Part 94)						
Location							
Place of Departure	Mossel Bay Aerodrome (FAMO), Western Cape Province		Place of Intended Landing	Mossel Bay Aerodrome (FAMO), Western Cape Province			
Place of Occurrence	Runway 28, Mossel Bay Aerodrome (FAMO), Western Cape Province						
GPS Co-ordinates	Latitude	34°09'25" S	Longitude	022°03'41" E	Elevation	548 feet (ft)	
Aircraft Information							
Registration	ZU-TNF						
Make; Model; S/N	Ravin 500 (Serial Number: 110523-17)						
Damage to Aircraft	Substantial		Total Aircraft Hours	460.4			
Pilot-in-command							
Licence Type	Private Pilot Licence (PPL)		Gender	Male		Age	64
Licence Valid	Yes	Total Hours	3200		Total Hours on Type	3200	
Total Hours Past 30 Days	7		Total Flying Hours on Type Past 90 Days	19.2			
People On-board	1 + 1	Injuries	0	Fatalities	0	Other (on ground)	0

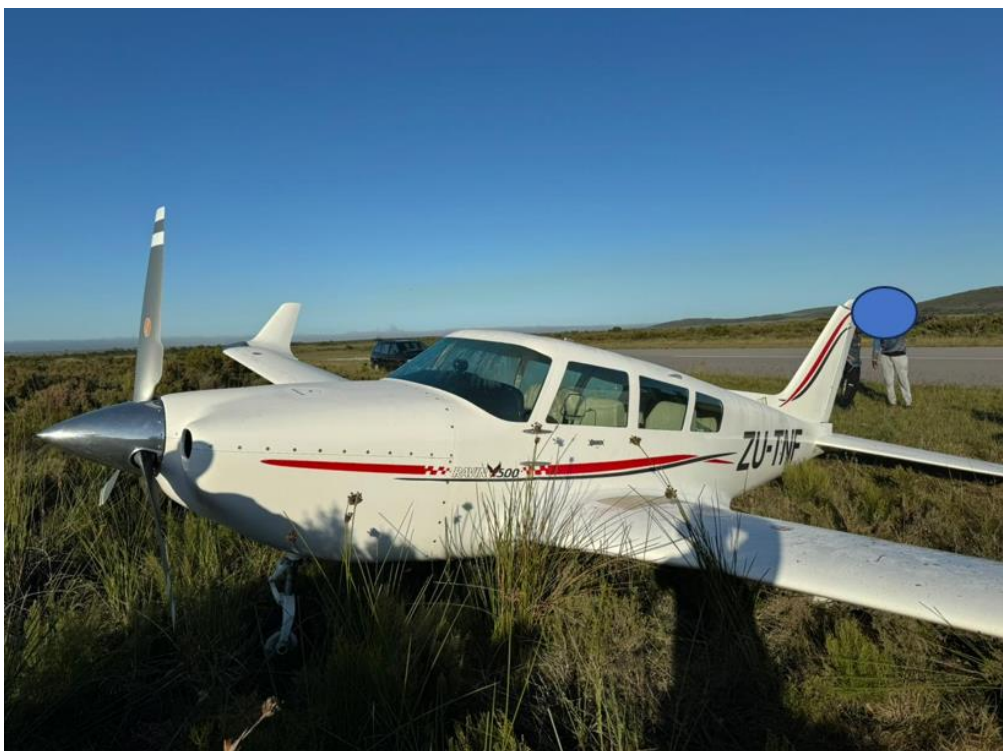
Figure 2: The aircraft as it came to rest. (Source: Pilot)

6.	The pilot flared too early and landed hard; this resulted in loss of directional control of the aircraft.
7.	The pilot also reported that he lost reference with the ground when the sun blinded his vision, hence, the early landing.
Probable Cause	
The pilot flared too early and landed hard, which resulted in loss of directional control.	
Contributing Factor(s)	
Temporary blindness (vision) due to the sun rays.	
Safety Action(s)	
None.	
Safety Message and/or Safety Recommendation/s	
None.	
About this Report	
<p><i>The decision to conduct a limited investigation is based on factors including whether the cause is known and the evidence supporting the cause is clear, the level of safety benefit likely to be obtained from an investigation and that will determine the scope of an investigation. For this occurrence, a limited investigation has been conducted, and the Accident and Incident Investigations Division (AIID) has relied on the information submitted by the affected person/s and organisation/s to compile this limited report. The report has been compiled using information supplied in the initial notification, as well as from follow-up desk top enquiries to bring awareness of potential safety issues to the industry in respect of this occurrence, as well as safety action/s that the industry might want to consider in preventing a recurrence of a similar occurrence.</i></p> <p><i>All times given in this report are Co-ordinated Universal Time (UTC) and will be denoted by (Z). South African Standard Time is UTC plus 2 hours.</i></p>

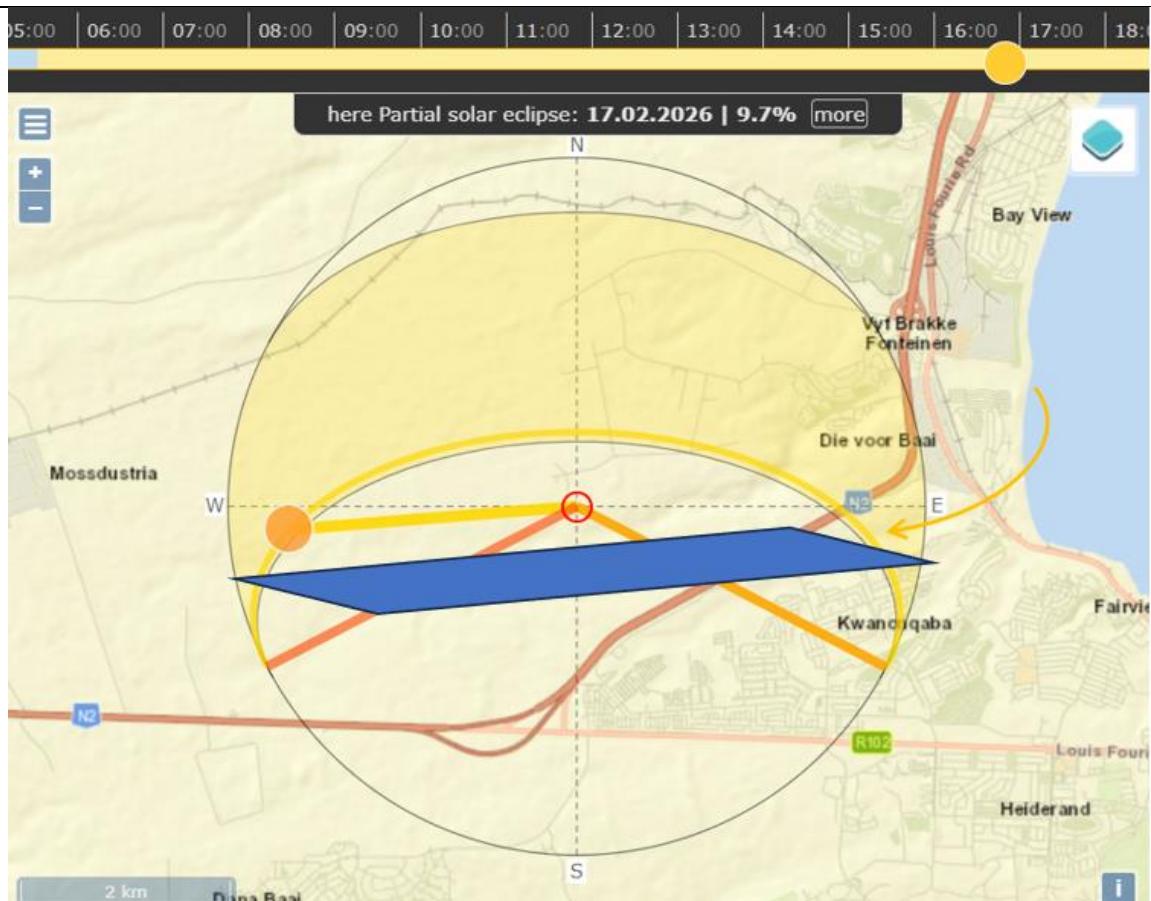
Figure 3: The sun is depicted by the orange dot on the day of the accident at 1645Z.
 (Source: <https://www.suncalc.org/#/-34.1625,22.0646,13/2024.01.11/16:49/1/3>)
