LIMITED OCCURRENCE INVESTIGATION REPORT – FINAL

Reference Number	CA18/2/3/10411						
Classification	Accident		Date	20 January 2024		Time	0750Z
Type of Operation	Parachutes and Drop Zone (Part 105)						
Location							
Place of Departure	Carletonville Aerodrome (FACR), Gauteng Province		Place of Intended Landing	Carletonville Aerodrome (FACR), Gauteng Province			
Place of Occurrence	Open field north-east of Carletonville Aerodrome (FACR) at GPS 26°21'47.59"S 27°21'58.01"E, at an elevation of 4835 feet						
GPS Co-ordinates	Latitude	26°21'49.19.5"S	Longitude	027°22'30" E	Elevation	5 000 ft	
Aircraft Information							
Registration	ZU-FFT						
Make; Model; S/N	Comp Air Inc; 7 SLX (Serial Number: 10077SLXT08)						
Damage to Aircraft	Destroyed		Total Aircraft Hours	105.4			
Pilot-in-command							
Licence Type	Private Pilot Licence (PPL)		Gender	Male		Age	62
Licence Valid	Yes	Total Hours	7 851.7		Total Hours on Type	26.5	
Total Hours 30 Days	6.8		Total Flying on Type Past 90 Days	20.1

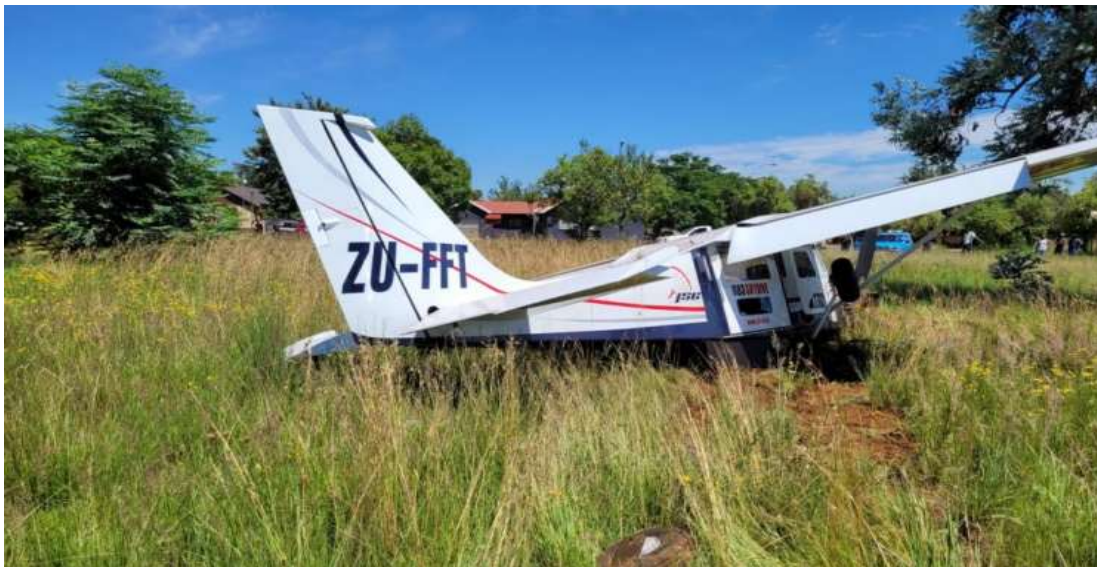
The main landing gears, propellers and the left wing were damaged during the accident. The two pilots and the three sky-divers were unharmed.

Figure 2: The ZU-FFT after it came to a stop at the accident site. (Source: Operator)

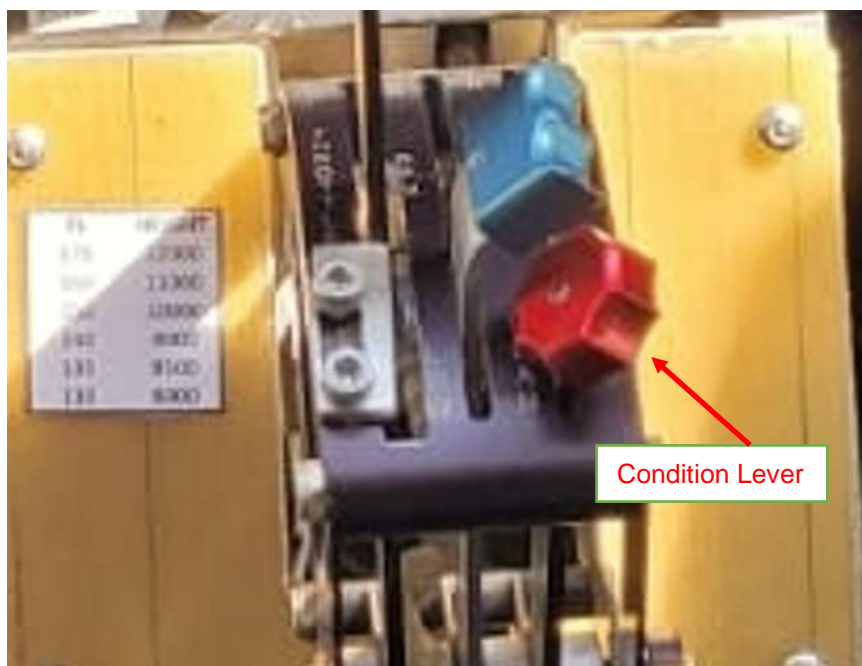
Figure 3. The quadrant with the condition lever moved backward. (Source: Operator)

During investigation, it was determined that the condition lever does not latch when pushed forward; it moves freely back and forth, thus, cutting off fuel supply to the engine.

6. The condition lever did not have a latching mechanism, which caused it to move back and forth freely during flight and, thus, cutting off fuel supply to the engine.

Lack of latching mechanism on the condition lever caused it to move freely during flight and cut off fuel supply to the engine, which resulted in engine failure.

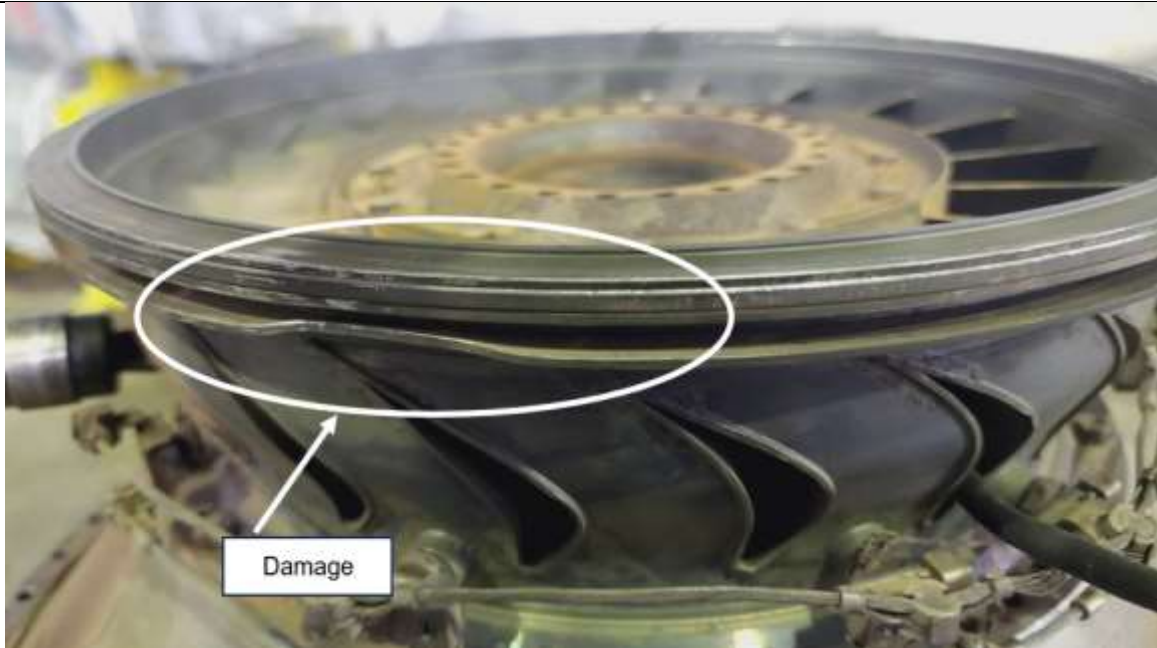
Engine strip down after accident. It has been reported that the engine failed after take-off. On inspecting the engine, the power turbine could not be turned. Upon splitting the power turbine and gas generator, the engine was able to turn freely with no restrictions. A visual inspection has been carried out on the Gas turbine. No inner damage to turbine blades and compressors was found. The outer casing was found to be distorted (Figure 3). This could be a result of the accident. No mechanical defects could be found on the visual inspection. After talking to one of the pilots that were in the aircraft at the time of the accident, revealed that the engine shut down because the condition lever was not properly in the gate, probably not properly rigged. For the engine to shut down moving the condition lever will only take approximately a centimetre from the gate. (Figures 5 & 6 show the condition lever not at the gate and at the gate.)

Figure 4: The damaged outer casing.

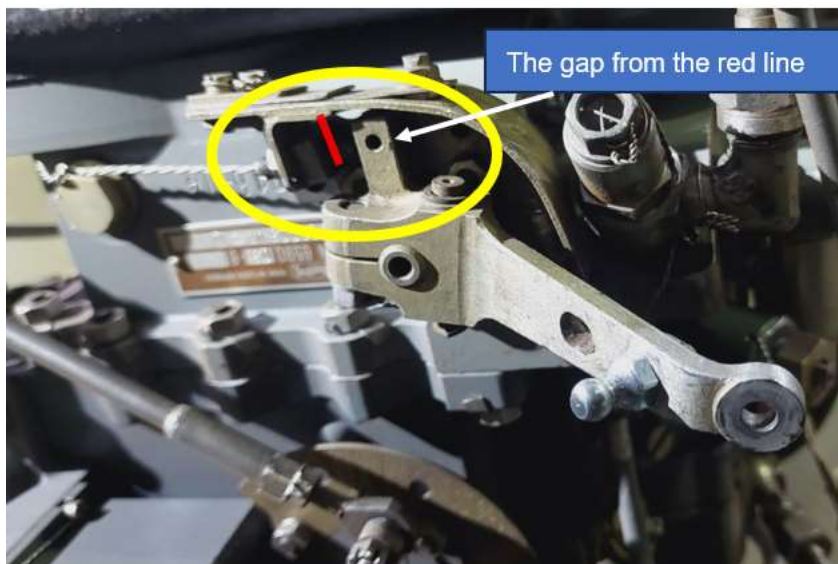
Figure 5: The condition lever which is not at the gate (with a gap).

7. The AMO found out that the condition lever was not properly rigged or in the gate.

Fitment of the condition lever that was not properly rigged.

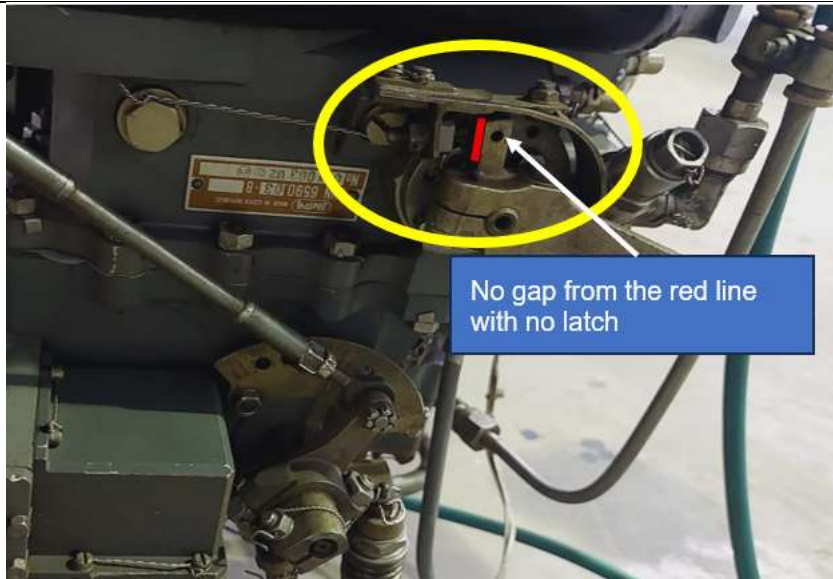
Figure 6: The condition lever at the gate (with no gap).
