LIMITED OCCURRENCE INVESTIGATION REPORT – FINAL

Reference Number		CA18/2/3/10412					
Classification	Accident	Date	23 January 2024		Time	1246Z	
Type of Operation	Private (Part 94)						
Location							
Place of Departure	Rhino Park Airfield, Gauteng Province		Place of Intended Landing	Rhino Park Airfield, Gauteng Province			
Place of Occurrence	Runway 09 Rhino Park Airfield						
GPS Co-ordinates	Latitude	25°49'59.64"S	Longitude	28°32'24.30E	Elevation	4649ft	
Aircraft Information							
Registration	ZU-FWN						
Make; Model; S/N	Sling 2 (Serial Number: 102)						
Damage to Aircraft	Substantial		Total Aircraft Hours	3319.25			
Pilot-in-command							
Licence Type	Private Pilot Licence (PPL)		Gender	Female	Age	23	
Licence Valid	Yes	Total Hours	77.6		Total Hours on Type	76.7	
Total Hours 30 Days	0		Total Flying on Type Past 90 Days		13.9		
People On-board	1+1	Injuries	0	Fatalities	0	Other (on ground)	0
What Happened							
<p>On Tuesday, 23 January 2024 at 1051Z, a pilot and a passenger on-board a Sling 2 aircraft with registration ZU-FWN were engaged in an hour building exercise. The pair took off from Rhino Park Airfield in Gauteng province to Pretoria General Flying Area 2 (GFA 2)

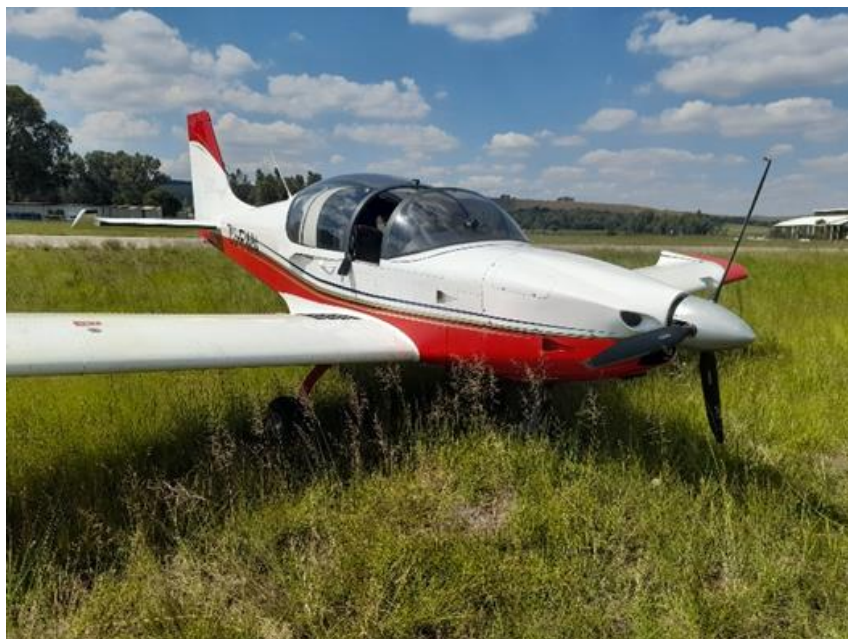
the propeller struck the ground. As a result, the pilot lost directional control of the aircraft and it veered off to the left of the runway where it came to a stop. The pilot turned off the master switch and, together with the passenger, disembarked from the aircraft; they were unharmed. The aircraft's nose gear was bent backwards which trapped the pedals; the engine cradle was also bent and broken; the nose gear tyre and the propeller were substantially damaged.

Figure 2: The aircraft post-accident. (Source: Operator)

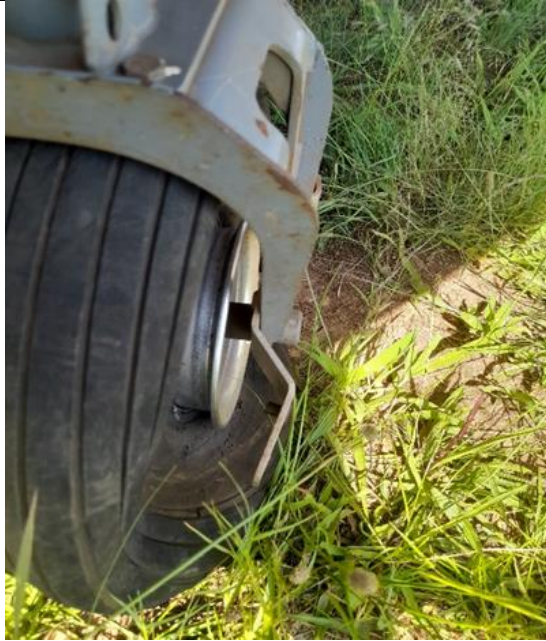
Figure 3: The burst nose wheel tyre. (Source: Operator)

<p>4. The Certificate of Registration (C of R) was issued to the present owner on 8 April 2022.</p> <p>5. The aircraft's airspeed was fast on approach, and the aircraft touched down hard before it bounced. As a result, the nose gear wheel burst and the propeller struck the runway.</p> <p>6. The pilot lost directional control of the aircraft and it veered off to the left of the runway before it came to a stop on the grass area.</p>
<p>Probable Cause(s)</p> <p>The aircraft's airspeed was high on approach which led to a hard landing and a bounce; followed by the nose gear tyre burst and the propeller strikes on the runway. The pilot lost directional control of the aircraft which led to the aircraft exiting the runway.</p>
<p>Contributing Factor(s)</p> <p>None.</p>
<p>Safety Action(s)</p> <p>None.</p>
<p>Safety Message</p> <p>Pilots are urged to be vigilant during the critical phases of flight such as take-offs and landings to prevent injuries and damage to property.</p>

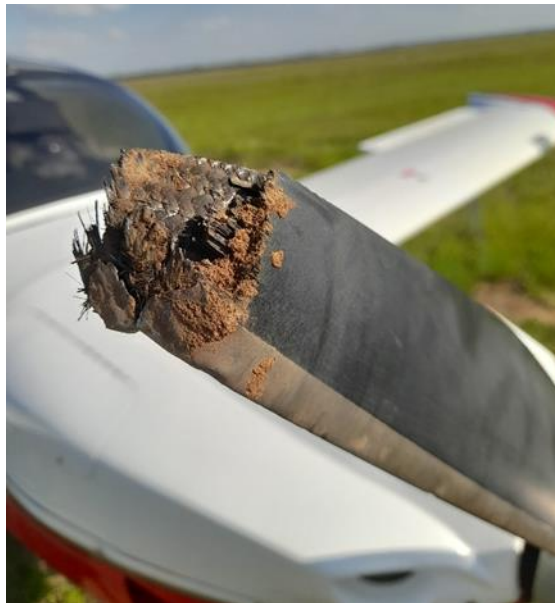
Figure 4: Damage on the propeller blade tip. (Source: Operator)
