**AIRCRAFT ACCIDENT REPORT AND EXECUTIVE SUMMARY**

<b>Reference:</b>		CA18/2/3/10413	
<b>Aircraft Registration</b>	ZU-VDD	<b>Date of Accident</b>	25 January 2024		<b>Time of Accident</b>	0728Z	
<b>Type of Aircraft</b>	Pioneer FlightStar		<b>Type of Operation</b>		Proving Flight (Part 24)		
<b>Pilot-in-command Licence Type</b>	National Pilot Licence (NPL)		<b>Age</b>	70	<b>Licence Valid</b>	No	
<b>Pilot-in-command Flying Experience</b>	<b>Total Flying Hours</b>		642.2		<b>Hours on Type</b>	274.3	
<b>Last Point of Departure</b>	Devondale Private Airstrip, Barkley West, Northern Cape Province						
<b>Next Point of Intended Landing</b>	Devondale Private Airstrip, Barkley West, Northern Cape Province						
<b>Damage to Aircraft</b>	Substantial						
<b>Location of the accident site with reference to easily defined geographical points (GPS readings if possible)</b>							
Ploughed field, approximately 500 metres south-east of Devondale private airstrip, Barkley West, at Global Positioning System (GPS) co-ordinates determined to be 28°29'17.11" South 024°39'16.86" East, at an elevation of 3 615 feet (ft)

**Reference Number** : CA18/2/3/10413  
**Occurrence Category** : Category 3  
**T

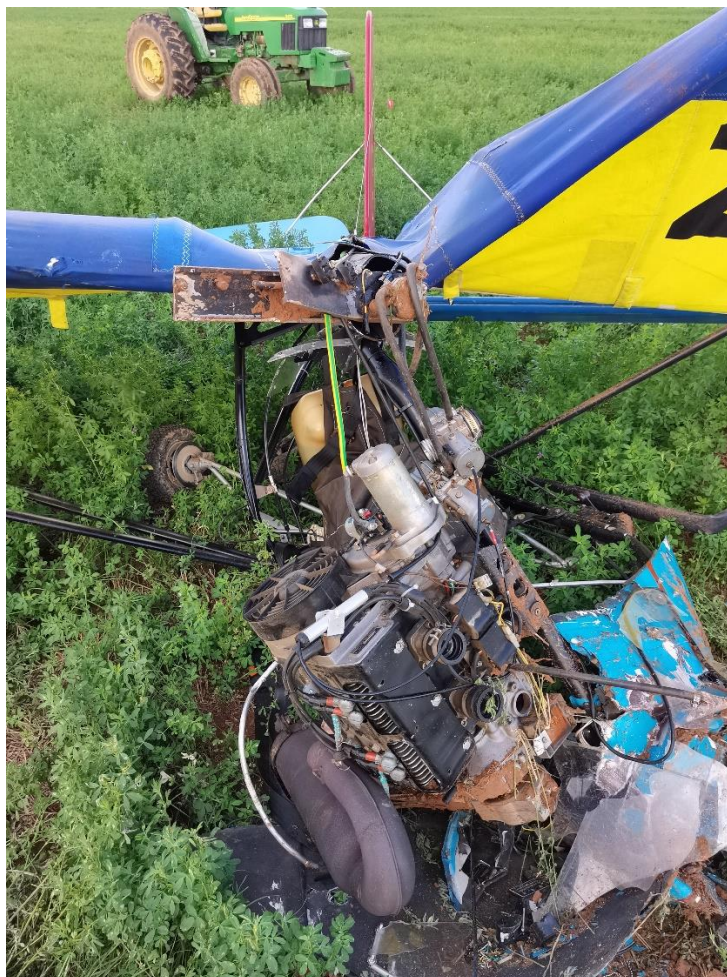
1.3.1. The aircraft was substantially damaged.

**Figure 3:** The aircraft after the crash.

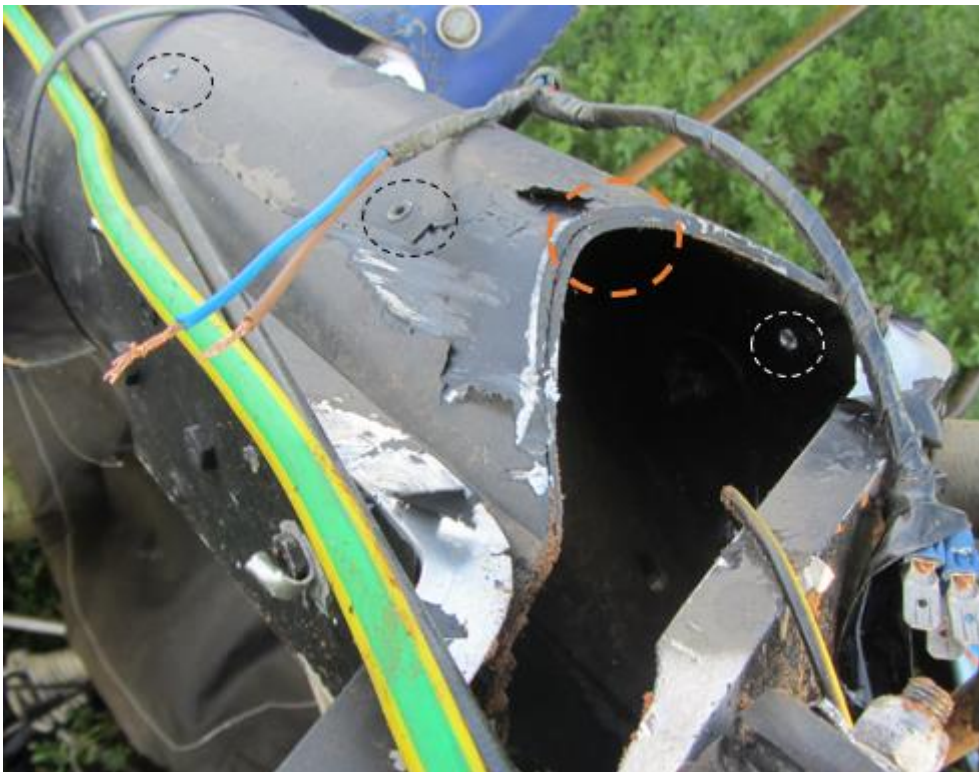
**Figure 4:** The repair scheme conducted after the incident on 7 February 1987.

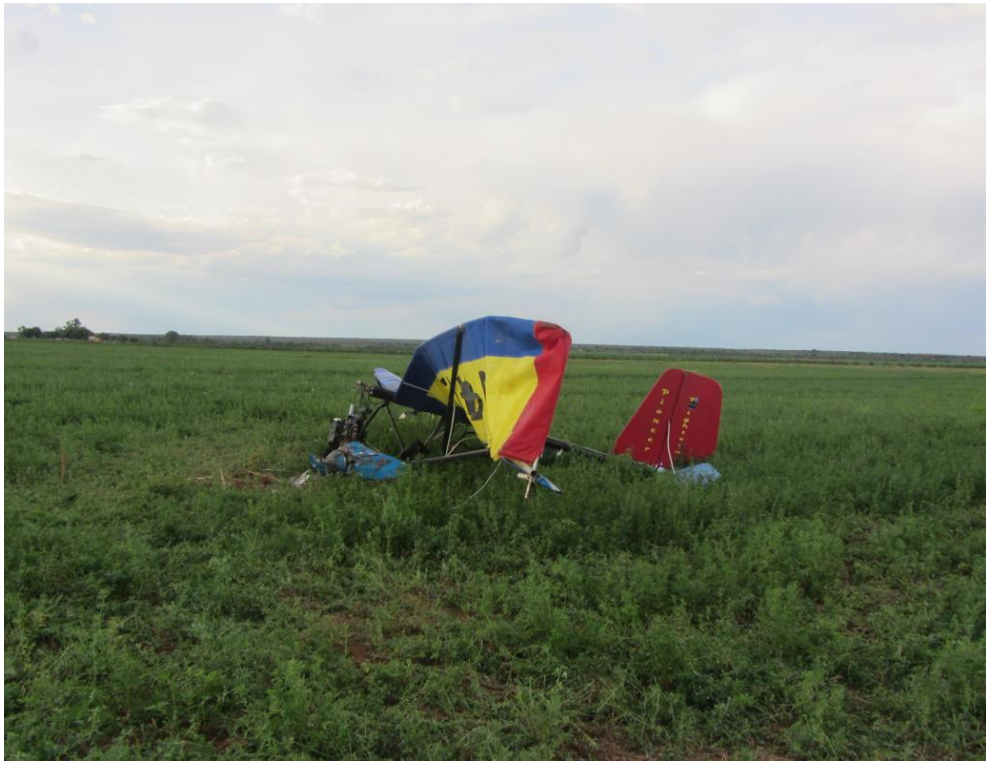
1.12.1 The aircraft impacted the vegetation-covered ground at a private farm in Barkley West, Northern Cape province. Ground scars showed that the aircraft impacted the ground in a near nose-down attitude and came to rest upright. The accident site was confined to an area of approximately 30m in diameter. The aircraft rested facing a south south-westerly direction.

**Figure 5:** The aircraft at the accident site.

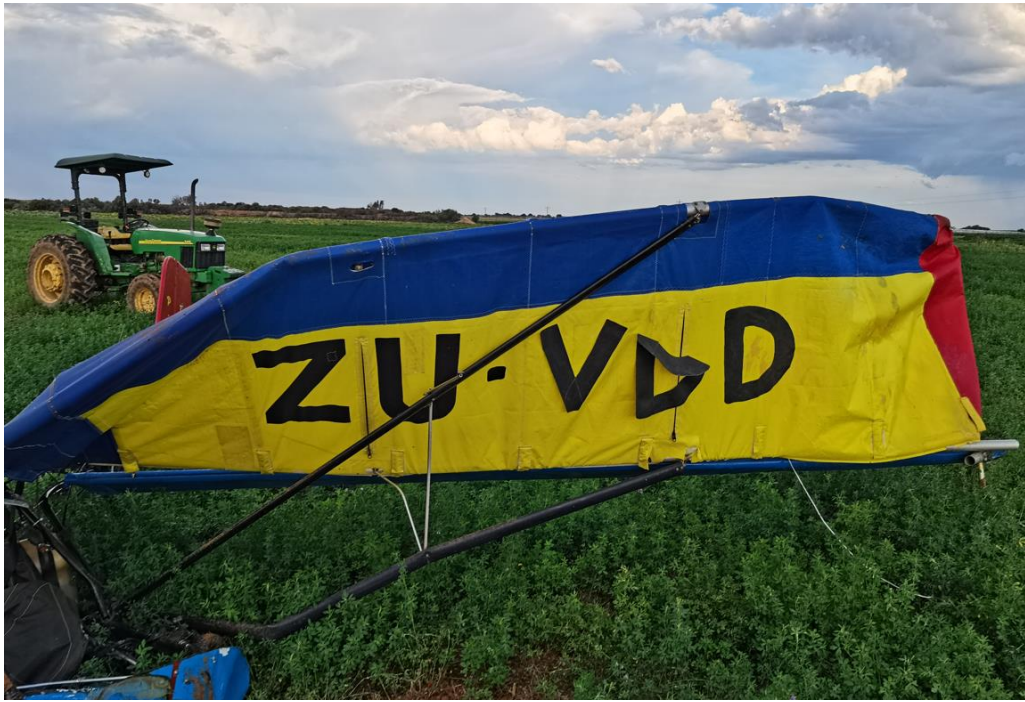
The nose section, which is made of a composite material, showed signs of deformation due to impact. The instrument panel sustained damage from the impact which caused the associated instruments to dislodge from their positions; they were found near the nose section. Both wings remained attached to the mainframe; the left wing was bent toward the mid-section on the leading and trailing edge structures, as well as at the bottom rear supporting beam. The fabric covering the structure was undamaged with no signs of separation. Both wing-tips fabric was covered in dirt and grass, an indication of contacting the ground. The main keel tube was still intact but was bent in the middle. The engine mounting position was deformed and had a 90-degree approximate bend to the right. The fuel tank remained intact; it contained ample clean fuel. A fuel sample was taken from the tank; it showed no signs of contaminants. The tricycle-type landing gear sustained impact damage. The nose gear had separated and was found near the nose section. Pieces of the Perspex were found around the front section.

**Figure 6:** The deformed left wing.

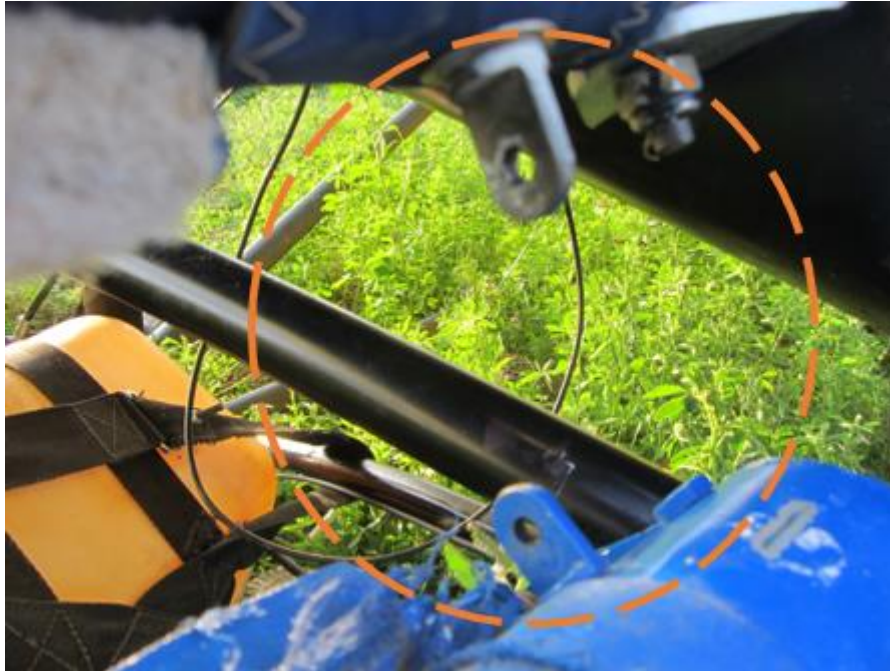
The nose section and cabin were heavily damaged. The flight controls were checked for continuity. The tail section, including the elevator and rudder flight control surfaces had remained intact, and any up or down movement was transferred to the cabin through the Teleflex cable. The right-side aileron was secure with four attachments (bolt, nut and safety ring) on the trailing edge, and the left aileron was secured with two attachments on the outboard side (pin and safety ring). The impact caused the mid-section of the left aileron to bend. Due to the missing attaching hardware, functionality of the ailerons was not possible, however, continuity was confirmed via Teleflex cables. The aileron mixture plate was still secured, and all attaching hardware was in place.

**Figure 7:** The orange circle shows the unsecured left aileron inboard attachment points.

3.2.15 The left aileron had missing attaching hardware which likely failed during the stall. The attaching hardware that was used on the aircraft was not the approved hardware for the aircraft, according to the Assembly Manual.

4.2.1. In the interest of safety, it is recommended that owners of aircraft adhere to the manufacturer recommended maintenance practices and the provisions of the CAR 2011 as amended with regards to the operation and maintenance of aircraft.

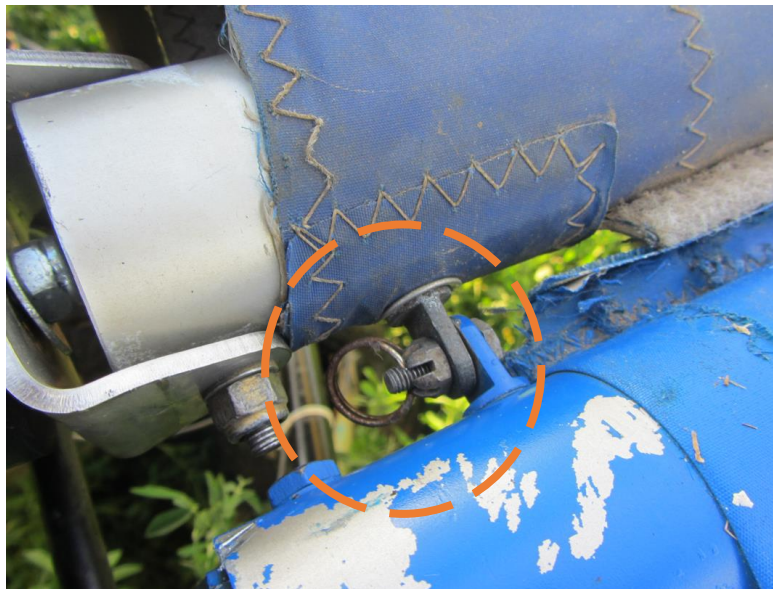
**Figure 8:** Right-side aileron attached with a bolt, nut and safety ring.

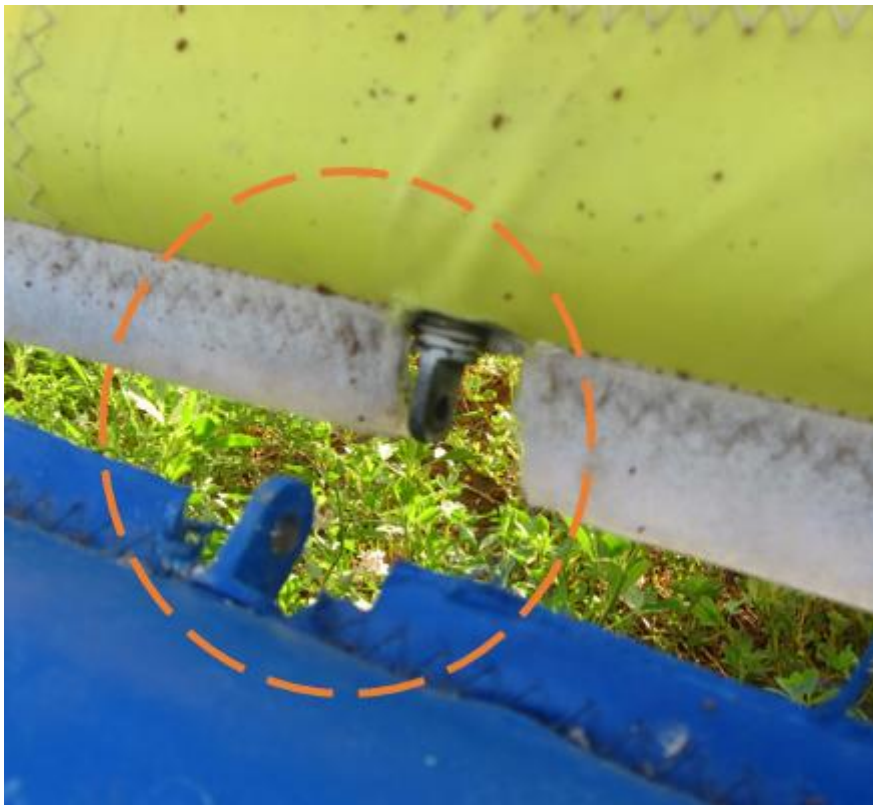
**Figure 9:** The orange circle shows the second unsecured attachment point of the left aileron.

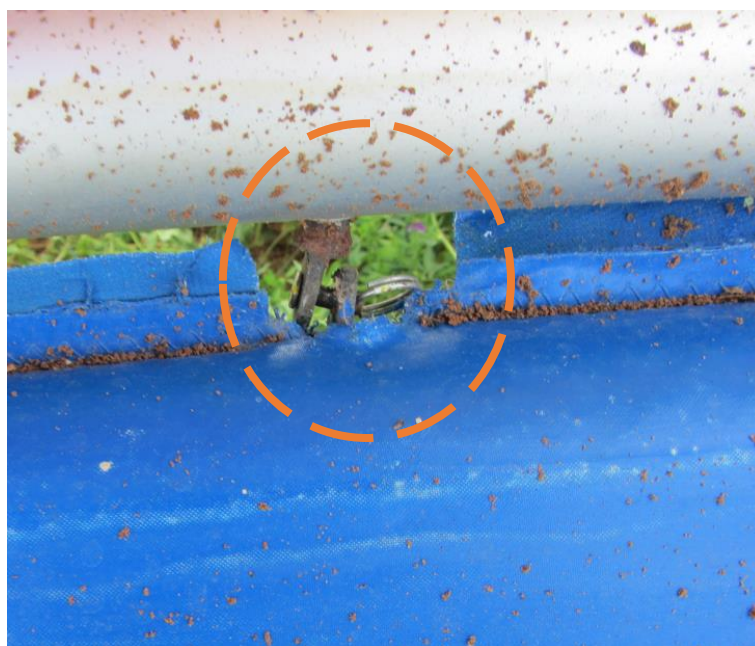
**Figure 10:** Attaching hardware found on the left aileron.

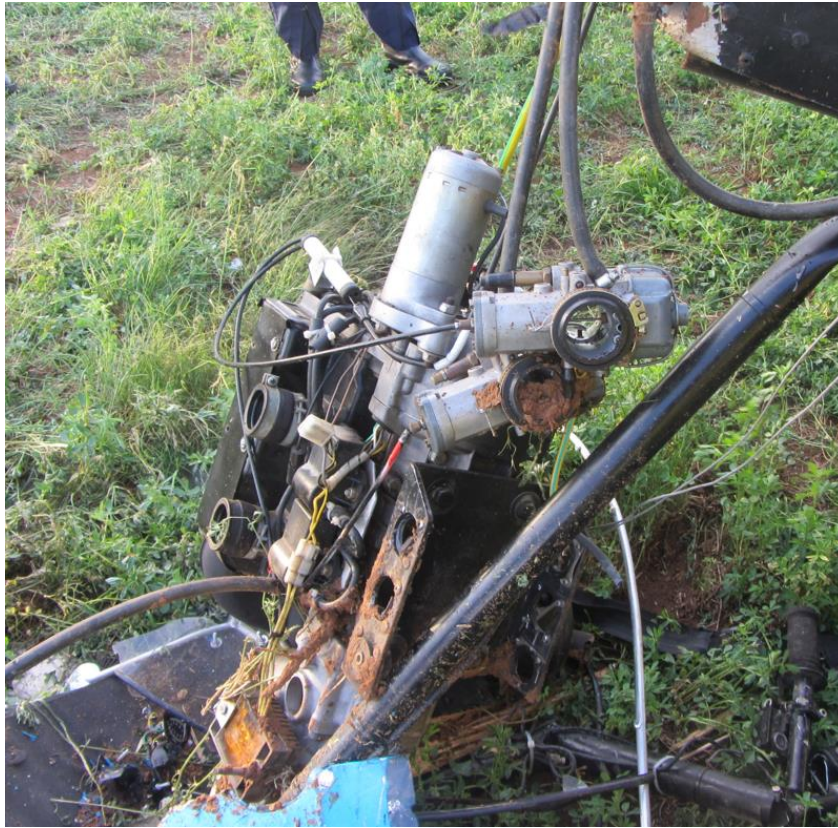
The engine had dislodged from its attaching points. Both carburetors had dislodged from their respective positions and were found suspended by the throttle cables and fuel pipes. Two of the wooden propeller blades had disintegrated; a piece of one of the blades was buried in the sand and the other blade was retrieved on the right side of the aircraft. Examination of the engine revealed that it was operating at full power during impact. One carburettor had soil and dirt on the intake side. The bowls were opened, and one carburettor

bowl had fuel and the other was dry. The carburettor filter looked clean and free of sediments. The fuel pipes were intact and showed no signs of rupture. The engine turned freely by hand.

**Figure 11:** The engine with soil and dirt on the front surface.

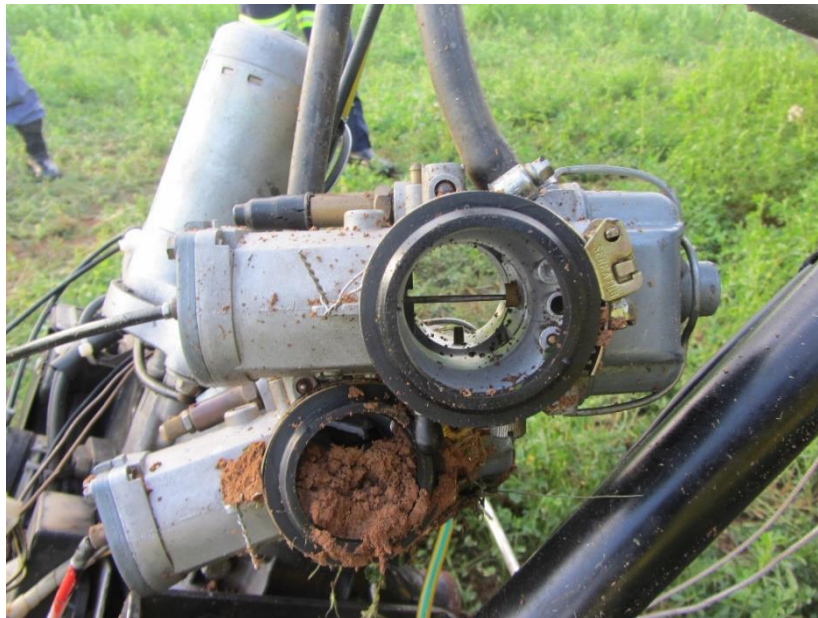
**Figure 12:** The dislodged carburetors.

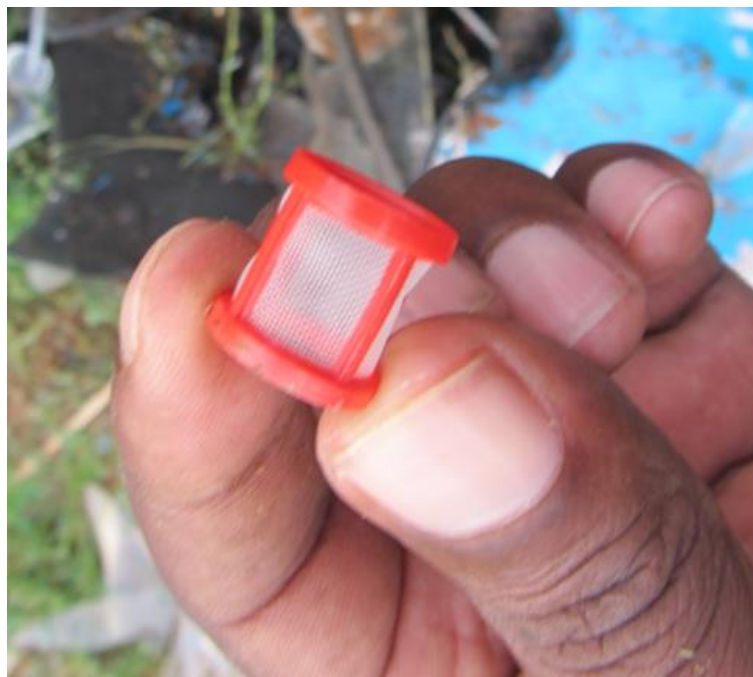
**Figure 13:** The dirt-free carburetor filter.

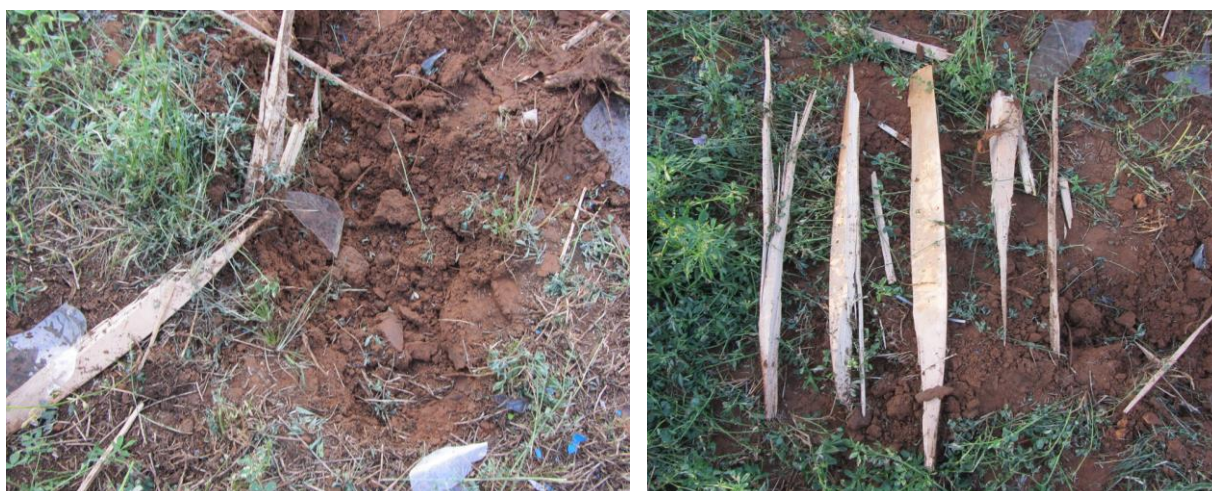
**Figure 14 (left and right):** One of the fragmented blades was buried on the ground with the hub (left), and the pieces of the fragmented blades spread out on the ground (right).

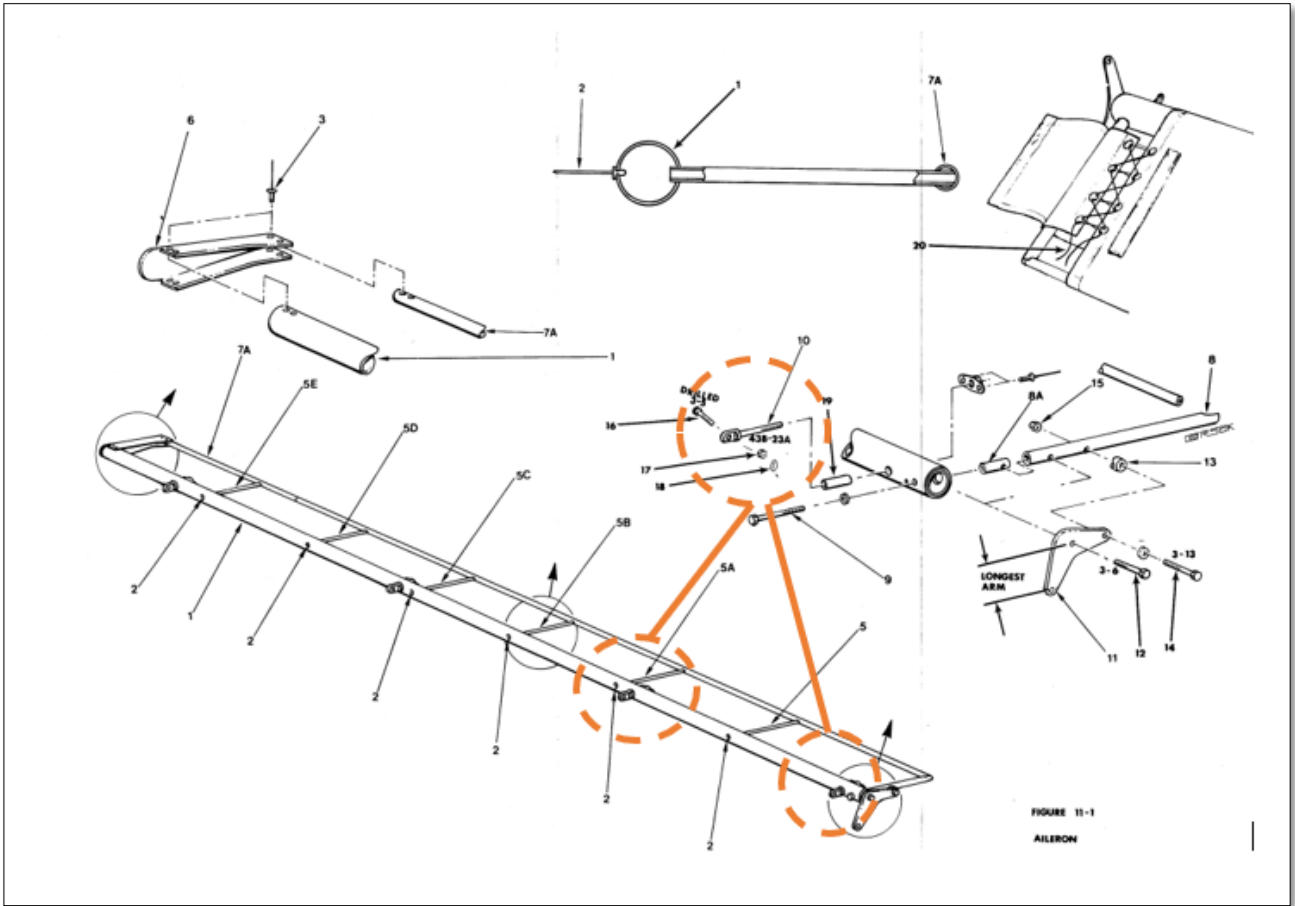
**Diagram 1:** The position of the missing hardware on the left aileron.

19. Secure flap on aileron sail with Velcro sewn to sail.
- 20. Secure aileron to rear wing spar with four bolts (16), and four nuts (17). Tighten nuts finger tight and install four safety rings (18).**
