**AIRCRAFT ACCIDENT REPORT AND EXECUTIVE SUMMARY**

<b>Reference:</b>		CA18/2/3/10414	
<b>Aircraft Registration</b>	ZS-LUW	<b>Date of Accident</b>	27 January 2024		<b>Time of Accident</b>	0600Z	
<b>Type of Aircraft</b>	Ayres S2R-T34 Turbo Thrush		<b>Type of Operation</b>		Private (Part 91)		
<b>Pilot-in-command Licence Type</b>	Commercial Pilot Licence (CPL)		<b>Age</b>	66		<b>Licence Valid</b>	Yes
<b>Pilot-in-command Flying Experience</b>	<b>Total Flying Hours</b>		3 717.2	<b>Total Hours on Type</b>		1 210	
<b>Last Point of Departure</b>	Bethlehem Aerodrome (FABM), Free State Province						
<b>Next Point of Intended Landing</b>	Kruger Mpumalanga International Airport (FAKN), Mpumalanga Province						
<b>Damage to Aircraft</b>	Destroyed						
<b>Location of the accident site with reference to easily defined geographical points (GPS readings if possible)</b>							
Southern side of Ermelo Airfield (FAEO) at Global Positioning System (GPS) co-ordinates determined to be South 26°29'46.0" East 029°59'04.0" at an elevation of approximately 5 800 feet (ft)

**Reference Number** : CA18/2/3/10414  
**Occurrence Category** : Category 1  
**Operator Name** : Osmond Aerial Spray (Pty) Ltd  
*

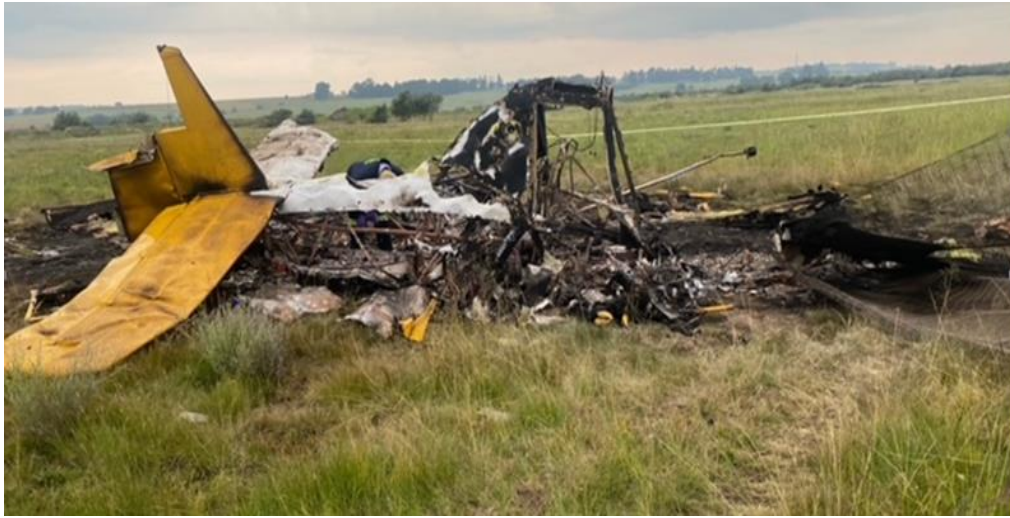
1.3.1. The aircraft was destroyed.

**Figure 3:** The wreckage at the accident site.

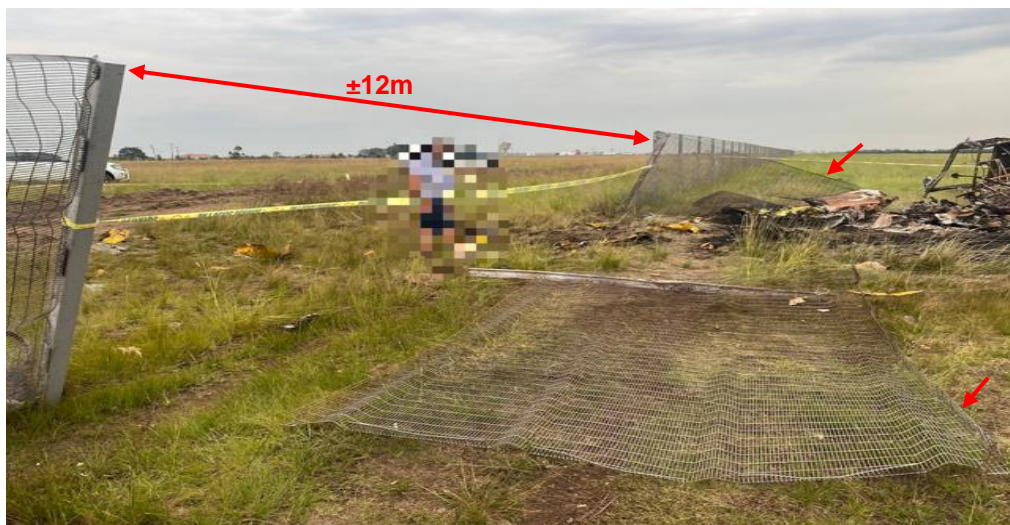
1.4.1 Other damage was limited to the FAEO perimeter fence. The aircraft knocked down about 12 metres (m) of the fence during the accident sequence.

**Figure 4:** The knocked down perimeter fence on the northern side of the airfield.

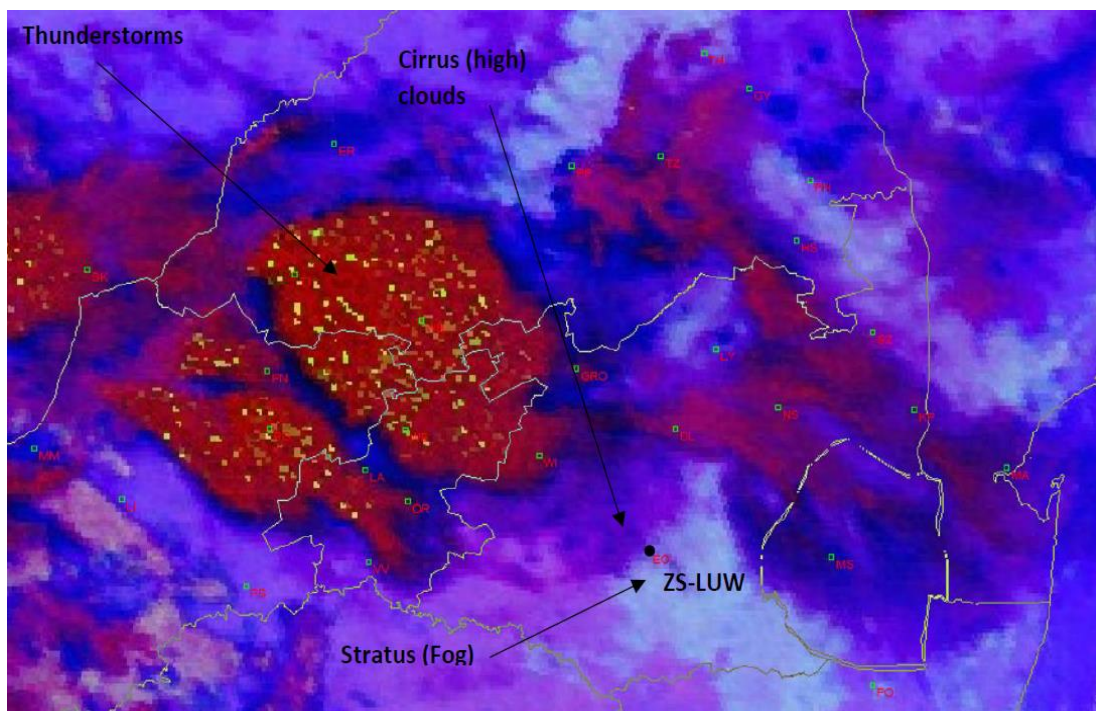
1.7.2 The satellite images at 0600Z on 27 January 2024 indicated a bank of thick Stratus (fog) Clouds over the eastern and central Mpumalanga Highveld areas.

**Figure 6:** The weather image showing thick Stratus (fog) Clouds at the accident area.

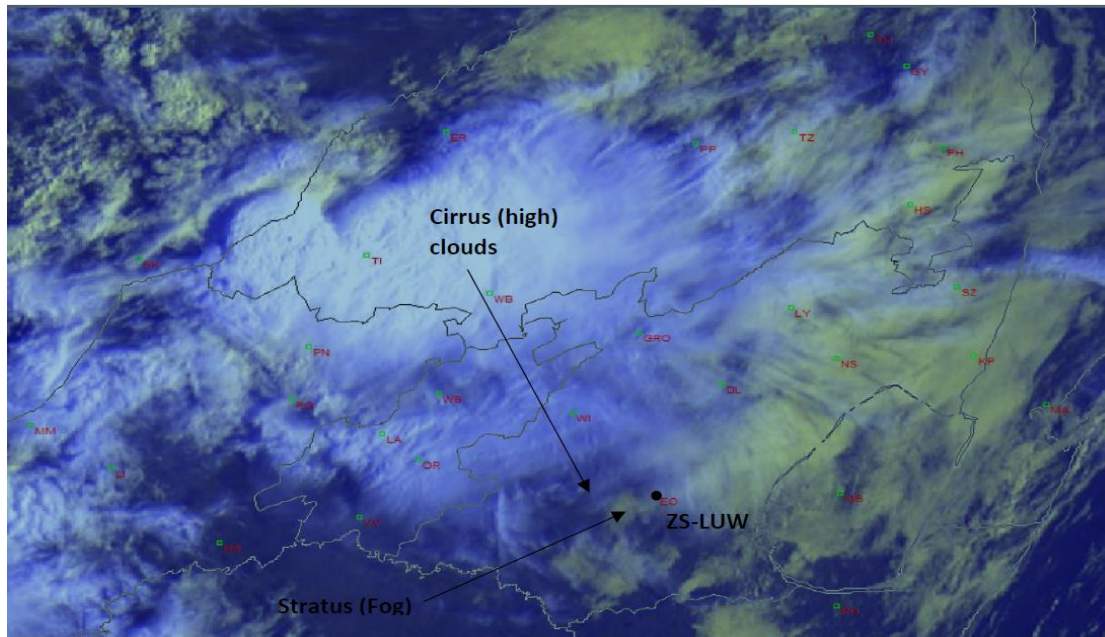
**Figure 7:** Thick Stratus (FOG) Clouds at the accident area.

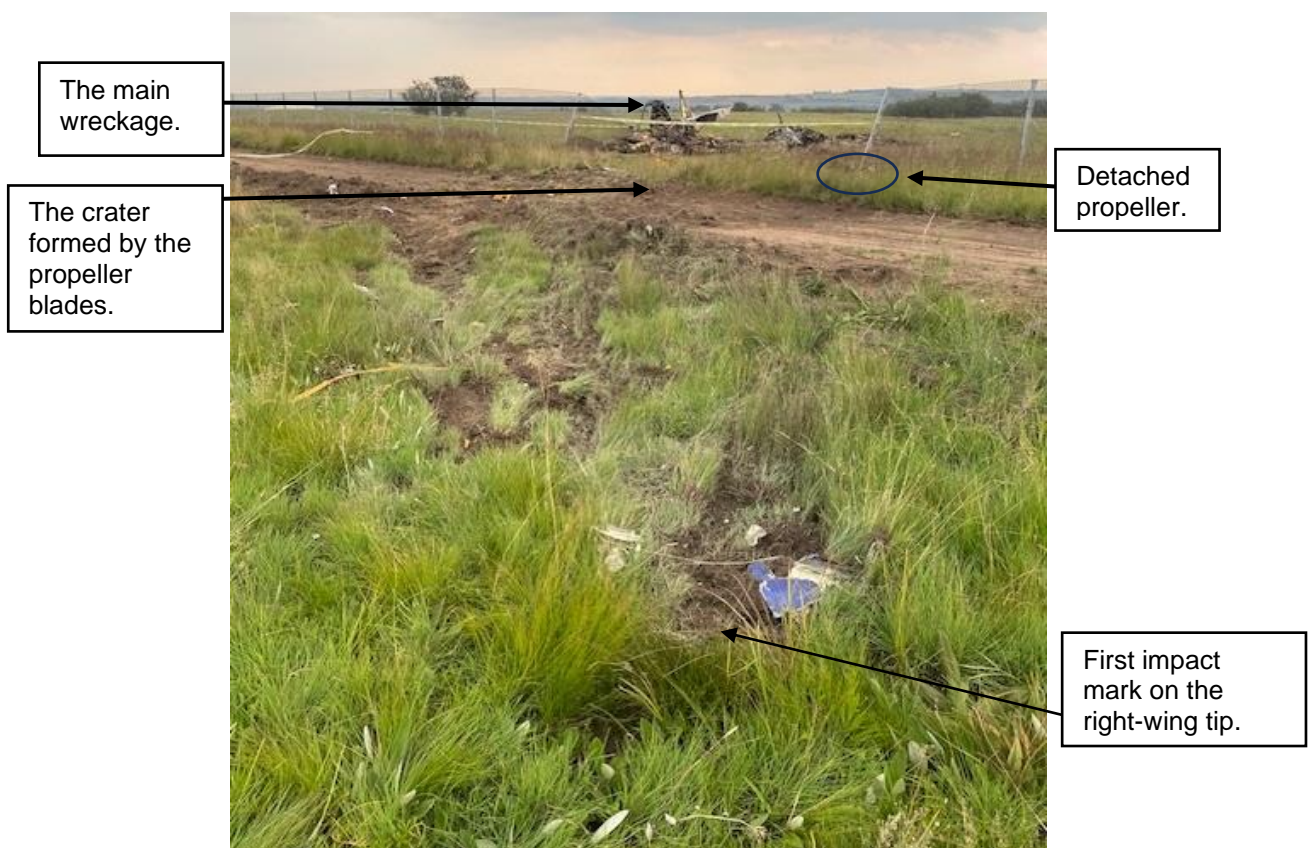
1.12.1. Evidence at the accident site showed that the aircraft was flying low in a northerly direction when it impacted the ground with the right-wing tip at FAEO. The estimated aircraft trajectory was 18° magnetic. Evidence revealed that the aircraft's nose pitched down and the propeller blades struck the ground. The main landing gears broke off and the chemical spray boom shattered. The aircraft kept momentum whilst swerving to the right before it impacted the northern side of the FAEO perimeter fence. The aircraft's wings had separated from its attachment points during the accident sequence.

**Figure 8:** The wreckage and the broken skids landing gear.

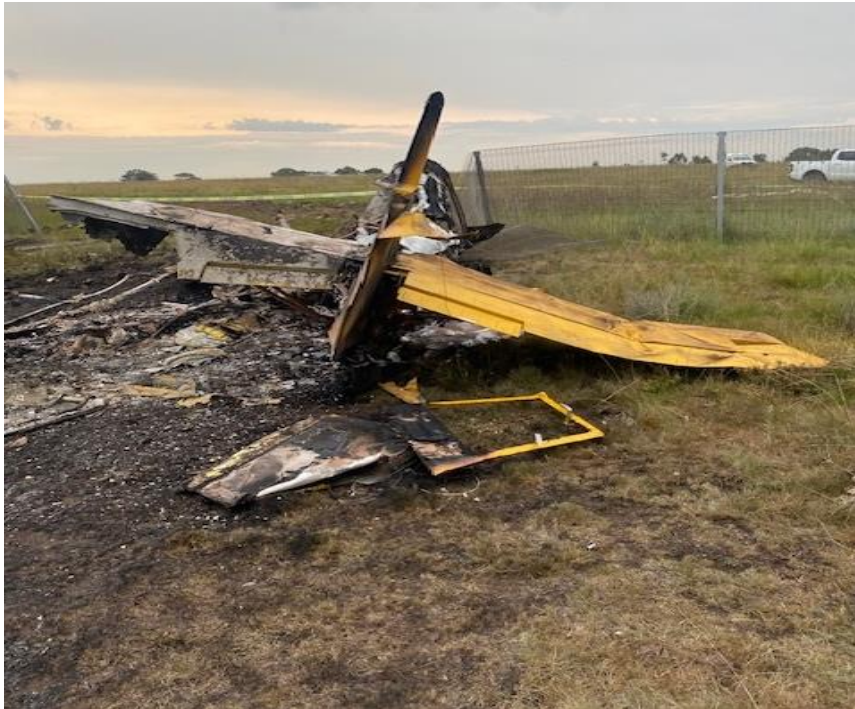
1.12.2. The aircraft came to a stop approximately 45m from the first point of impact beyond the airfield's perimeter fence; it faced the direction from which it had approached. The engine had separated from the airframe/fire wall and the chemical hopper had separated from the aircraft's nose section. The propeller was located approximately 11m forward of the first impact point. Most of the aircraft's structure was consumed by post-impact fuel-fed fire that erupted.

**Figure 9:** The wreckage facing the direction from which it had approached (south).

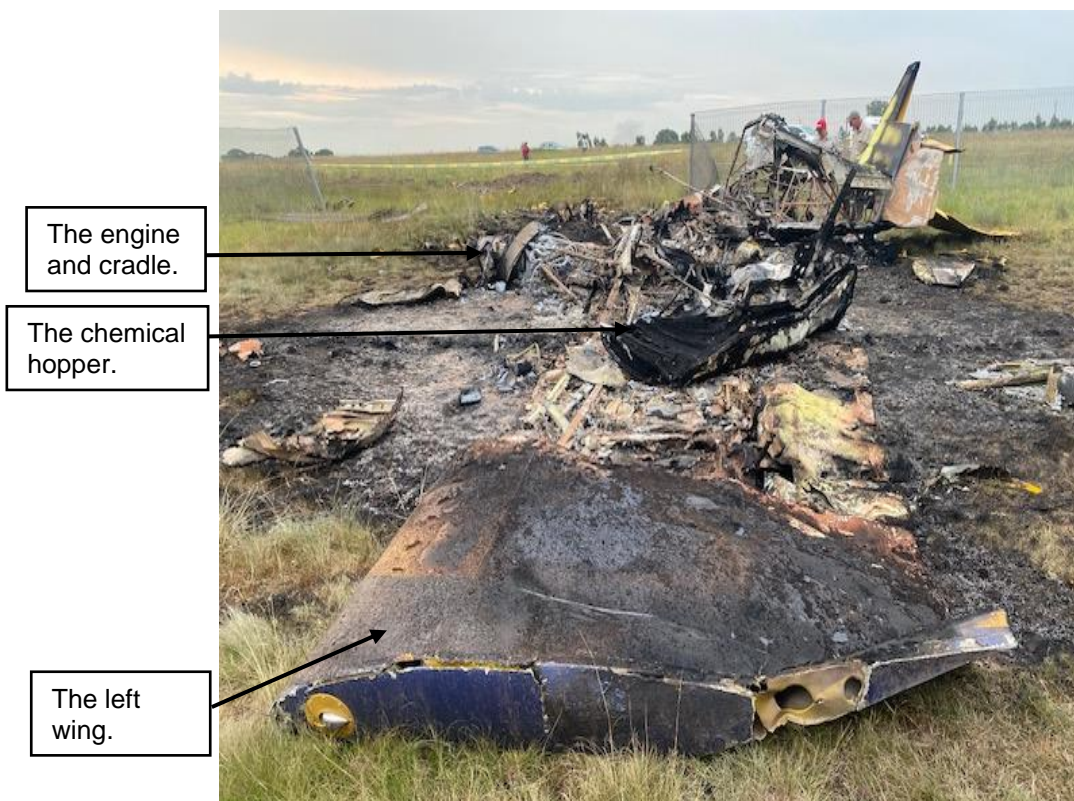
**Figure 10:** The left wing, engine and chemical hopper.

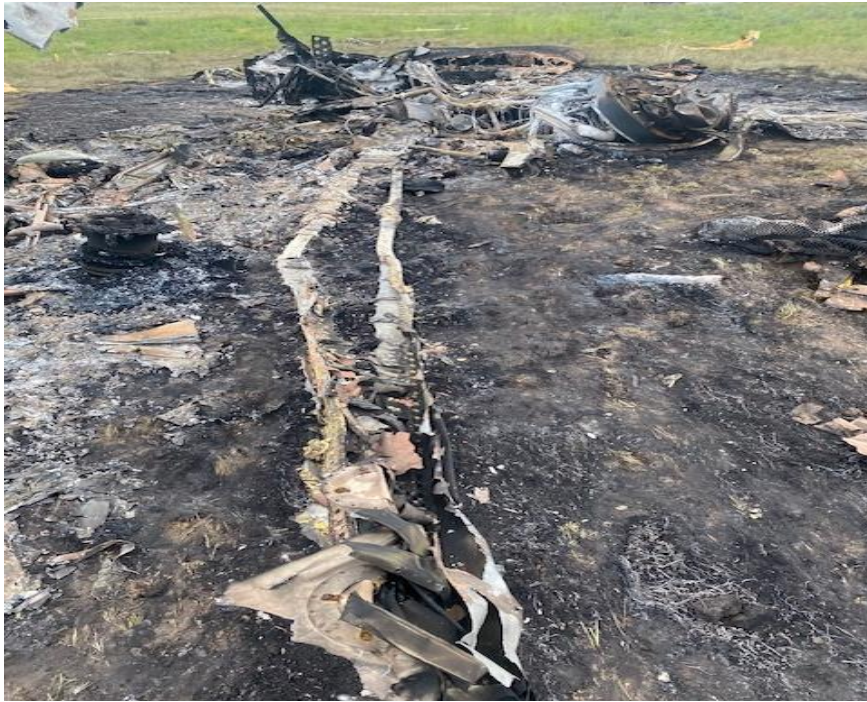
**Figure 11:** The right wing that was destroyed by the fire.

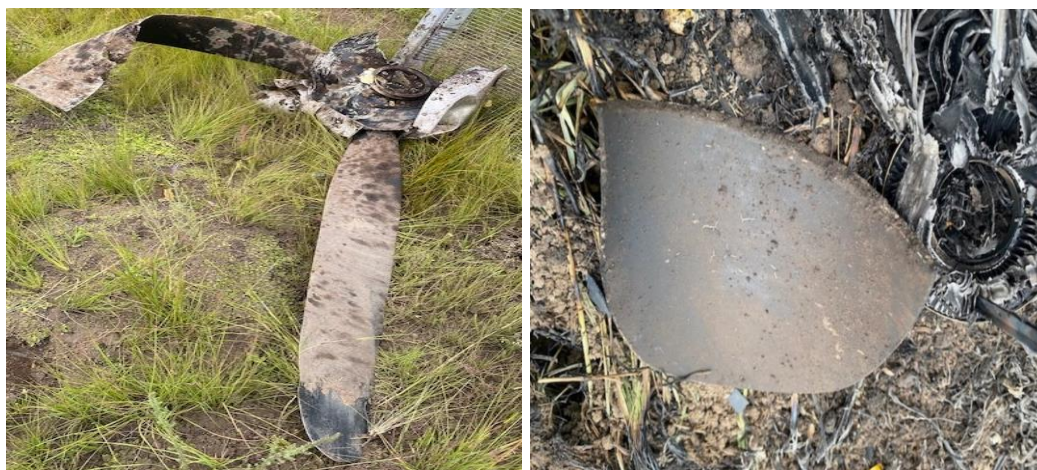
1.16.2 The propeller was found to have separated from the hub. The reduction gearbox had also separated from the engine. One propeller blade tip broke off during the accident sequence, an indication that the engine was producing a substantial amount of power on impact. The amount of power produced could not be determined.

**Figures 12 and 13:** The propeller that separated from the hub (left); and the blade tip that broke off from one of the blades (right).
