AIRCRAFT ACCIDENT REPORT AND EXECUTIVE SUMMARY

Reference:		CA18/2/3/10415	
Aircraft Registration	ZS-FON	Date of Accident	29 January 2024		Time of Accident	1135Z	
Type of Aircraft	Beechcraft King Air C90A		Type of Operation		Private Flight (Part 91)		
Pilot-in-command Licence Type	Airline Transport Pilot Licence (ATPL)		Age	42	Licence Valid	Yes	
Pilot-in-command Flying Experience	Total Flying Hours		8 478.6		Hours on Type	246.7	
Last Point of Departure	Lanseria International Aerodrome (FALA), Gauteng Province						
Next Point of Intended Landing	Bona-Bona Game Lodge Airfield, North West Province						
Damage to Aircraft	Substantial						
Location of the accident site with reference to easily defined geographical points (GPS readings if possible)							
Runway 17 at Bona-Bona Lodge Airfield (GPS co-ordinates: 27°01'18.40" South 026°13'16.52" East) at an elevation 4 760 feet (ft)							
Meteorological Information	Surface wind: 170°/10kts; temperature: 31°C; visibility: 9999m

Probable Cause/s and/ or Contributory Factors							
A fracture on the front face rib caused the failure of the left main wheel outer bearing which led to the wheel separating from the axle during the landing ro

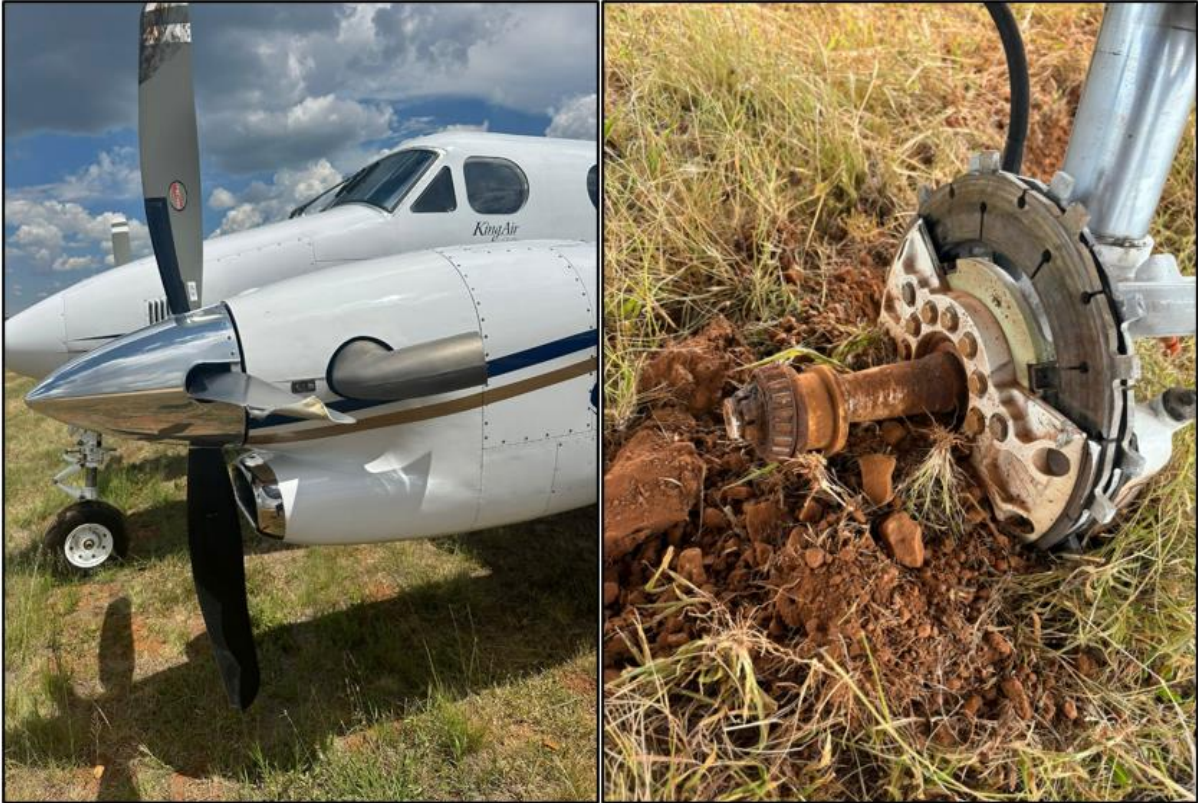
1.3.1 The aircraft was substantially damaged during the accident sequence.

Figures 2 and 3: Damage to the No.1 propeller blades (left) and the left main landing gear axle (right) post-accident. (Source: Pilot)

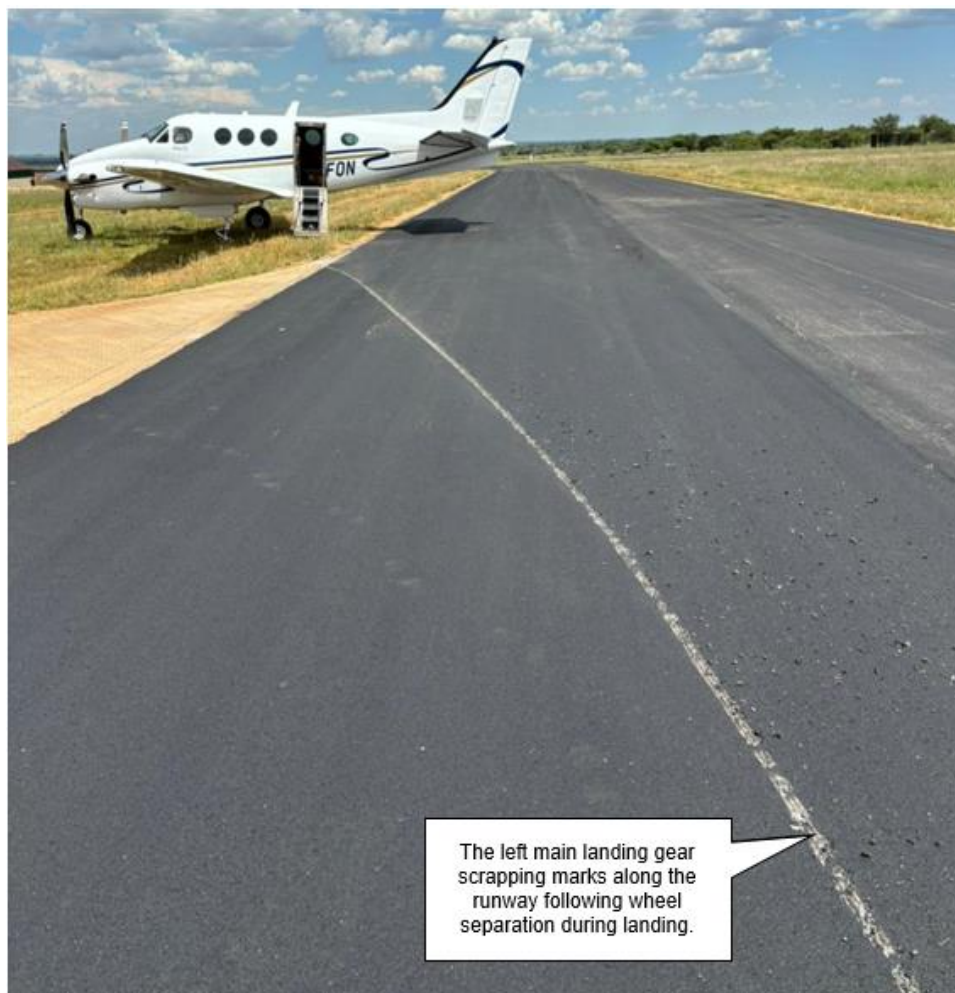
1.12.1. The accident occurred on Runway 17 at Bona-Bona Game Lodge Airfield during the landing roll. The left main wheel assembly separated from the axle and advanced towards the No 1 engine and impacted the propeller blades and damaged them. The aircraft continued to skid on its left gear brake assembly for approximately 38m before it stopped next to the runway.

Figure 4: The aircraft after the accident and the scrape marks on the runway. (Source: Pilot)

1.12.2. The scrape mark on the runway extended from where the wheel assembly came off to the resting position of the aircraft (see Figure 4).

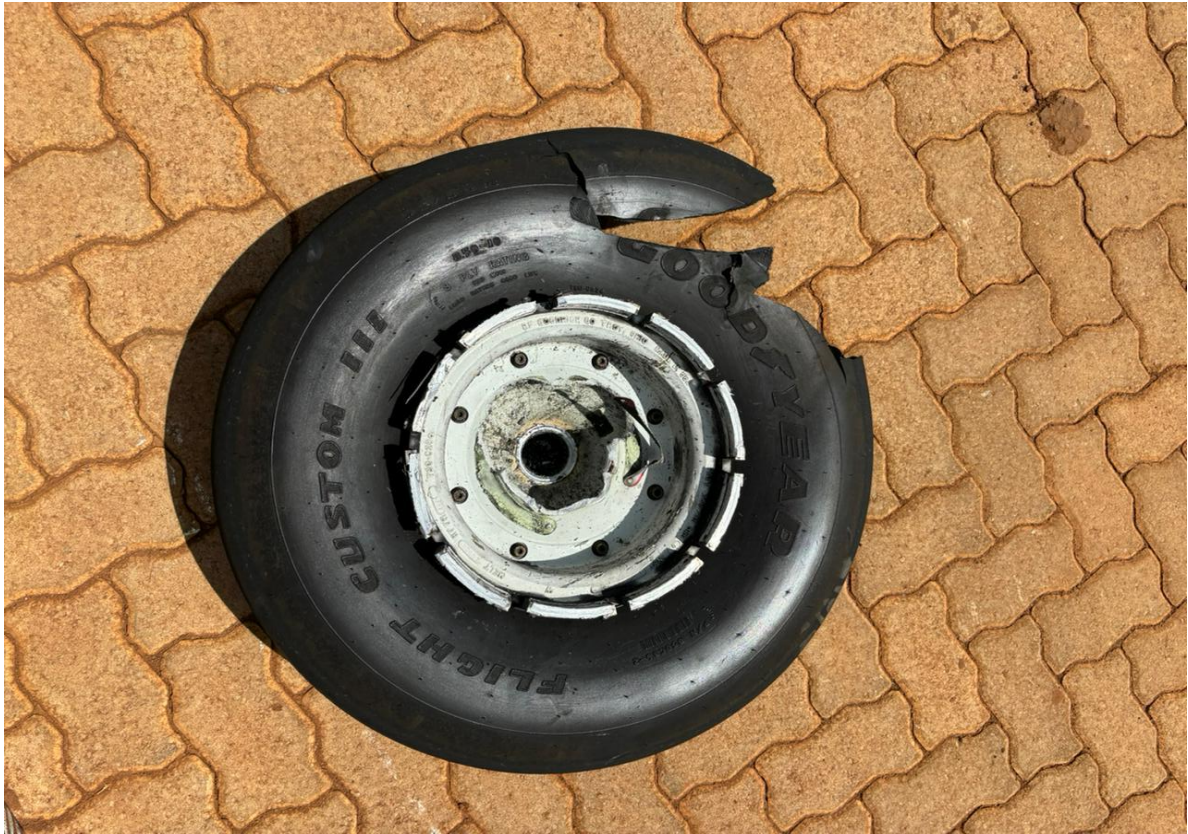
1.12.3. The wheel assembly separated and rolled forward and through the rotating left engine propellers, thus, causing damage to the propeller blades. The wheel was found on the paved taxiway a few metres from where the aircraft had stopped. The damage on the tyre was consistent with the damage caused by metal that had cut-through it. The inboard wheel hub was also damaged.

Figure 5: Damage to the left main landing gear inboard hub. (Source: Operator)

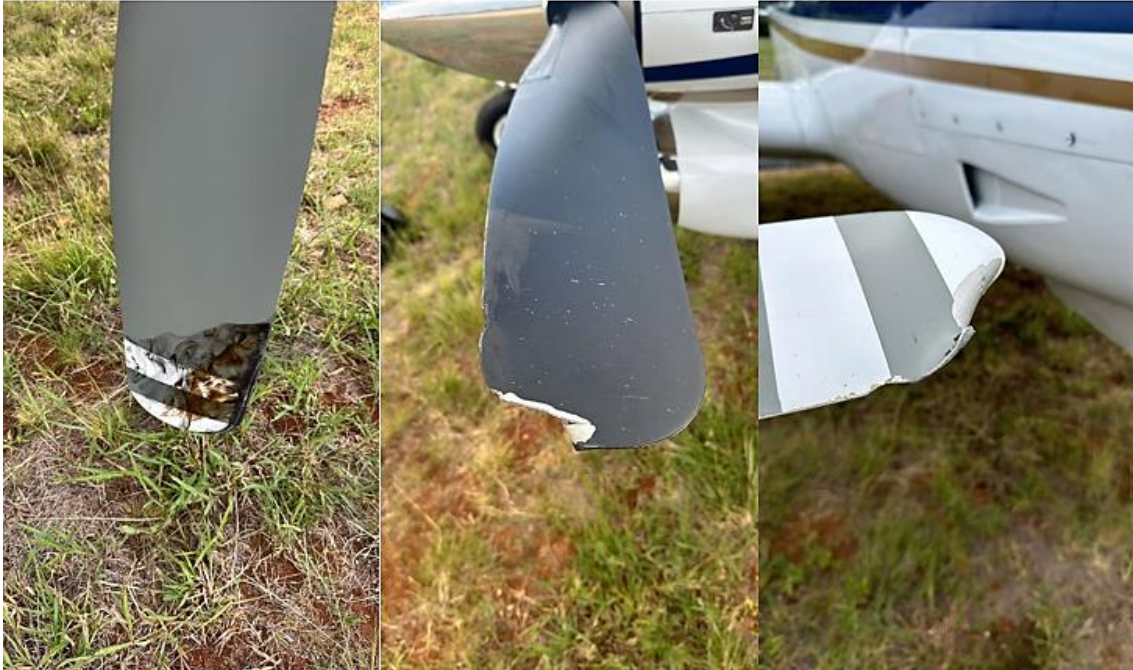
1.12.4 The propeller blade tips were damaged. One of the blades had evidence of tyre material on it (see Figure 6).

Figures 6, 7 and 8: Tyre material on the blade tip (left), and damage to the two propeller blades (middle and right). (Source: Pilot)

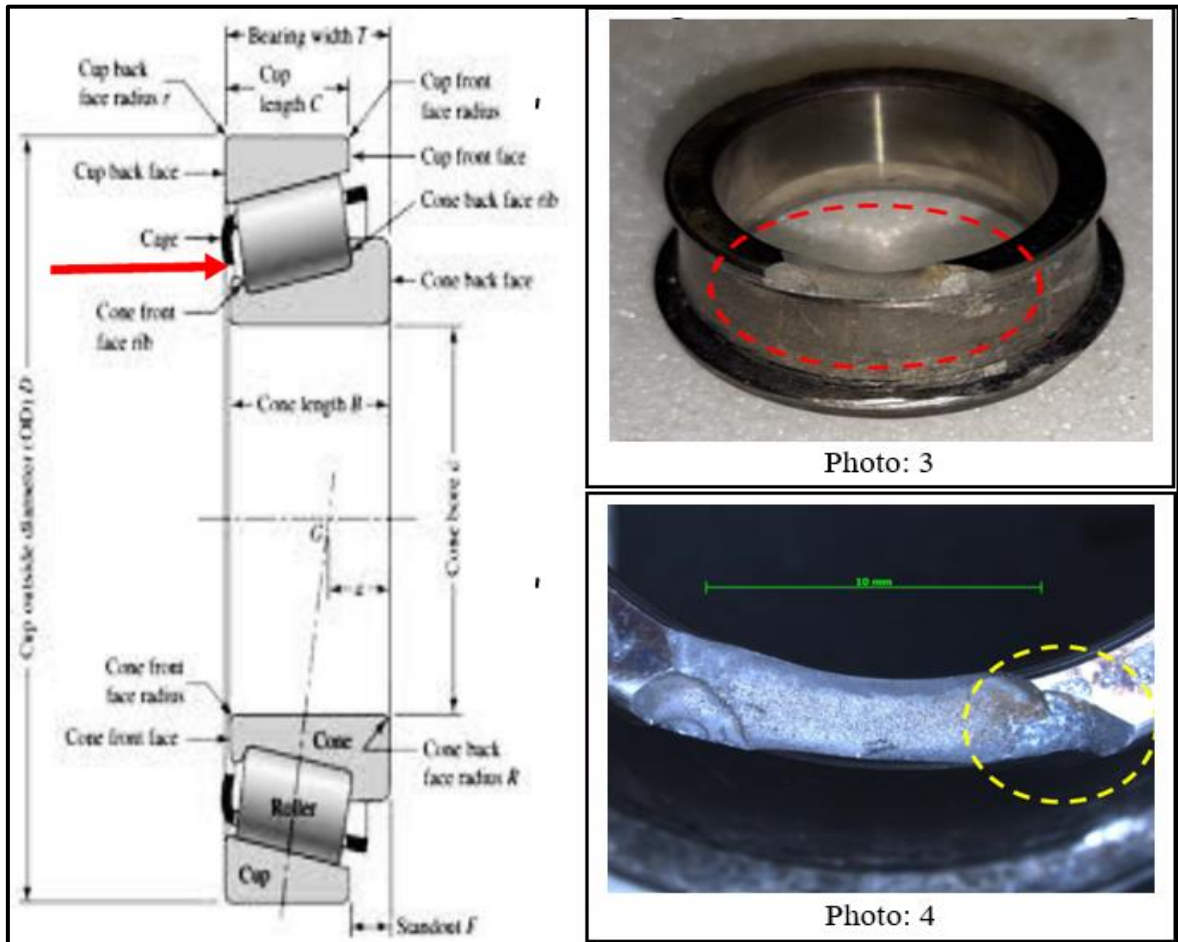
Figure 9: The failed bearing.

- *The visual inspection of the outer cone-bearing inner ring revealed a fracture within the cone front face rib as shown above in Figure 9. (Photos 3 red dashed circle; Diagram 2 red arrow). Discolouration on the fracture surface (Photo 4, yellow dashed circle) suggests fracture initiation before final failure.*

- *The investigation results revealed a fracture within the cone front face rib of the left main wheel outer cone-bearing inner ring. This probably resulted in the mechanical interaction between the fractured section/s and the bearing rollers/raceway/separator assembly. The subsequent wear and damage to the separator possibly led to the disintegration of the cone-bearing assembly during operation.*
- *The inspection confirmed that the primary fracture had initiated at an undetermined operational period before the final failure.*
- *Indications of possible manufacturing discrepancies were noted but not investigated.*
- *Considering the catastrophic nature of the failure and the improbability of detecting a pre-existing fracture within the cone front face rib, it could be derived that normal maintenance inspection/s could not have predicted this failure.*

4.2.1. It is recommended that the manufacturer reviews its maintenance program to ensure that a proper mandatory inspection is performed on the failed components. The inspection should include any of the non-destructive testing (NDT) methods of crack detection.

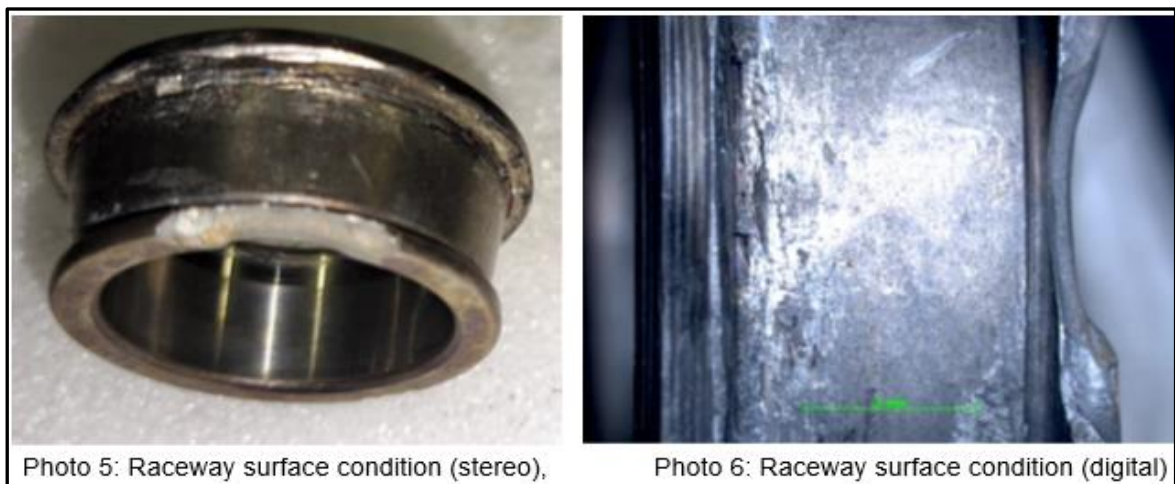
Figure 10: The raceway surface condition.

The raceway surface revealed extensive wear damage (Photos 5 and 6).

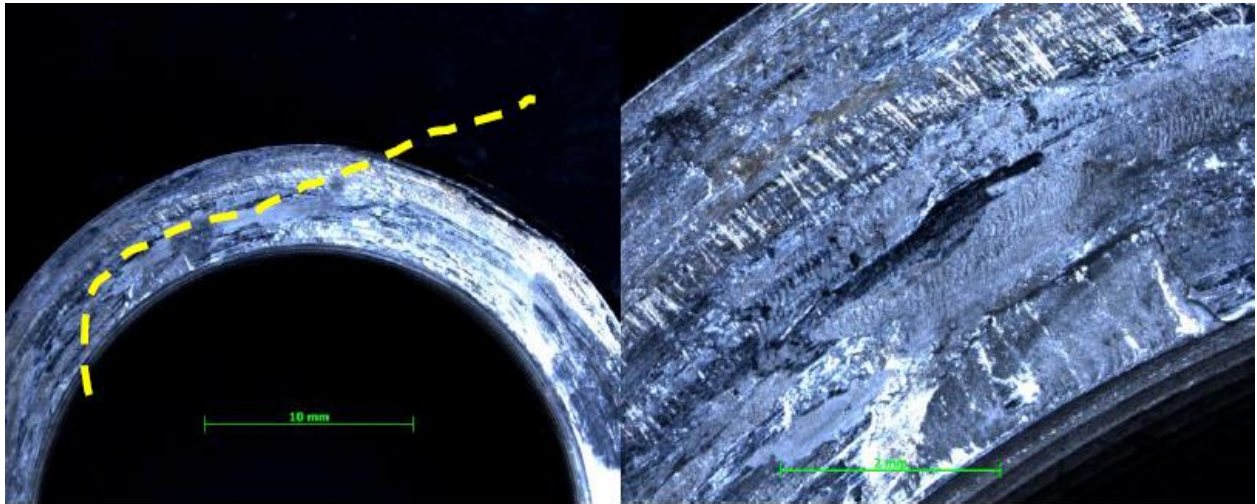
Photo 7: Outer cone back face/bearing cage interface (stereo)

Figure 11: Damage on the back area of the outer cone.

Extensive surface damage on the back cone face/bearing cage (Photo 7) indicates relative rotational movement within the assembly during operation.

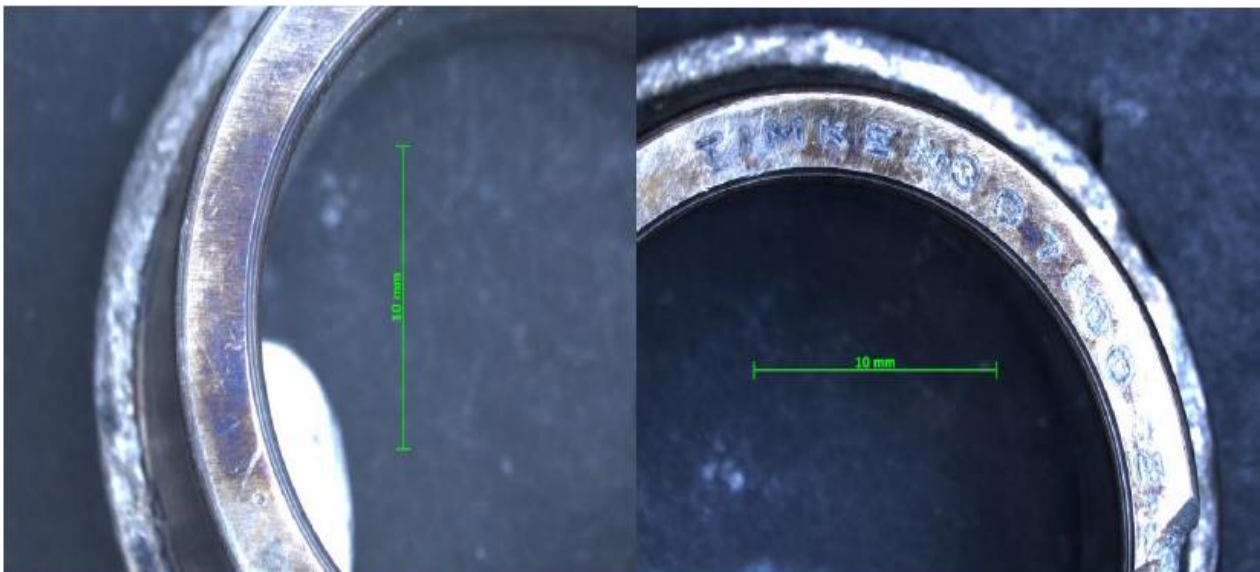
Photo 8: Surface discoloring (stereo)

Figure 12: Discolouration on the surface

Surface discolouration (Photo 8) can be attributed to high-temperature exposure during operation. However, the extent proved to be limited, suggesting the exposure time was limited and probably only during the final failure sequence.

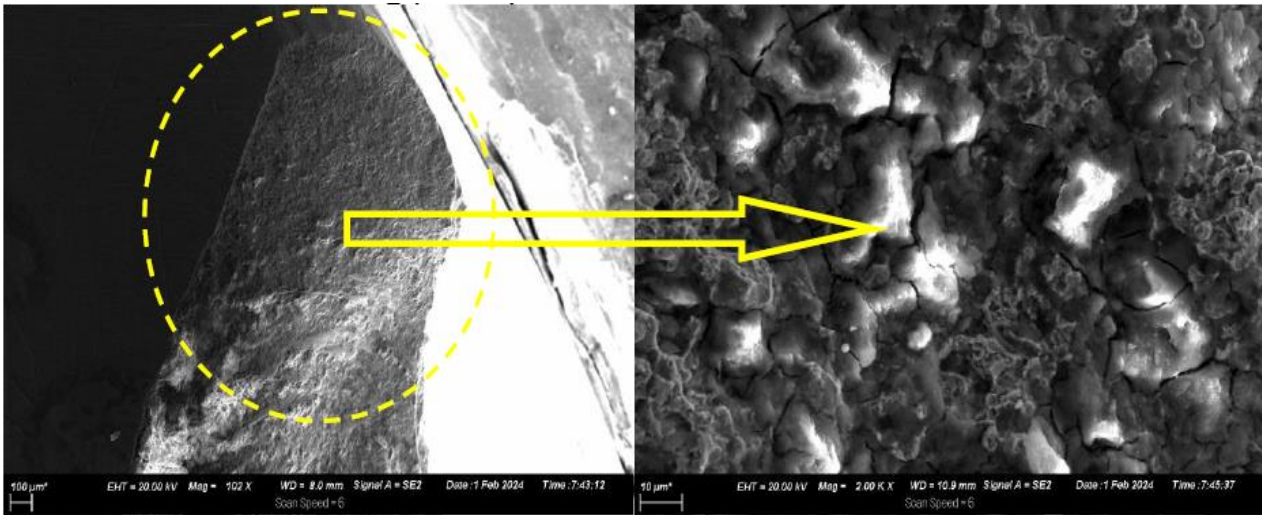
Fractograph 1: Fracture surface morphology, initiation zone (100-2000X, SE1, FEGSEM)

Figure 13: Morphology of the fractured surface

Fractured surface contamination (Fractograph 1) confirms that the pre-existing fracture within the cone front face rib (Photo 4) was exposed to operating conditions for an undetermined period before the final fracture.

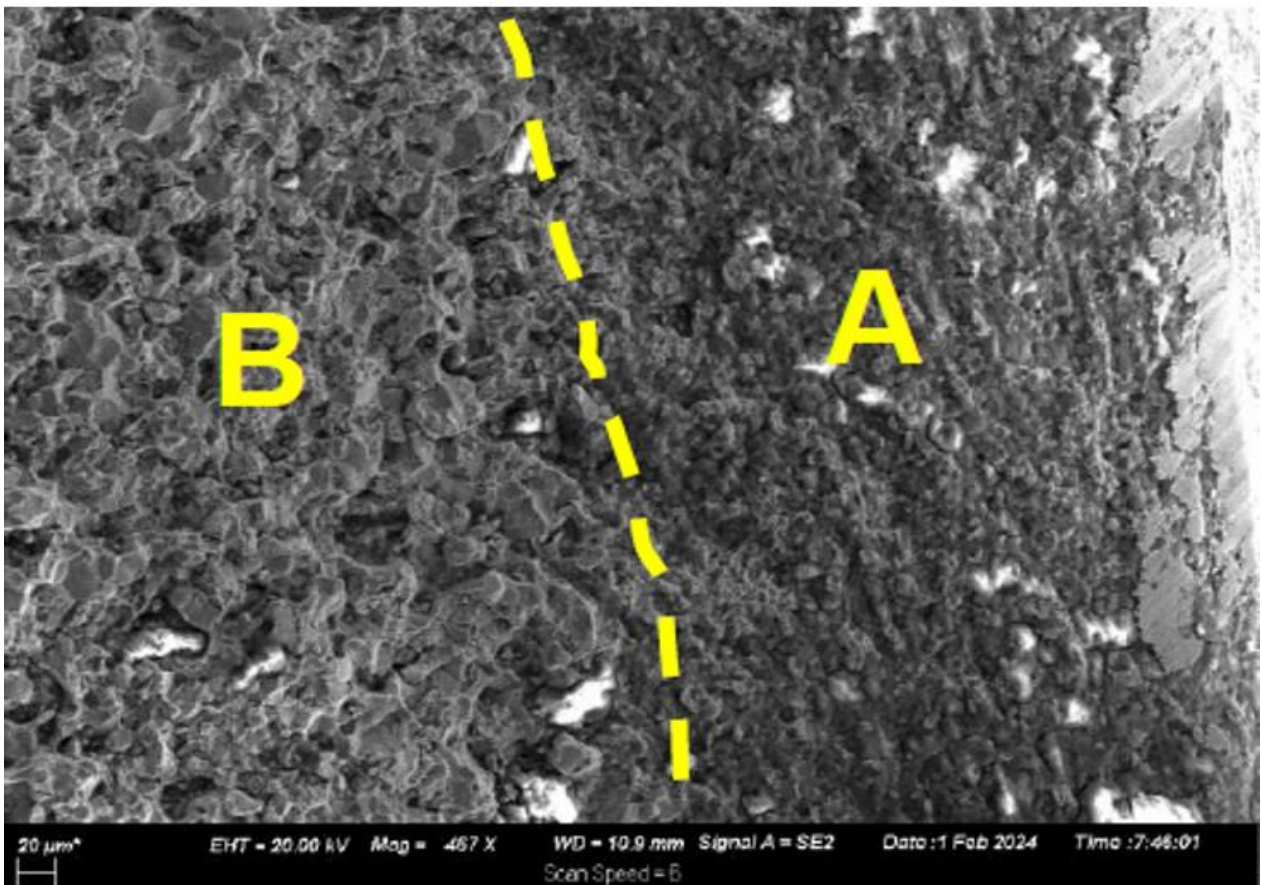
Fractograph 2: Fracture surface morphology showing contamination (407X, SE1, FEGSEM)

Figure 14: Morphology of the fractured surface showing contamination.

This notion is further supported by the clear transition from the pre-existing (A) to the final fracture morphologies (B) (Fractography 2, yellow dashed line).

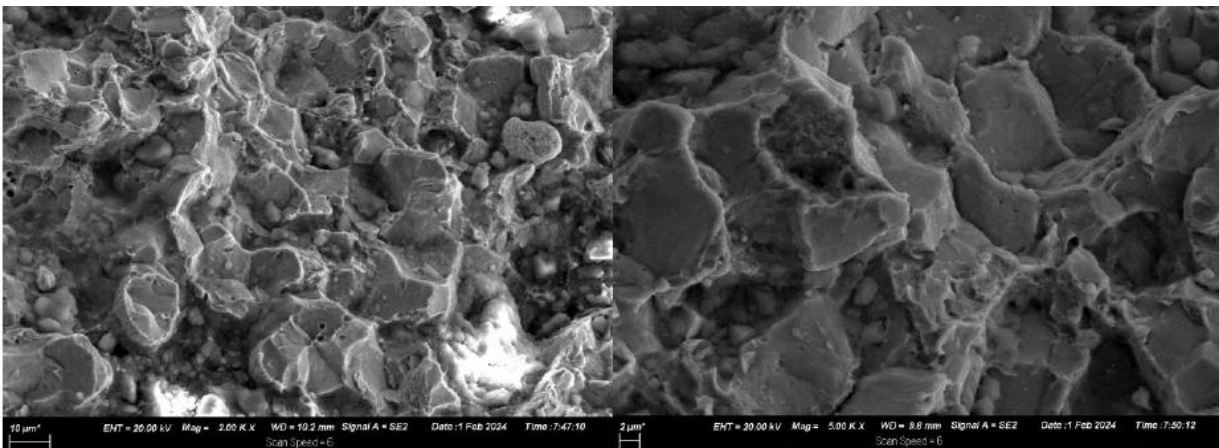
Fractography 3: Fracture surface morphology showing inter-granular mode (2000-5000X, SE1, FEGSEM)

Figure 15: Morphology showing intergranular mode of the fracture surface.

The central region fracture surface revealed clear indications of an intergranular morphology (Fractography 3). This condition is detrimental to the mechanical properties of the base material. It can be attributed to one or more of the following: incorrect heat treatment during manufacturing, exposure to high concentrations of atomic hydrogen or other discrepancies not determined by this investigation.

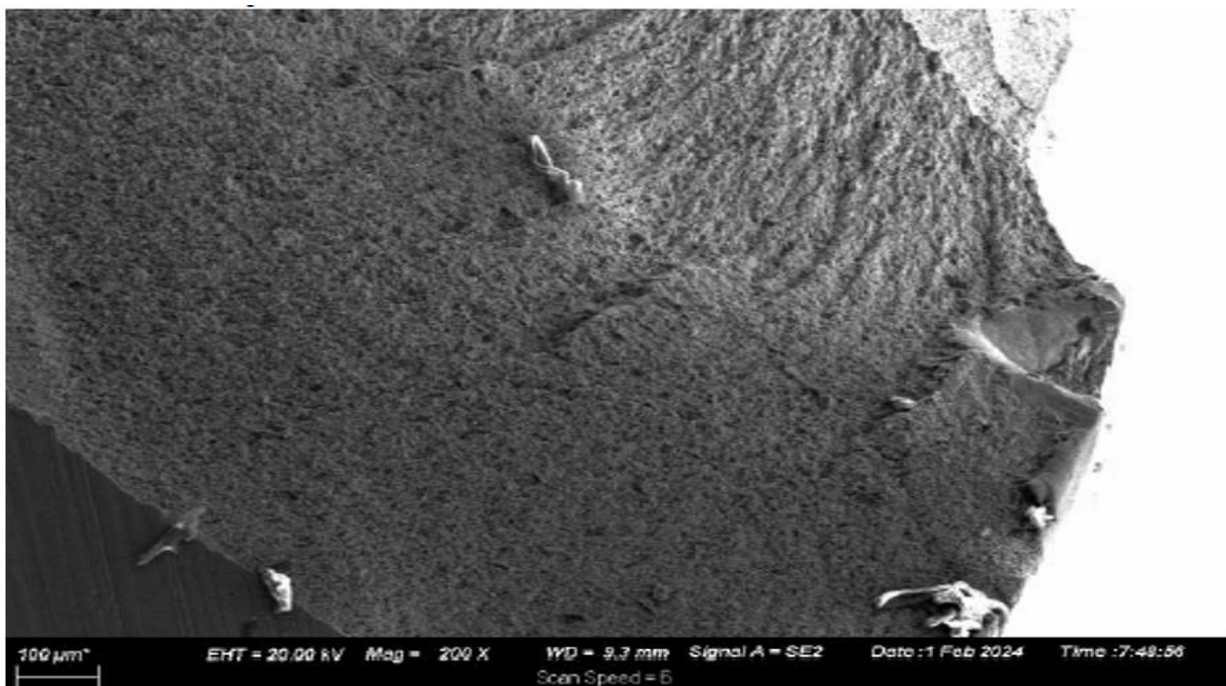
Fractography 4: Fracture surface morphology, final fast rupture (200X, SE1, FEGSEM)

Figure 16: Morphology of the fractured surface showing the final fast rupture.

Morphologies of the remainder of the fractured surface correspond with the final rupture and were most probably induced during the very final sequence of the failure.

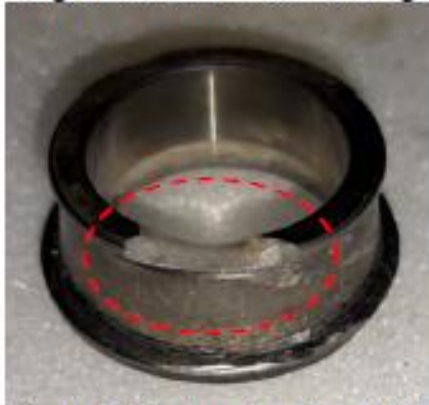
The visual inspection of the outer cone-bearing inner ring revealed a fracture within the cone front face rib (Photo 3, red dashed circle; Diagram 2, red arrow). Fracture surface discoloring (Photo 4, yellow dashed circle) suggest fracture initiation prior to final failure.

Photo 3: Fracture location (digital)

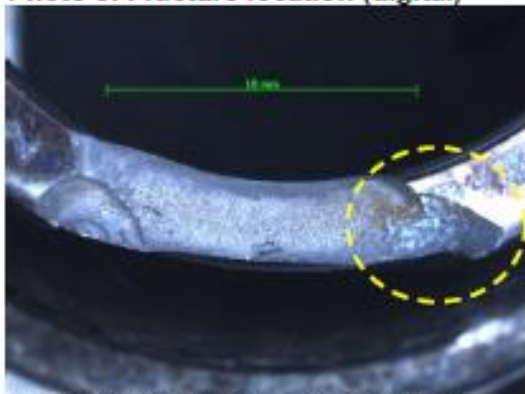
Photo 4: Fracture location (stereo)

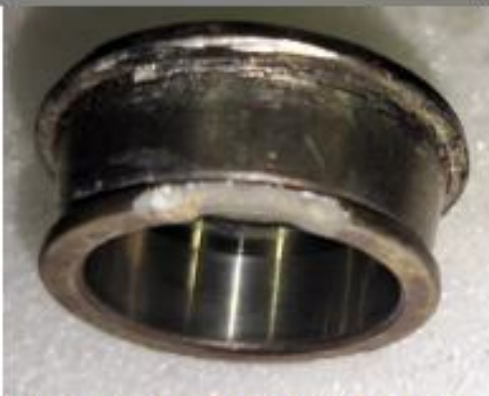
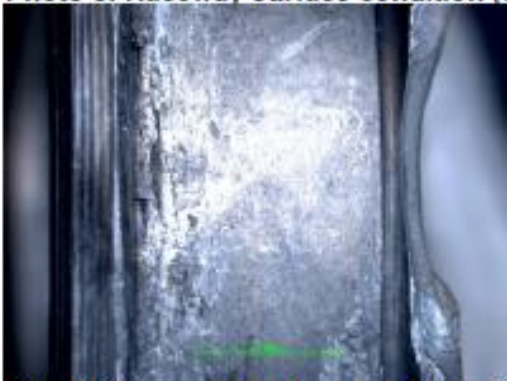
The raceway surface revealed extensive wear damages (Photo's 5 and 6).

Photo 5: Raceway surface condition (digital)

Photo 6: Raceway surface condition (stereo)

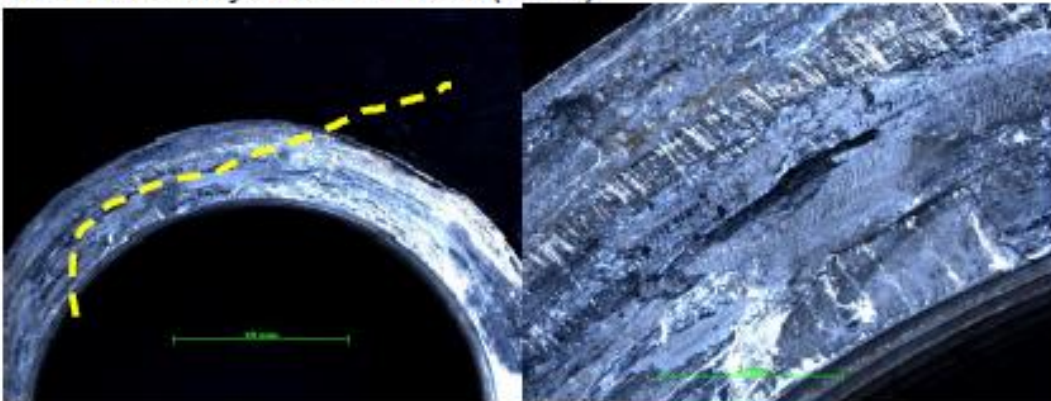
Photo 7: Outer cone back face/bearing cage interface (stereo)

Extensive surface damages at the cone back face/bearing cage interface (Photo 7) indicates relative rotational movement within the assembly during operation.

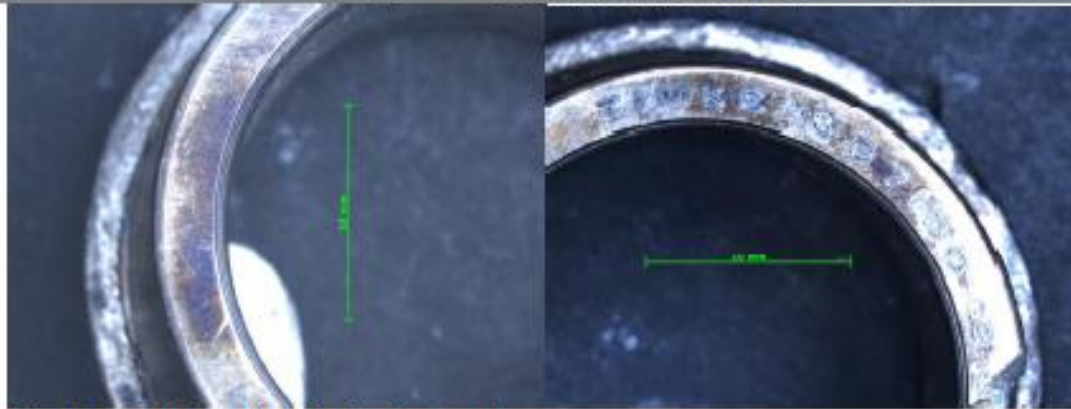
Surface discoloring (Photo 8) can be attributed to high temperature exposure during operation. However, the extend thereof proved to be limited suggesting the exposure time was limited and most probably only during the final failure sequence.

Photo 8: Surface discoloring (stereo)

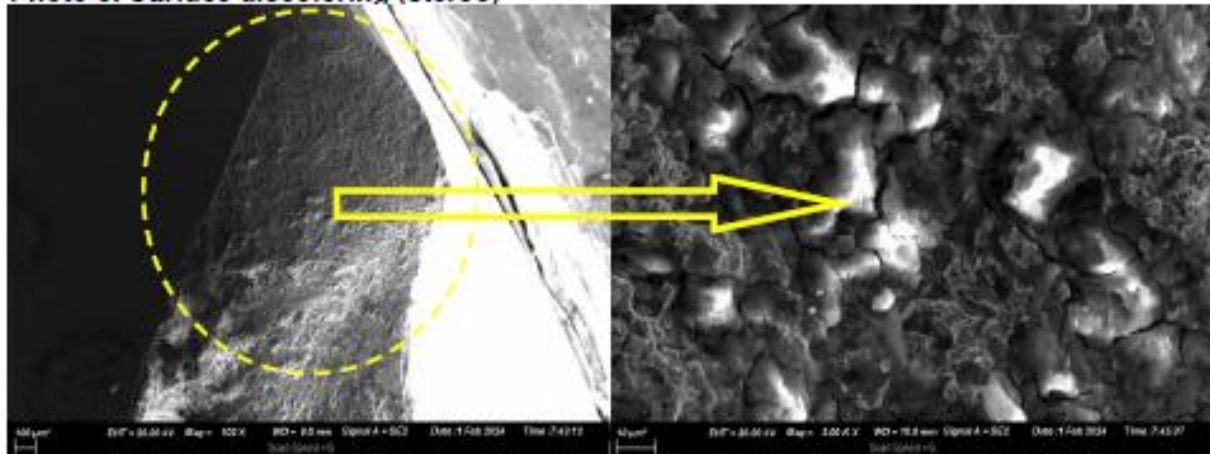
Indications of fracture surface contamination (Fractograph 1) confirms that the pre-existing fracture within the cone front face rib (Photo 4) was exposed to operating conditions for undetermined period prior to final fracture. This notion is further supported by the clear transition from the pre-existing- (A) to the final fracture morphologies (B) (Fractograph 2, yellow dashed line).

Fractograph 1: Fracture surface morphology, initiation zone (100-2000X, SE1, FEGSEM)

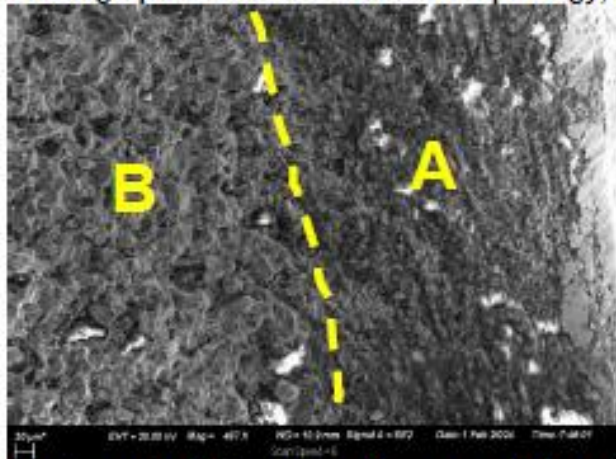
Fractograph 2: Fracture surface morphology showing contamination (407X, SE1, FEGSEM)

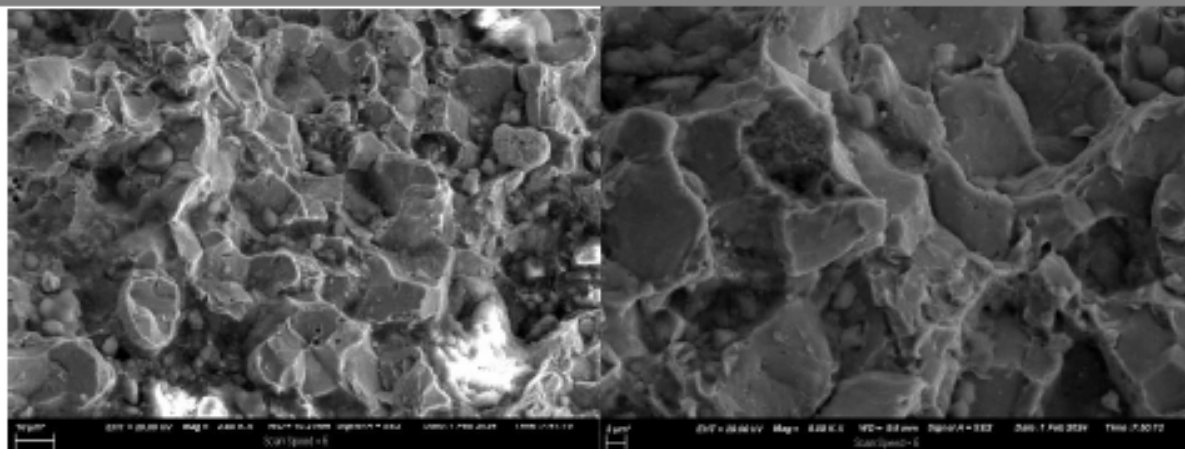
The central region fracture surfaces revealed clear indications of an inter-granular morphology (Fractograph 3). This condition is detrimental to the mechanical properties of the base material and can be attributed to one or more of the following: Incorrect heat treatment during manufacturing, exposure to high concentrations of atomic Hydrogen, or other discrepancies not determined by this investigation.

Fractograph 3: Fracture surface morphology showing inter-granular mode (2000-5000X, SE1, FEGSEM)

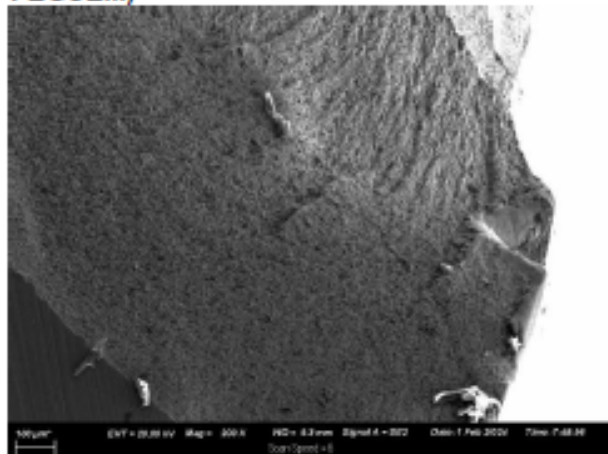
The morphologies of the remainder of the fracture surfaces corresponds with final rupture and were most probably induced during the very final sequence of the failure.

Fractograph 4: Fracture surface morphology, final fast rupture (200X, SE1, FEGSEM)
