LIMITED OCCURRENCE INVESTIGATION REPORT – FINAL

Reference Number	CA18/2/3/10416						
Classification	Accident	Date	1 February 2024		Time	0915Z	
Type of Operation	Private (Part 91)						
Location							
Place of Departure	Wonderboom Aerodrome (FAWB), Gauteng Province		Place of Intended Landing	Wonderboom Aerodrome (FAWB), Gauteng Province			
Place of Occurrence	Runway 29 at Wonderboom Aerodrome (FAWB)						
GPS Co-ordinates	Latitude	25° 26' 43" S	Longitude	028° 14' 27" E	Elevation	4 046 ft	
Aircraft Information							
Registration	ZS-ELL						
Make; Model; S/N	Piper; PA-28-140 (Serial Number: 28-041)						
Damage to Aircraft	Substantial			Total Aircraft Hours	13983.6		
Pilot-in-command							
Licence Type	Private Pilot Licence (PPL)		Gender	Male		Age	25
Licence Valid	Yes	Total Hours	89.6		Total Hours on Type	89.6	
Total Hours 30 Days	1.7		Total Flying on Type Past 90 Days	1.7			
People On-board	1 + 0	Injuries	0	Fatalities	0	Other (on ground)	0
What Happened

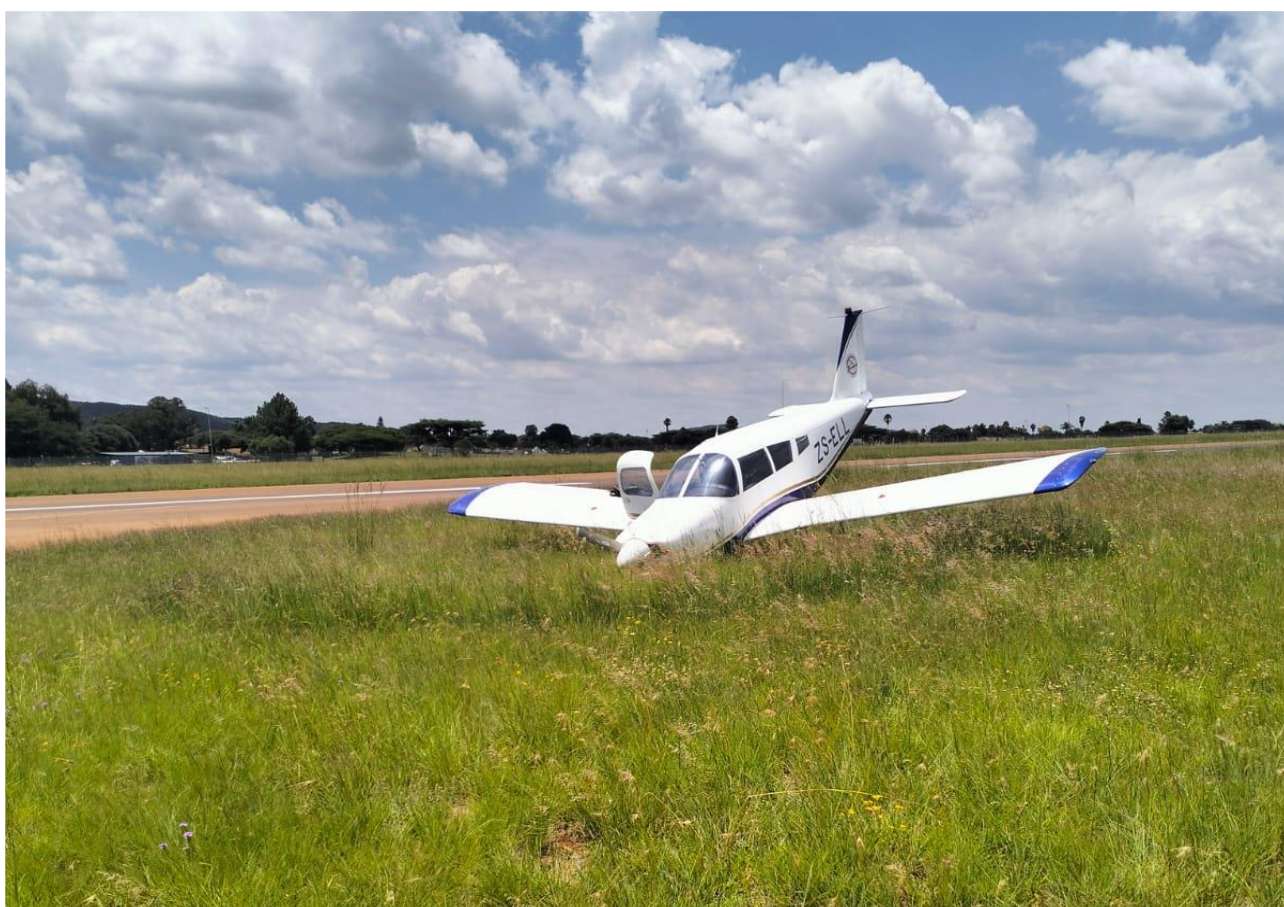
Figure 2: The aircraft after it came to a stop.

4.	<u>Conclusion</u>
4.1	The aircraft experienced a crosswind from the right during the second circuit and landing. Thus, the pilot lost directional control and the aircraft veered off to the left of RWY 29.
Probable Cause	
Loss of directional control during landing which led to a runway excursion.	
Contributing Factor(s)	
None.	
Safety Action(s)	
None.	
Safety Message	
None.	
About this Report	
<p><i>The decision to conduct a limited investigation is based on factors including whether the cause is known and the evidence supporting the cause is clear, the level of safety benefit likely to be obtained from an investigation and that will determine the scope of an investigation. For this occurrence, a limited investigation has been conducted, and the Accident and Incident Investigations Division (AIID) has relied on the information submitted by the affected person/s and organisation/s to compile this limited report. The report has been compiled using information supplied in the initial notification, as well as from follow-up desk top enquiries to bring awareness of potential safety issues to the industry in respect of this occurrence, as well as possible safety action/s that the industry might want to consider in preventing a recurrence of a similar occurrence.</i></p> <p><i>All times given in this report are Co-ordinated Universal Time (UTC) and will be denoted by (Z). South African Standard Time is UTC plus 2 hours.</i></p>

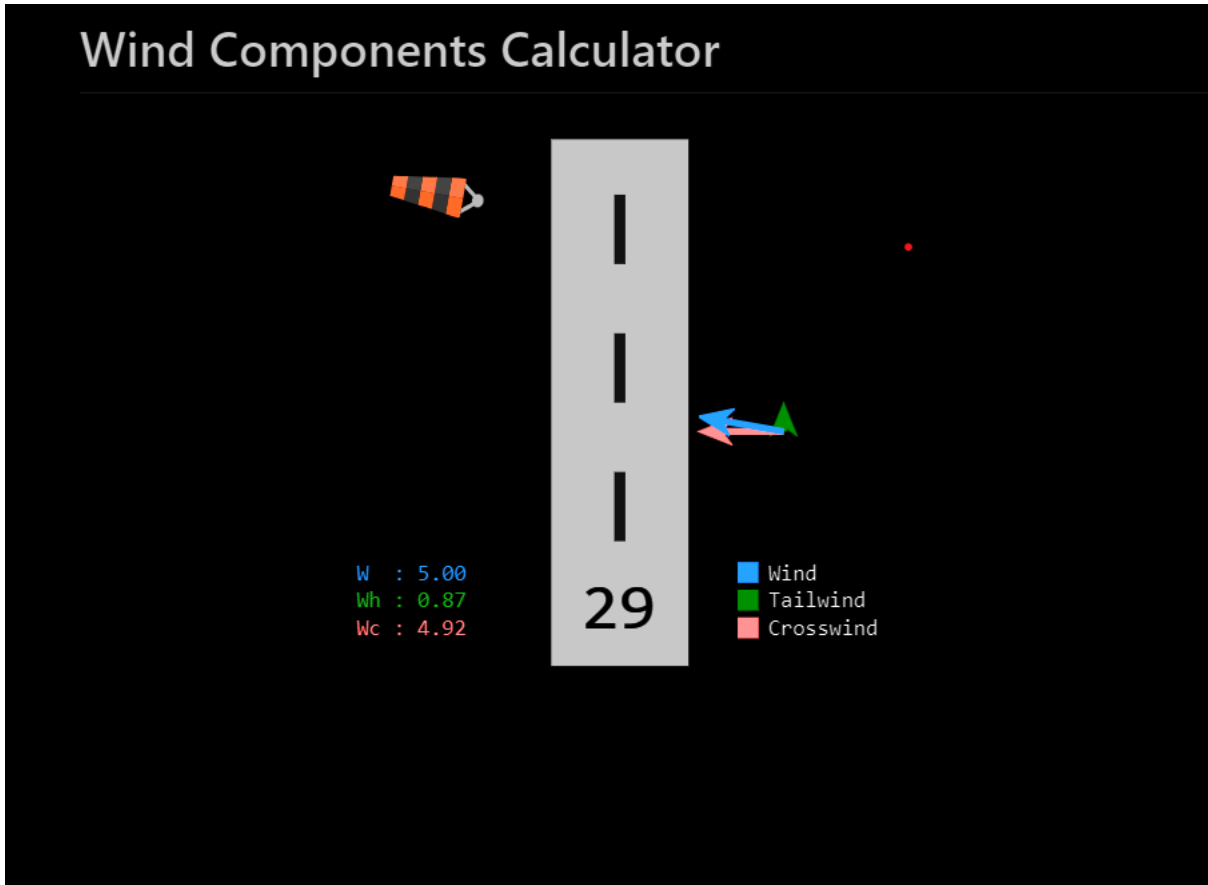
Figure 3: The wind component calculation. (Source: <https://e6bx.com/wind-components/>)

3.	<u>Meteorological Information</u>
3.1	The weather was a contributory factor to this accident as there was a 4.92 knots crosswind during landing, even though the crosswind condition was within the maximum 17 knots as per the POH.
