AIRCRAFT ACCIDENT REPORT AND EXECUTIVE SUMMARY

Reference:		CA18/2/3/10417	
Aircraft Registration	ZS-IRW	Date of Accident	6 February 2024		Time of Accident	0948Z	
Type of Aircraft	Grumman G-164A		Type of Operation		Agricultural (Part 137)		
Pilot-in-command Licence Type	Commercial Pilot Licence (CPL)		Age	31	Licence Valid	Yes	
Pilot-in-command Flying Experience	Total Flying Hours		922.2		Hours on Type	360.6	
Last Point of Departure	Klippan Private Airstrip, Mpumalanga Province						
Next Point of Intended Landing	Middelburg Aerodrome (FAMB), Mpumalanga Province						
Damage to Aircraft	Substantial						
Location of the accident site with reference to easily defined geographical points (GPS readings if possible)							
South of Wonderfontein Colliery at GPS position 25°52'14.29" South 029°53'43.90" East, at an elevation of 5 732 feet							
Meteorological Information	Surface wind: 280°/2kts; temperature: 26°C; dew point: 15°C; CAVOK						
Number of People On-board	1 + 0	Number of People Injured	0	Number of People Killed	0	Other (On the Ground)	0

Occurrence Details

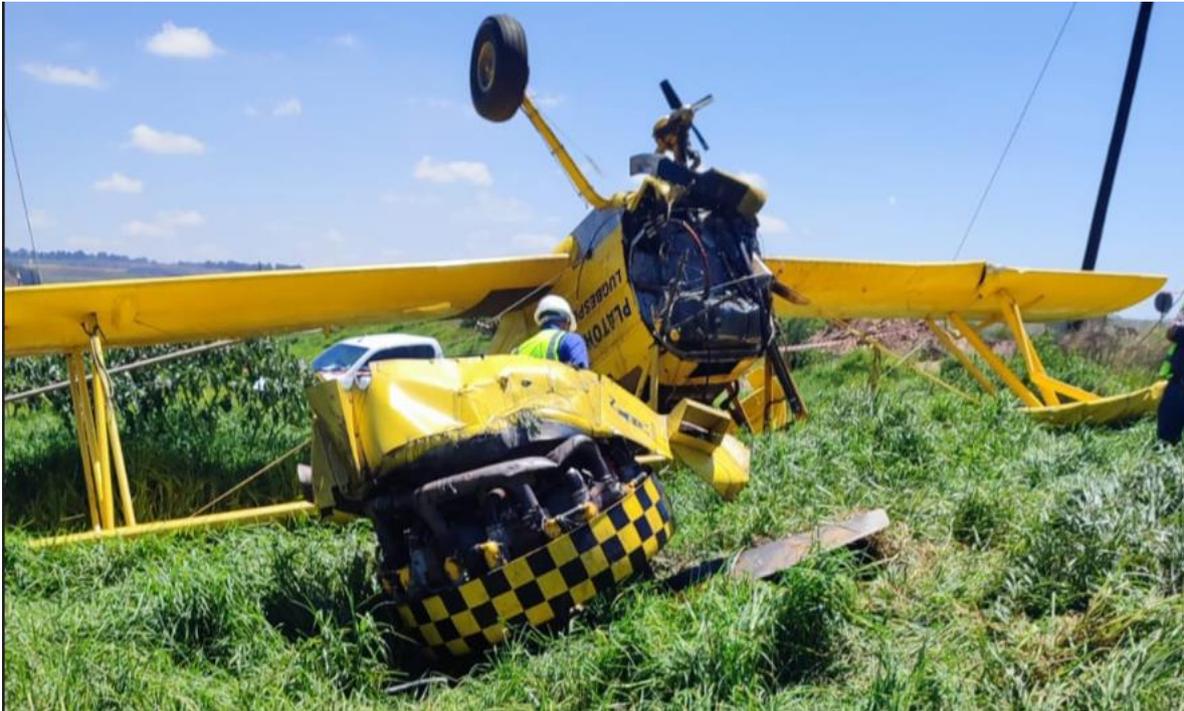
1.3.1. The aircraft was substantially damaged during the accident sequence.

Figure 2: The aircraft as it came to rest in an inverted attitude.

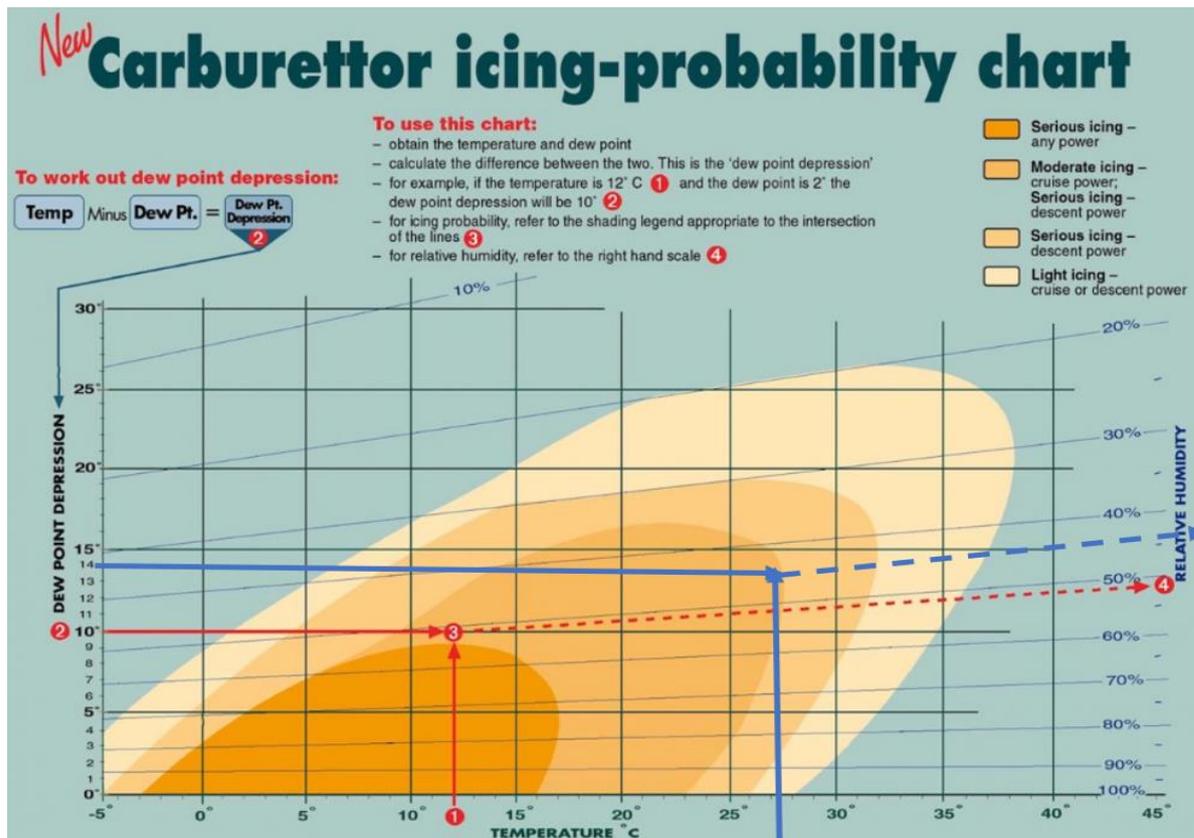
Figure 4: Icing-probability Chart.

1.7.2. The carburettor icing-probability chart on the day of the flight indicated a dew point depression of 14°C with a temperature of 27°C, and a dew point of 13°C with relative humidity at 42%. This did not place the engine at risk as the aircraft was in the climb phase.

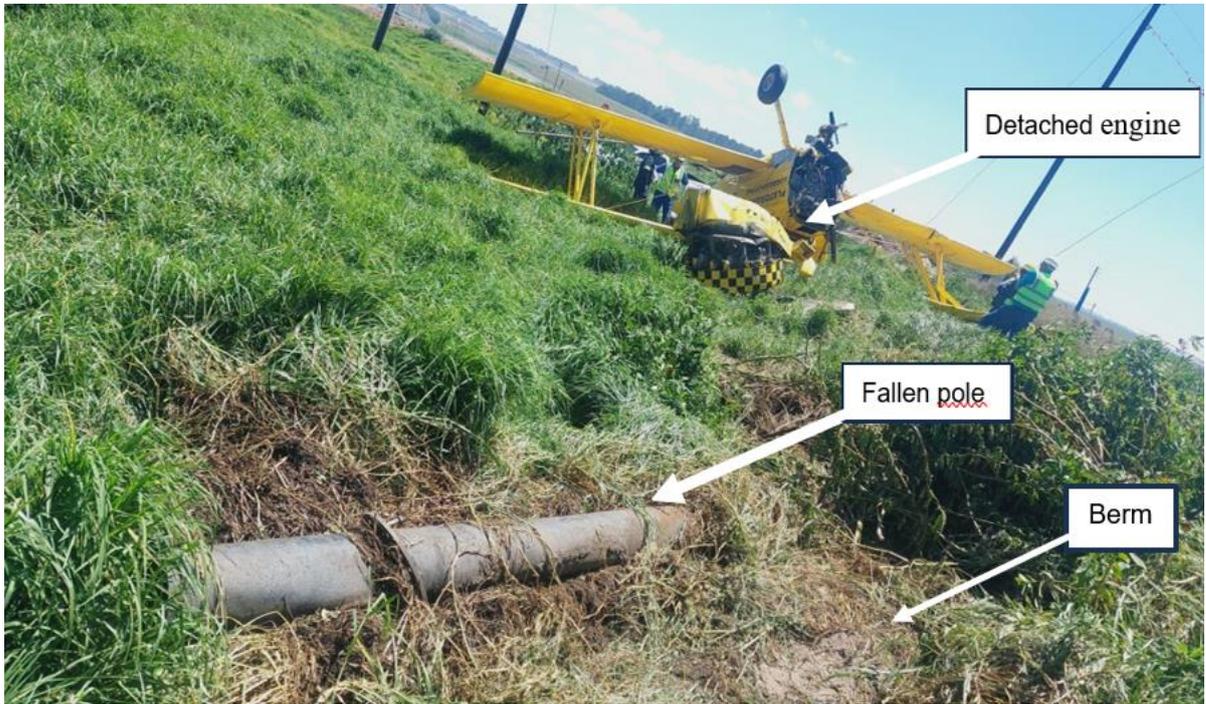
The aircraft landed and rolled approximately 30m on the soft soil south-east of Wonderfontein Colliery. During the landing roll, the landing gear struck a berm and a pole which laid across the landing path. This caused the aircraft to nose over and impact a wire which supported the pole before it rested.

The aircraft's wings, ailerons, wing support struts, vertical stabiliser, nose landing gear, propeller, engine and engine thrust mounts were damaged. The right main landing gear and engine detached from the fuselage during the accident sequence. The wreckage distribution was localised in the vicinity of the accident site.

Figure 5: The aircraft at the accident site.

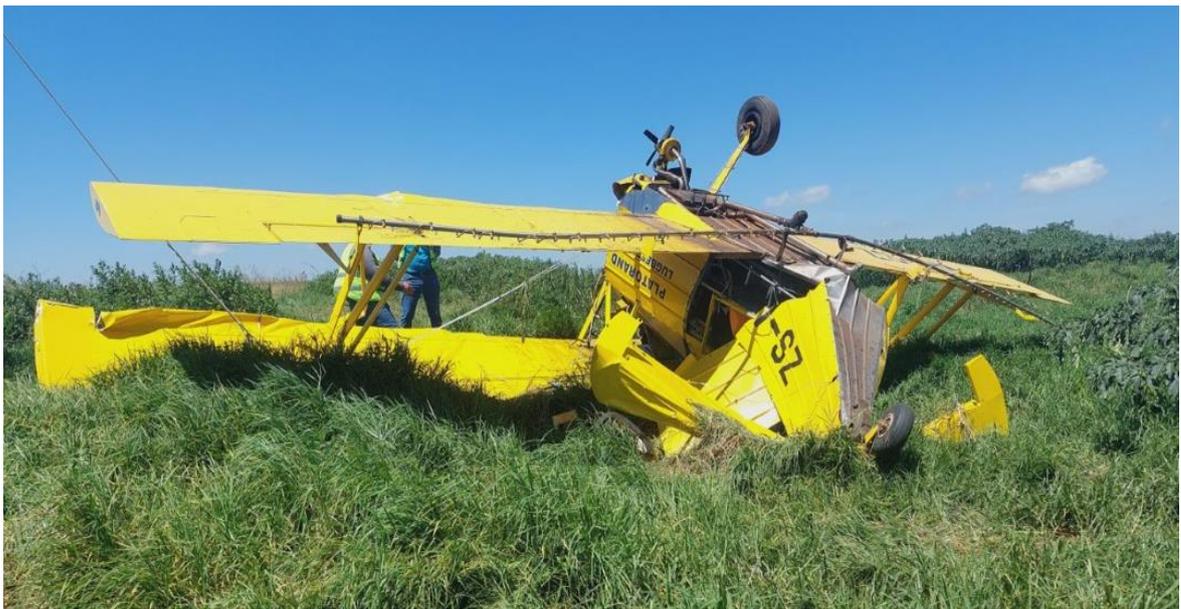
Figure 6: The aircraft in an inverted position.

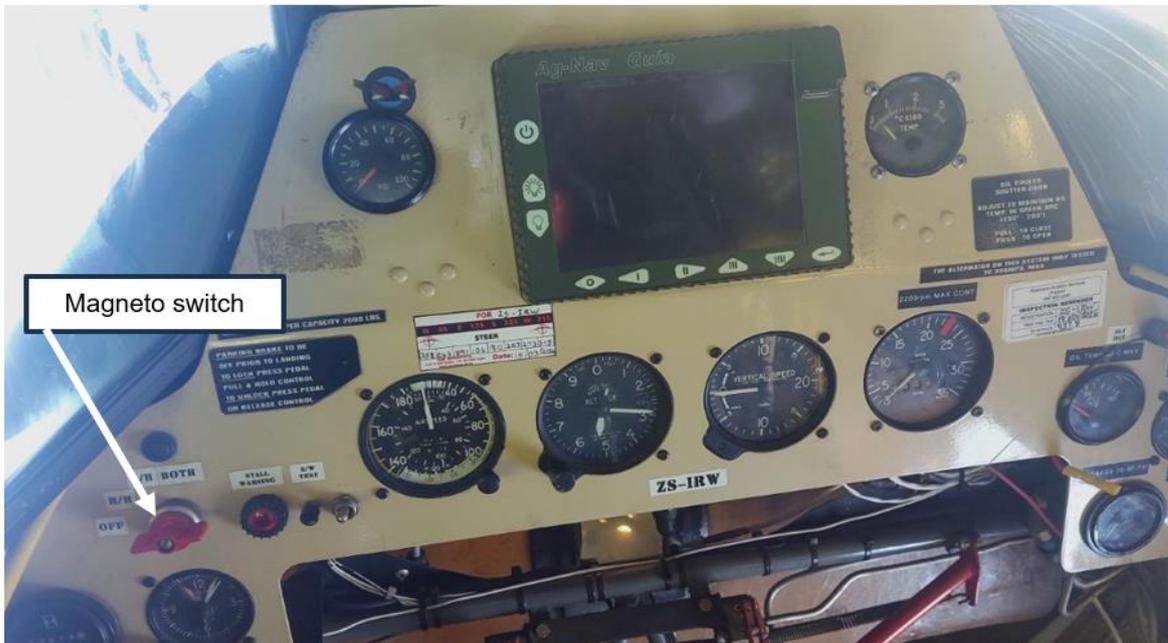
1.12.1. The instrument panel was found intact and had no signs of damage. The magneto switch was in the OFF position.

Figure 7: The instrument panel.

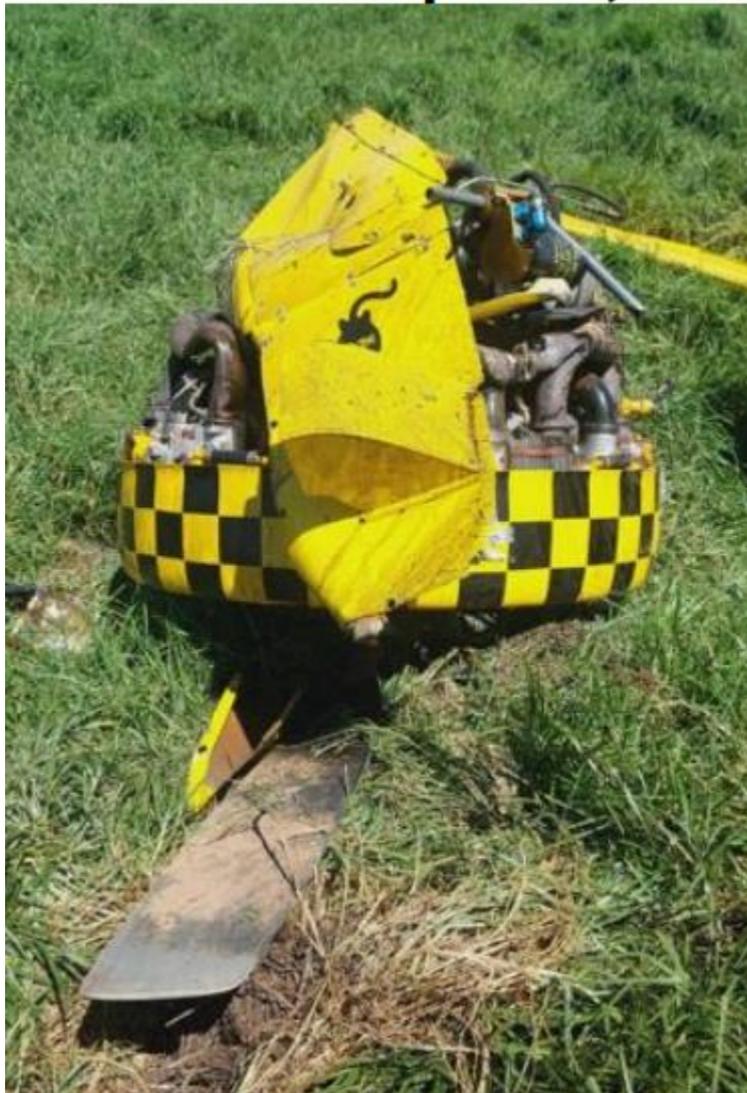
Photo 1: The engine post-accident.

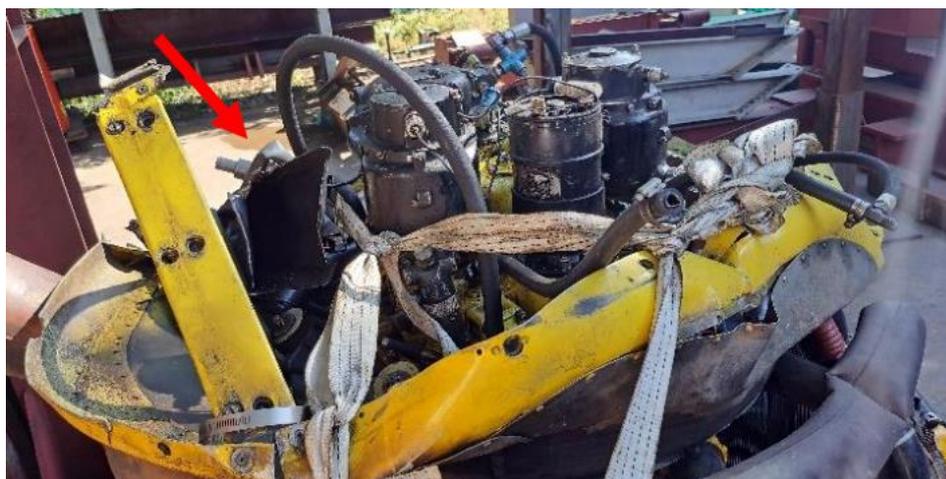
The visual inspection revealed damage and fractures to the engine mount frame (cradle) consistent with the reported impact sequence (Photo 2, red arrow). No indications of pre-existing damage and/or fractures were noted. The engine casing and cylinder assemblies revealed no signs of breaching (Photo 3).

Photo 2: Engine cradle condition (digital).

The observed damage to the engine mount frame, carburettor, and other components were caused by the impact sequence and were consistent with no-power at the time of the crash.

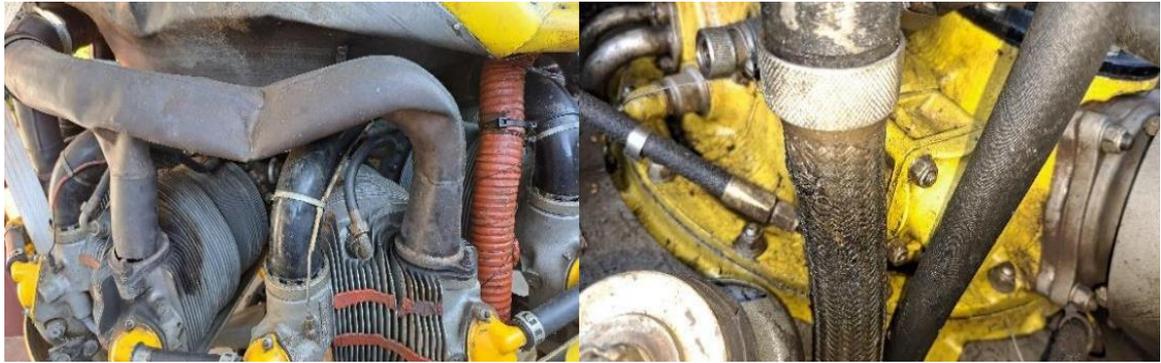
Photo 3: Cylinder and Crankcase conditions (digital).

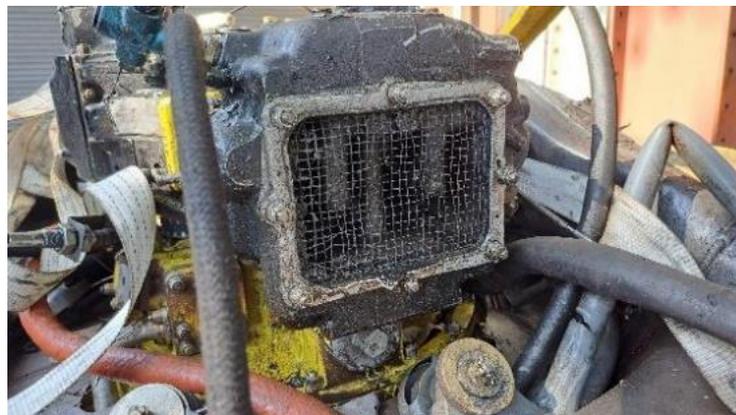
The fuel mixture control unit (carburettor) showed extensive impact damage (Photo 5).

Photo 5: Fuel control unit damage (digital).

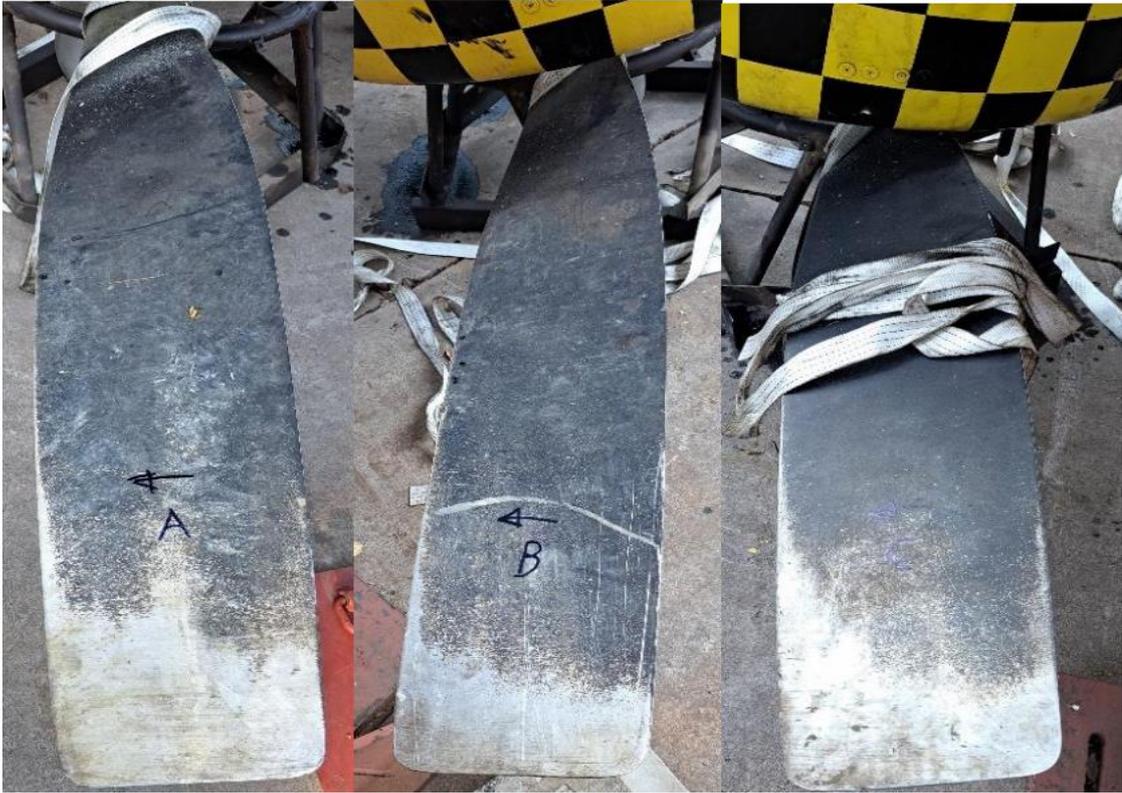
The propeller assembly revealed no clear indications of malfunction while the damage was consistent with a low/no RPM on impact (Photo 6).

Photo 6: Propeller blade conditions (digital).

Damage to the propeller assembly and other findings suggested that the engine was not delivering power at the time of impact.

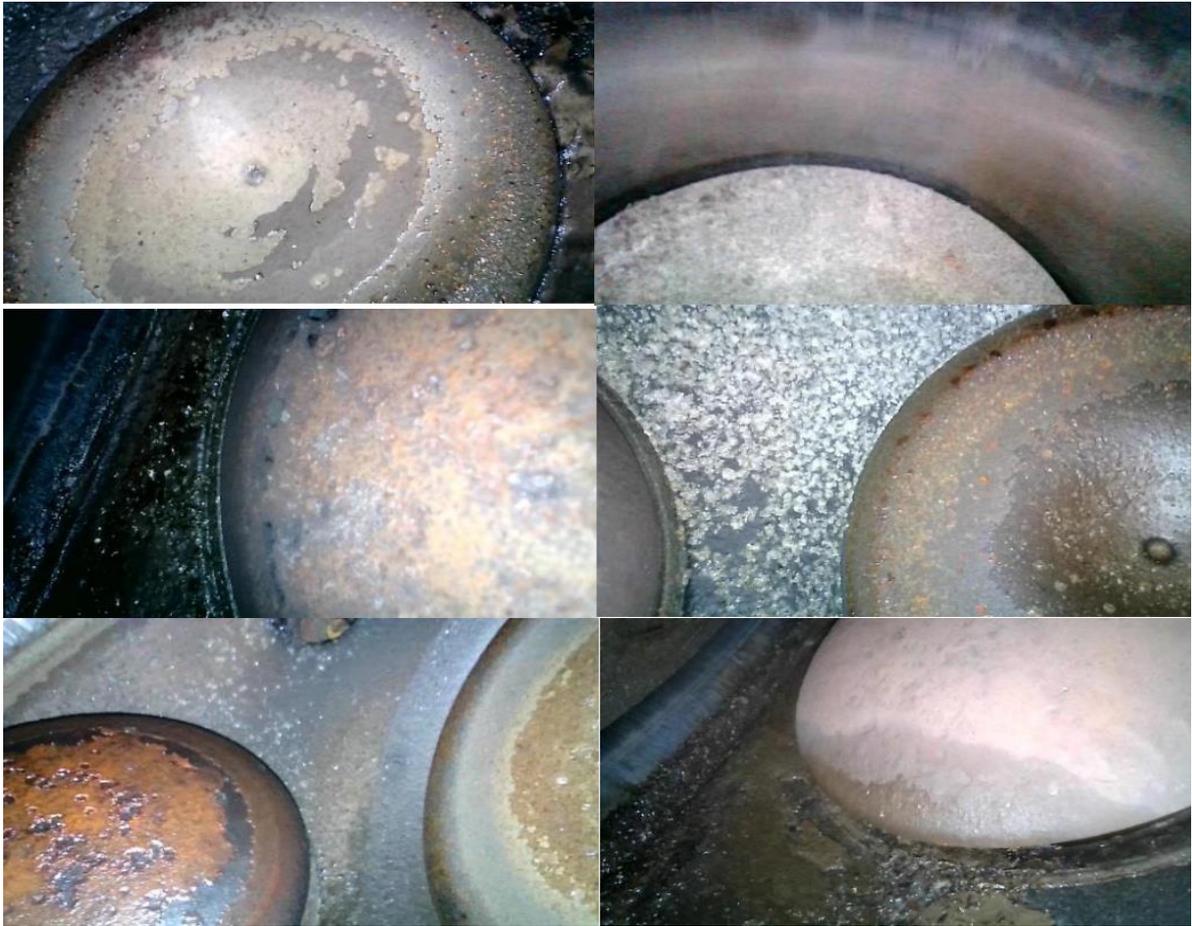
The inspection revealed no clear indications of excessive cylinder wall wear/corrosion, piston head damages, intake/exhaust valve head damage, intake/exhaust valve seat damage and/or any other clear discrepancies (Photo 7) that could have contributed to the reported sudden stoppage of the engine during operation. No clear indications of high-temperature exposure were noted.

Photo 7: Borescope inspection (digital).

The borescope inspection revealed no internal damage or anomalies in the cylinders, piston heads, valves, or valve seats, and no signs of excessive wear, corrosion or high-temperature exposure.

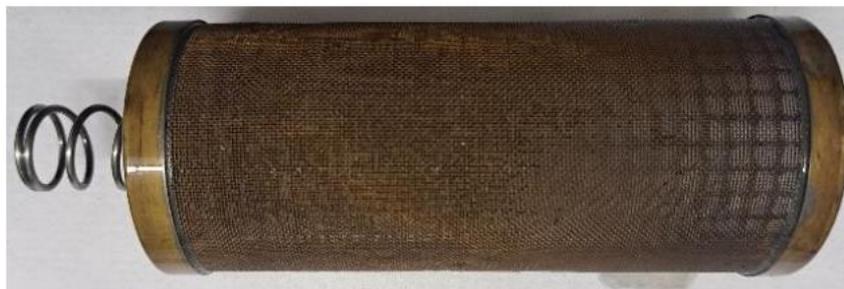
Debris was removed from the oil filter for high-magnification inspection (Photo 8). The SEM and EDS analysis revealed no clear indications of excessive engine wear particulates and/or foreign matter ingestion.

Photo 8: Oil filter.

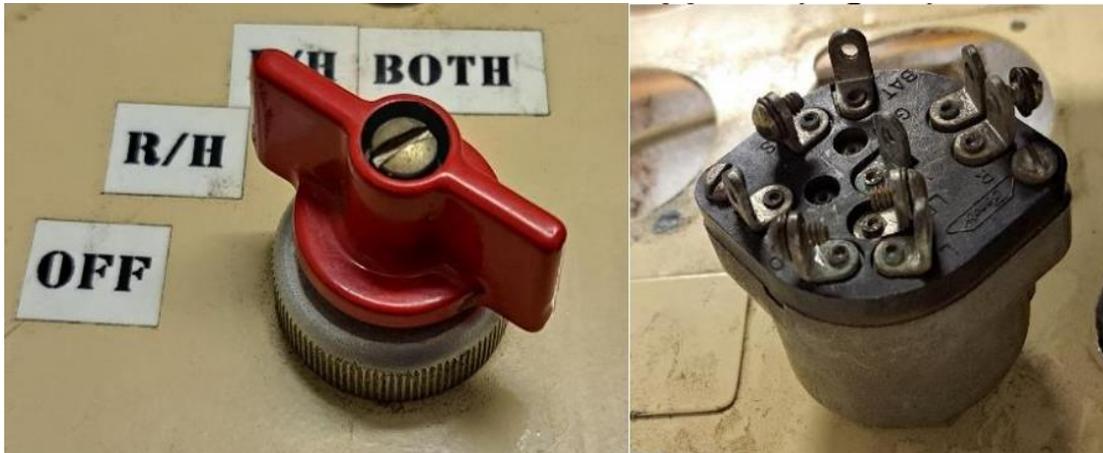
The magneto selector switch was available and removed for laboratory inspection (Photo 9). The switch body revealed no clear indications of a loose turning knob, fractures and/or high temperature exposure to the electrical terminals. There was no clear resistance to rotation. The electrical continuity test between the terminals corresponded with to the required selection

Photo 9: Magneto selector switch.

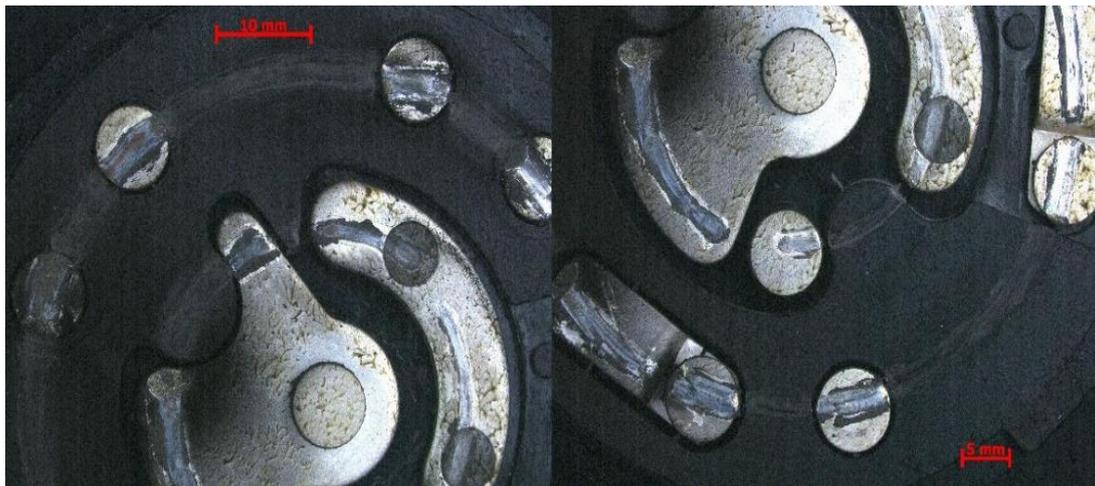
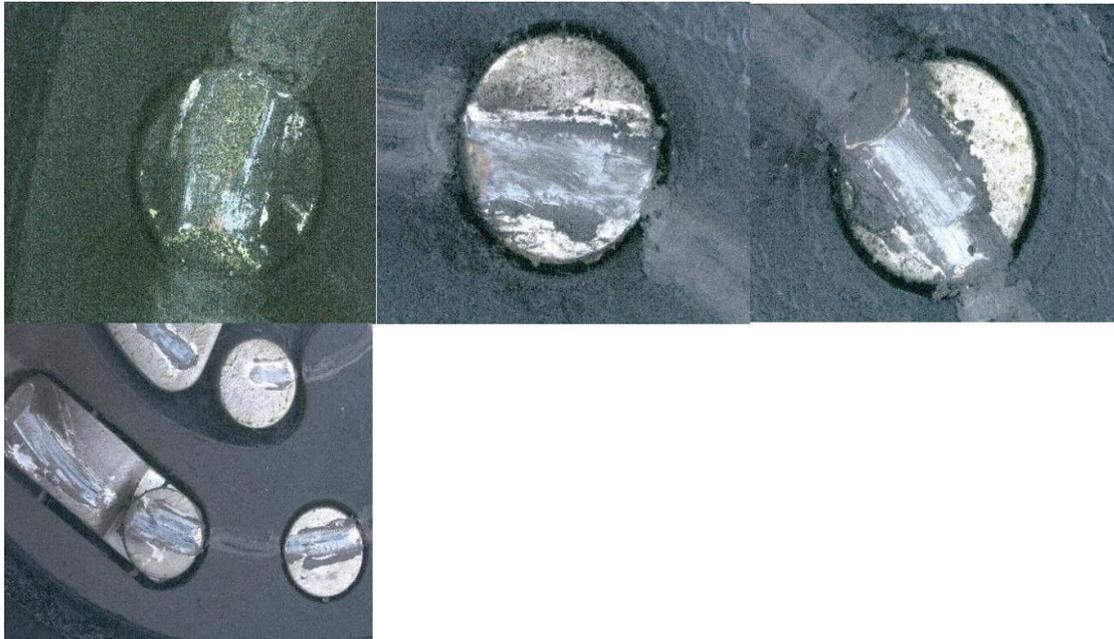
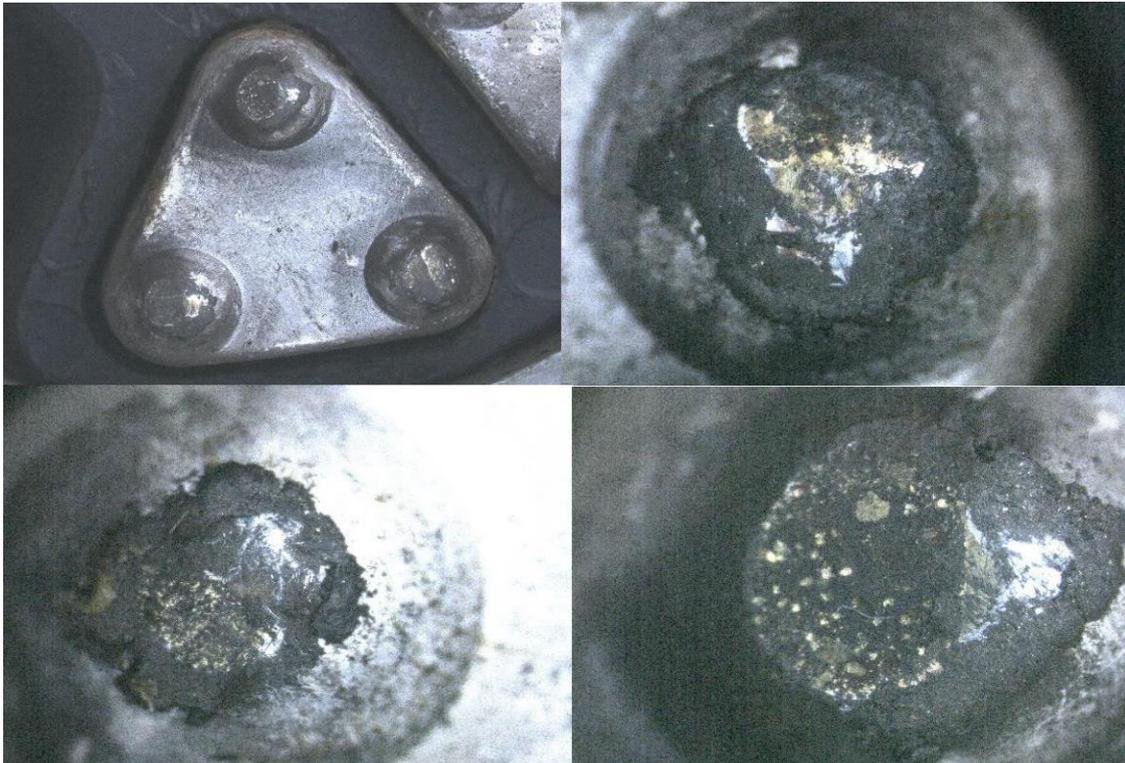
The magneto selector switch was opened under controlled conditions for an internal inspection. The inspection revealed notable wear to the individual contact surfaces (Photos 10 and 11). Indications of foreign material build-up and electrical arcing were noted (Photo 12).

It can be derived that the most probable cause of the sudden stoppage is an electrical failure with emphasis on the conditions that will allow both magneto assemblies to malfunction due to wear, the accumulated foreign material build-up and electrical arcing. The most probable condition then is when both magnetos are inadvertently 'earthed' during operation. It can be considered a low probability that the PIC will decisively introduce this condition via the Magneto Selector switch during flight (OFF). The combination of the noted wear, and electrical arcing

The magneto selector switch appeared externally intact and passed basic electrical tests. However, internal inspection revealed worn contacts, foreign material build-up, and electrical arcing, which could cause intermittent magneto failure and contribute to engine stoppage. The magnetos are on-condition items which means that they will not be removed or internally

Given the wear on the magneto contact poles, foreign material build-up, and electrical arcing in the selector switch, it is likely that both magnetos failed and caused the engine stoppage.

- 3.4.1 Internal excessive wear, foreign material build-up, and electrical arcing on the magneto selector switch.

- 4.2.1. It is recommended that the Regulator investigates the possibility to mandate the internal inspection or overhaul of magnetos at 100-hour inspection and, subsequently, overhaul the magnetos at every 500-hour intervals.
- 4.2.2 It is recommended that the type certificate holder investigates the possibility to add internal magneto inspection and overhaul at every 100- or 500-hour intervals.
