LIMITED OCCURRENCE INVESTIGATION REPORT – FINAL

Reference Number	CA18/2/3/10418						
Classification	Accident		Date	30 January 2024		Time	0925Z
Type of Operation	Training (Part 141)						
Location							
Place of Departure	Morningstar Airfield, Western Cape Province		Place of Intended Landing	Morningstar Airfield, Western Cape Province			
Place of Occurrence	Morningstar Airfield, Western Cape Province						
GPS Co-ordinates	Latitude	34°45'32" S	Longitude	018°33'52" E	Elevation	200 feet	
Aircraft Information							
Registration	ZU-RDY						
Make; Model; S/N	Xenon 2 RST (Serial Number: CAH08973S)						
Damage to Aircraft	Substantial			Total Aircraft Hours	469.4		
Pilot-in-command							
Licence Type	Recreational Student Pilot Licence (RSPL)		Gender	Male		Age	19
Licence Valid	Yes	Total Hours	11.4		Total Hours on Type	11.4	
Total Hours Past 30 Days	8.3		Total Flying Hours on Type Past 90 Days	8.3			
People On-board	1 + 0	Injuries	0	Fatalities	0	Other (on ground)	0

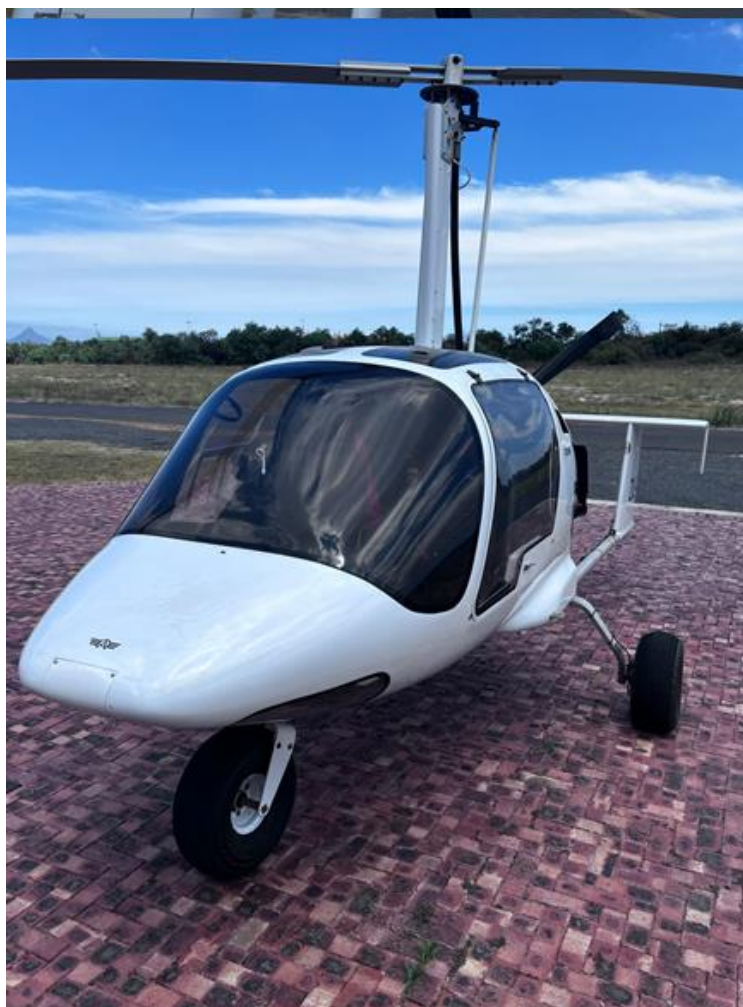
Figure 2: The aircraft after the accident. (Source: Pilot)

5. The gyrocopter rotor blade flapped excessively during take-off which led to the trailing blade striking the ground.

During the take-off roll, the gyrocopter rotor blade flapped excessively which resulted in the trailing blade striking the ground.

Aggressive inputs on the controls.

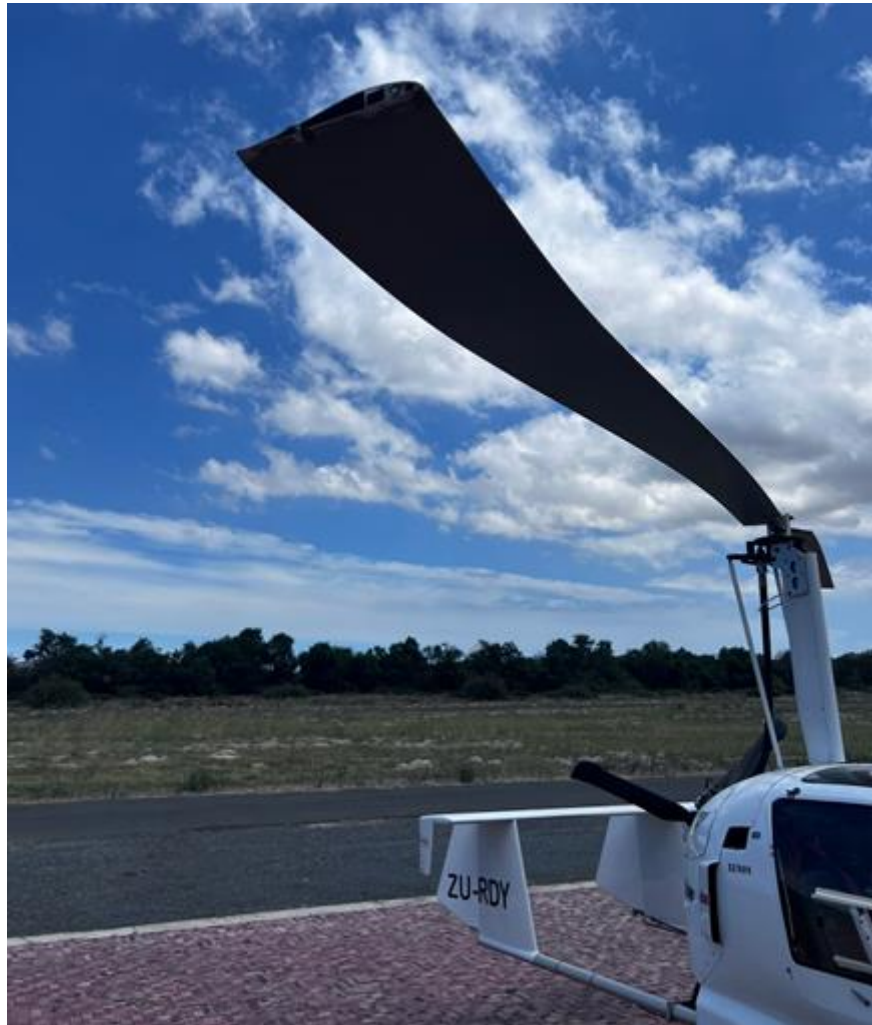
Figure 3: The damaged rotor blade. (Source: Pilot)

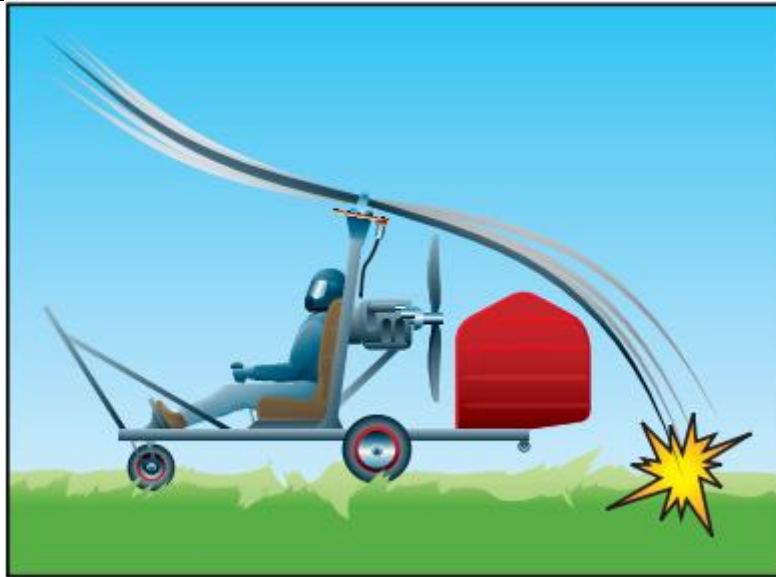
On a gyroplane with a semi-rigid, teeter-head rotor system, blade flap may develop if too much airflow passes through the rotor system while it is operating at low r.p.m. This is most often the result of taxiing too fast for a given rotor speed. Unequal lift acting on the advancing and retreating blades can cause the blades to teeter to the maximum allowed by the rotor head design. The blades then hit the teeter stops, creating a vibration that may be felt in the cyclic control. The frequency of the vibration corresponds to the speed of the rotor, with the blades hitting the stops twice during each revolution. If the flapping is not controlled, the situation can grow worse as the blades begin to flex and bend. Because the system is operating at low r.p.m., there is not enough centrifugal force acting on the blades to keep them rigid. The shock of hitting the teeter stops combined with uneven lift along the length of the blade causes an undulation to begin, which can increase in severity if allowed to progress. In extreme cases, a rotor blade may strike the ground or propeller.

Figure 4: Taxiing too fast or gusting winds can cause the blade to flap if the rotor is turning slowly. If not controlled, the rotor blade could strike the ground. (Source: [faa-h-8083-21.pdf](#))
