AIRCRAFT ACCIDENT REPORT AND EXECUTIVE SUMMARY

Reference:		CA18/2/3/10419		
Helicopter Registration		ZS-RLS	Date of Accident		15 February 2024		Time of Accident	1820Z
Type of Helicopter		Bell 407			Type of Operation		Training (Part 141)	
Pilot-in-command Licence Type		Commercial Pilot Licence		Age	39	Licence Valid	Yes	
Pilot-in-command Flying Experience		Total Flying Hours		2 609.4		Hours on Type	157.2	
Last Point of Departure		Ultimate Heliport, Midrand, Gauteng Province						
Next Point of Intended Landing		Ultimate Heliport, Midrand, Gauteng Province						
Damage to Helicopter		Substantial						
Location of the accident site with reference to easily defined geographical points (GPS readings if possible)								
On Runway 35 at Grand Central Aerodrome (GPS co-ordinates: 25°59'19.96" South 028°08'40.20" East) at an elevation of 5 337 feet (ft)								
Meteorological Information		Surface wind: 300°/10 kt; temperature: 24°C; dew point: 17°C

Reference Number : CA18/2/3/10419
Occurrence Category : Accident (Category 1)
Type of Operation : Training (Part 141)
Name of Operator : National Airways Corporation (NAC)
Helicopter Registration : ZS-RLS
Aircraft Make and Model : Bell 407
Nati

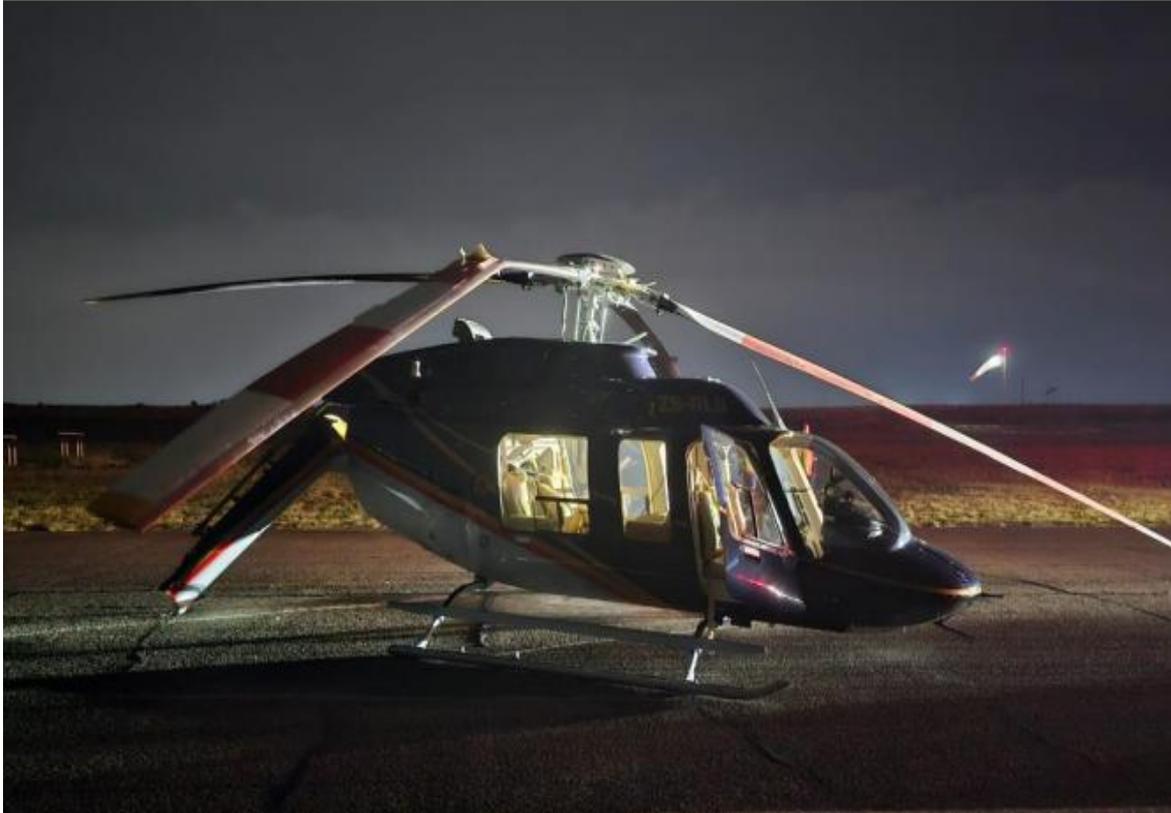
1.3.1. The helicopter sustained substantial damage.

Figure 2: The helicopter after the accident.

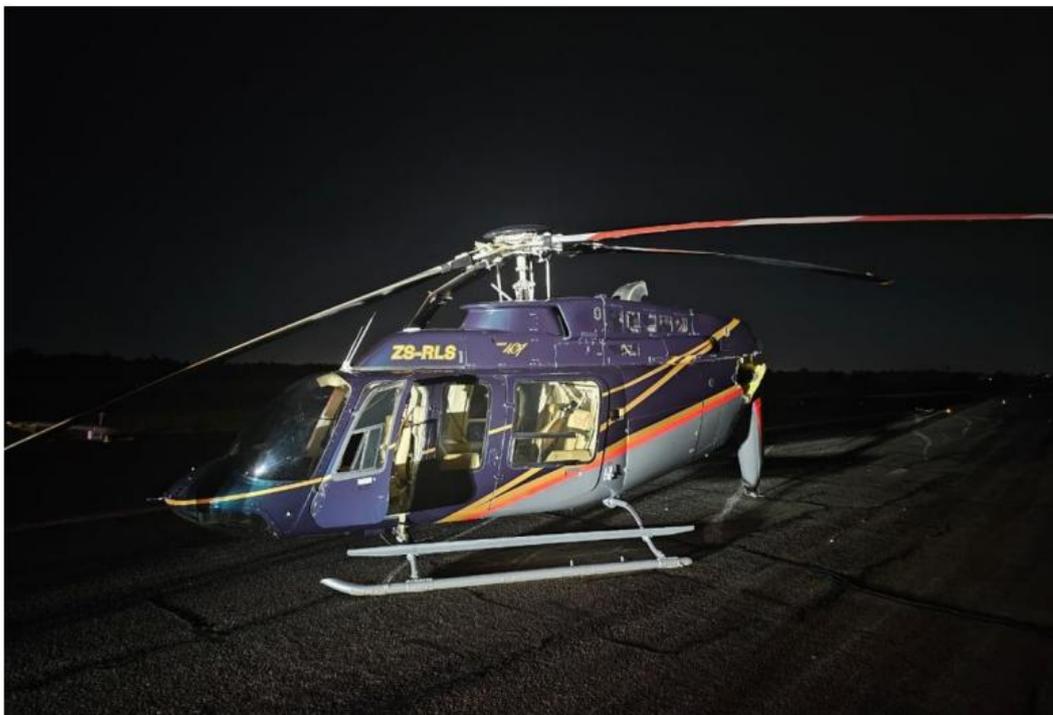
1.12.1. The helicopter came to rest facing north, approximately 475 metres (m) from the threshold of Runway 35. The cabin and the cockpit structure had remained intact. The skid landing gear showed signs of deformation, but it was still attached to the fuselage. The tail boom separated from the airframe; it was severed at two points, which meant that there were three structural pieces of the tail boom on site, namely: the tail cone, horizontal stabiliser and the front section of the tail boom. The severed structural pieces of the tail boom were located at the edge of the runway and on the right side of the wreckage. There were scrape marks on the runway that spanned 45m from the point of impact.

There was no fuel or oil leakage on the upper deck of the helicopter or on the ground. The instrument panel was found intact. The helicopter had dual flight controls installed. It was confirmed that the collective pitch lever control was fully down, and the twist grip/throttle lever was at the maximum open position. The position of the throttle lever on the Hydro Mechanical Unit (HMU), which is located on the right side of the engine, confirmed the position of the throttle lever at the maximum open position. The fuel valve and the master switch were turned off whilst the booster pumps were turned on. The cockpit had two doors; the right door Perspex sheet had a crack. The battery terminal was disconnected.

Figure 3: The helicopter post-accident.

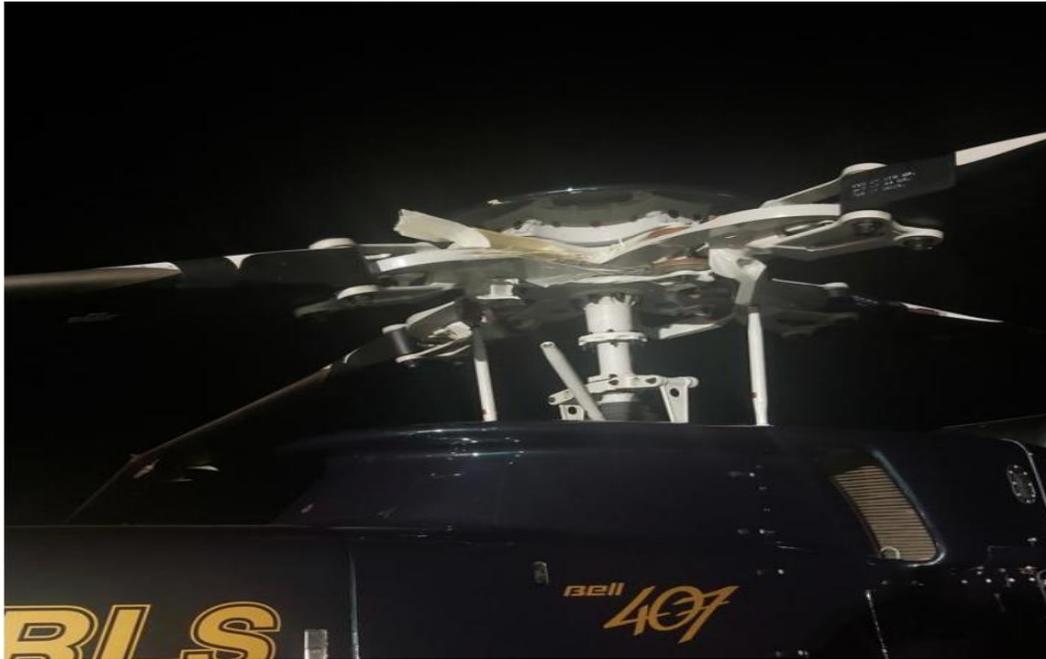
All four main rotor blades exhibited signs of impact damage on the mid-section and on the tips. The main rotor head had fractured. The attachment points of the white pitch change link had fractured and separated; the white pitch change link was located approximately 3m forward of the nose section. Three of the pitch change control tubes were still attached to the main rotor head; one of the pitch change control tubes near the clevis attachment had failed. The rotating and non-rotating swashplates were still secured.

Figure 4: Damage to the main rotor head.

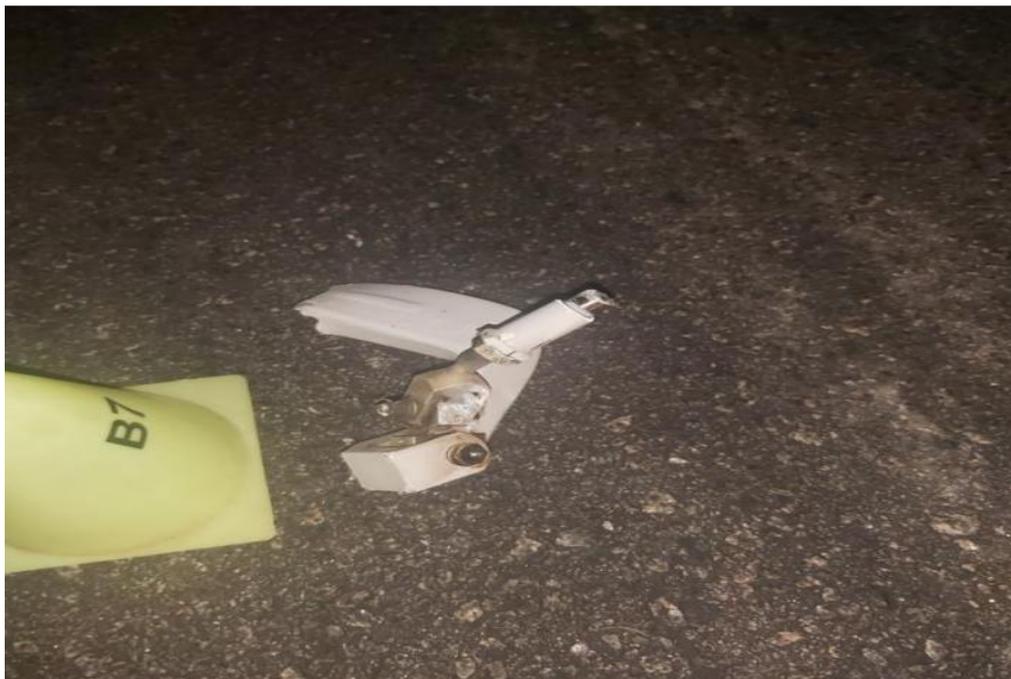
Figure 5: The damaged pitch change link attachment.

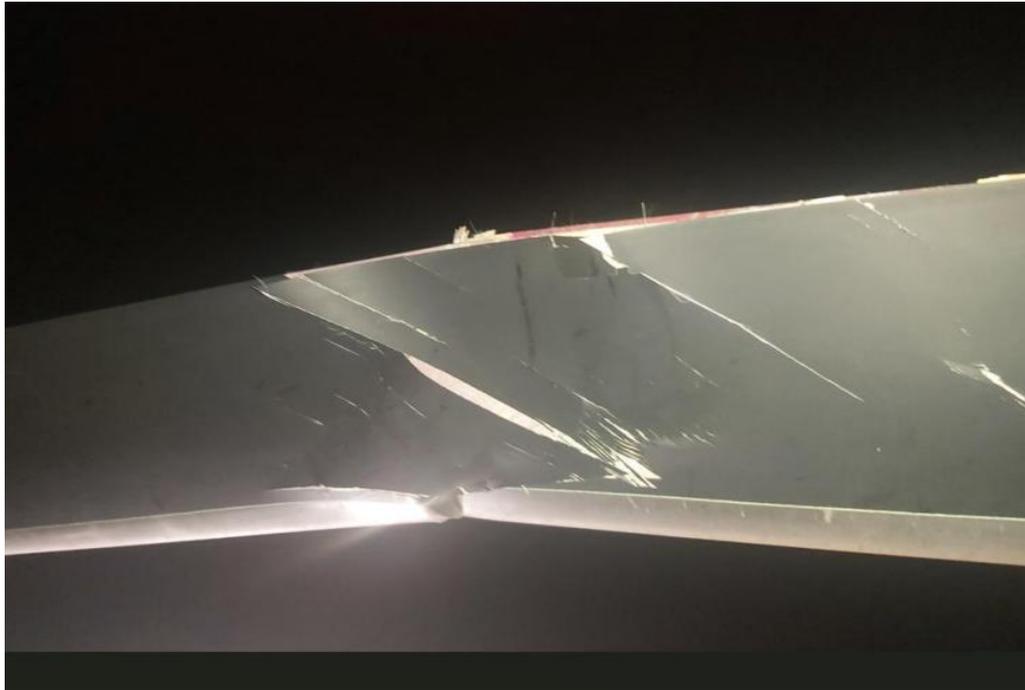
Figure 6: The damage sustained to one of the main rotor blades.

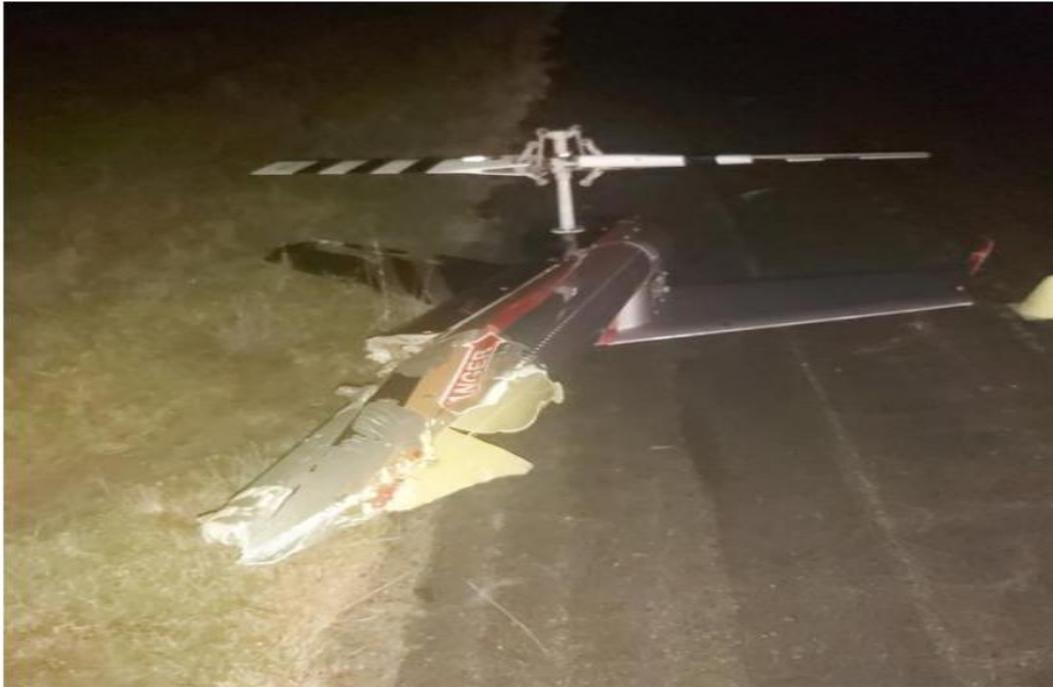
The main rotor blades severed the tail boom at the point it attaches to the fuselage. The horizontal stabiliser and tail cone exhibited signs of damage after they contacted the main rotor blades. The tail cone skin had an imprint that matched the profile of the main rotor blade leading edge paint. Scrape marks were found on the underside of the tail rotor guard, but the

Figure 7: The tail cone at the accident site.

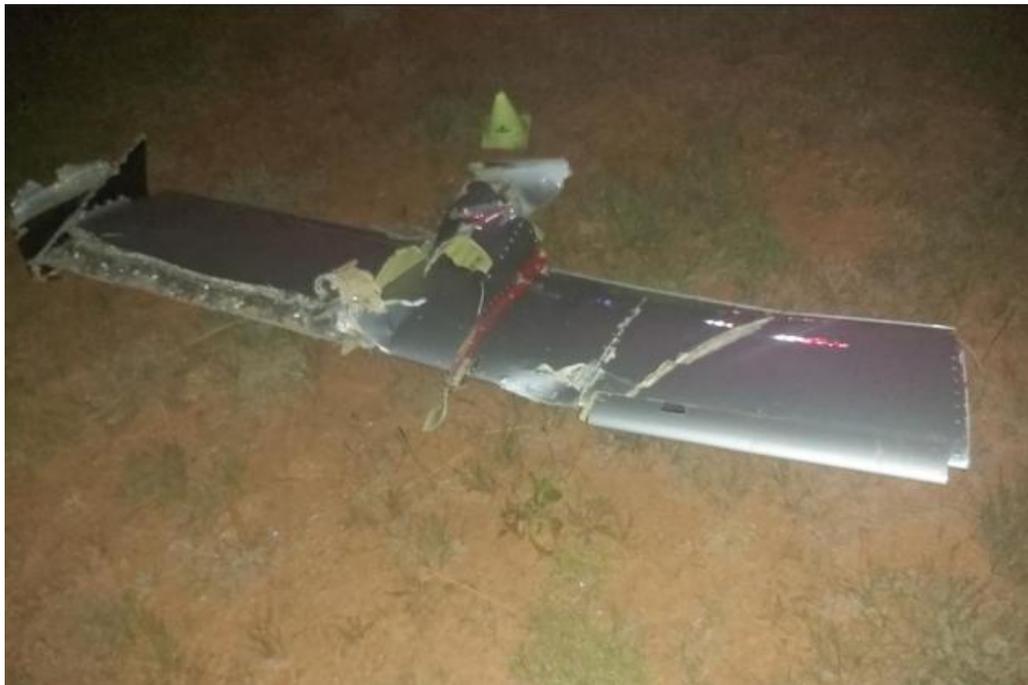
Figure 8: The severed horizontal stabiliser.

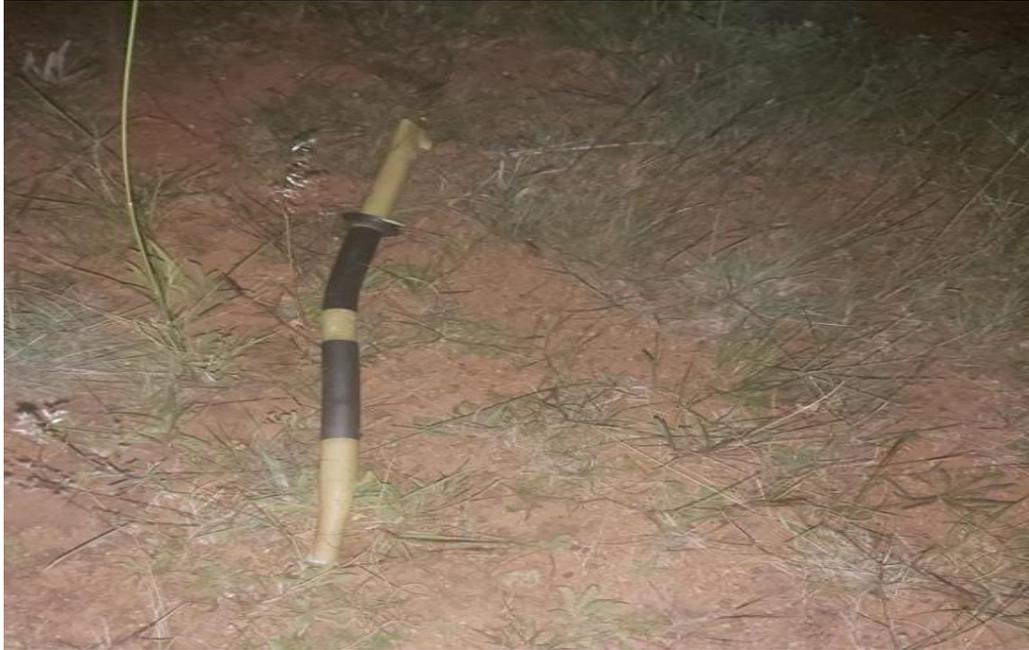
Figure 9: A section of the tail rotor drive shaft at the accident site.

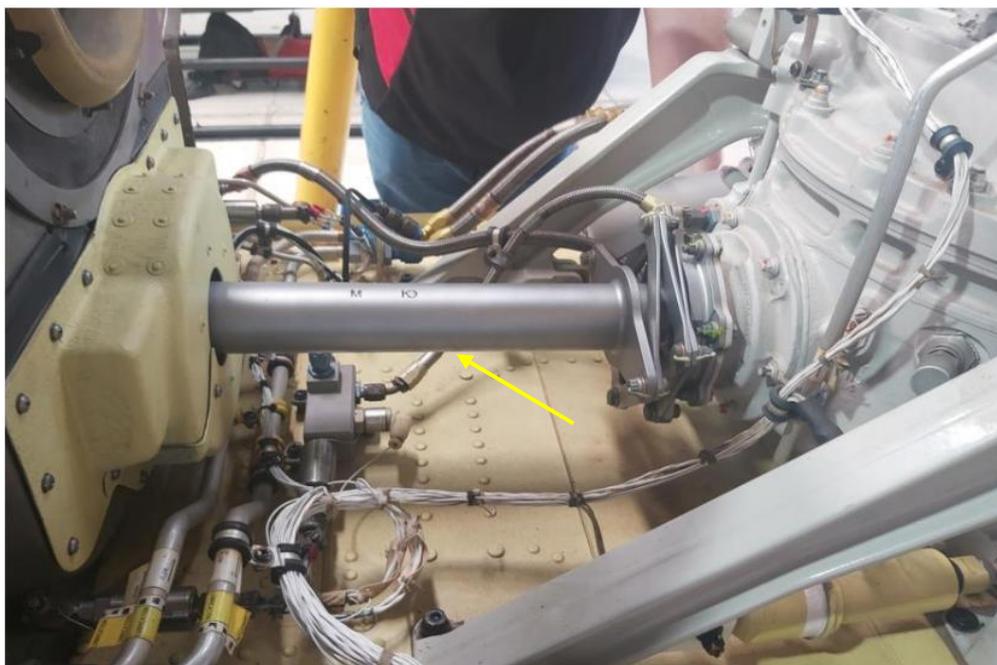
The engine was found intact and in good condition. The outside surface of the compressor blades was in good condition. The compressor was turned by hand, and it rotated smoothly. The turbine blades were not damaged. There were no signs of fuel or oil pipe rupture or dislocation. The forward and lower chip detectors were removed and checked for metal chips; they were found clean. Fuel sample from the forward and rear tanks was collected; the fuel was of the correct grade (Jet A1) and had no sediments or impurities.

Figure 10: The engine drive shaft.

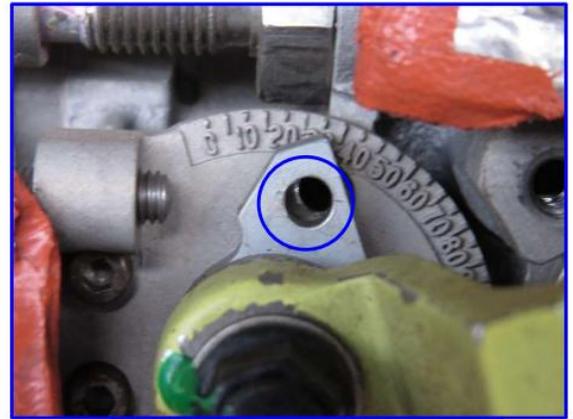
- IV. The throttle linkage rigging to the HMU was misaligned by 5° to the lower side. Damage sustained during the accident was not sufficient to alter the throttle to the HMU rigging.

Figure 13: HMU rigging misalignment.

2.2.13. During engine examination by the accredited representative and the IIC, it was noted that the HMU engine rigging was misaligned. However, this did not contribute to the engine flame-out as this was still within the allowable limitations for normal engine operation.

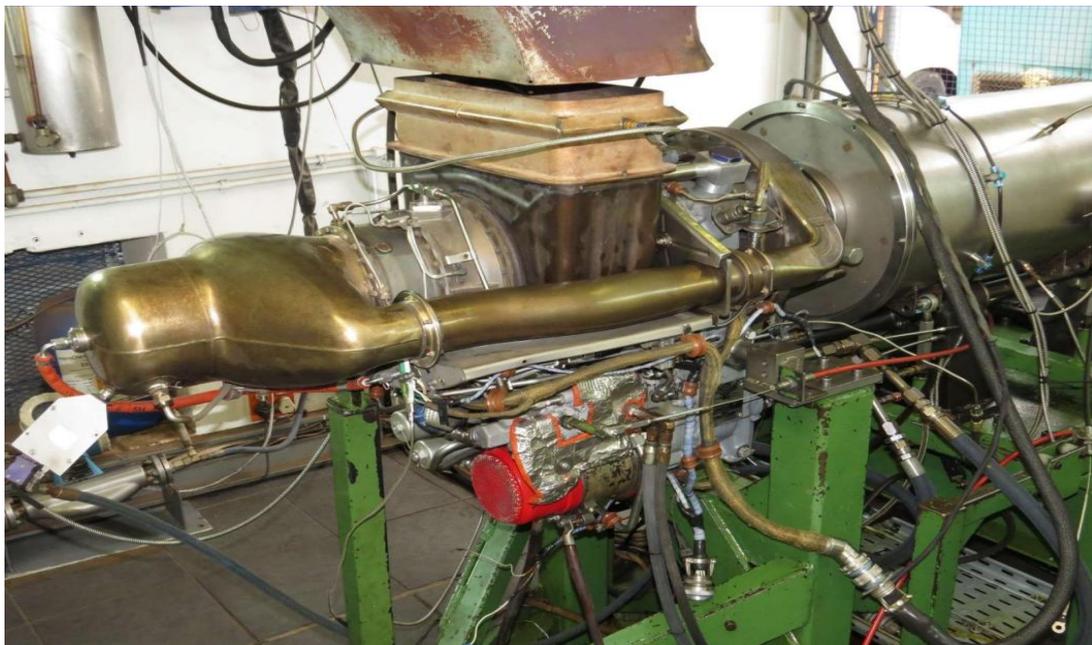
Figure 14: The engine on the test bench.

- a) There was no visible, external evidence of pre-impact fire, damage or malfunction of the engine.
- b) Continuity was established for both the rotational speed of the low-pressure spool (N1) and the rotational speed of the high-pressure compressor and turbine spool (N2). Both rotors could be rotated by hand, and they moved smoothly with no noise.
- c) The engine was placed on a test bench with the intent of running a 6-point performance test in accordance with Rolls-Royce M250-C40 Series Overhaul Manual procedures. The engine performed satisfactorily at all measured test points.

- d) All available evidence supports that the engine could produce sufficient power and respond to throttle inputs.

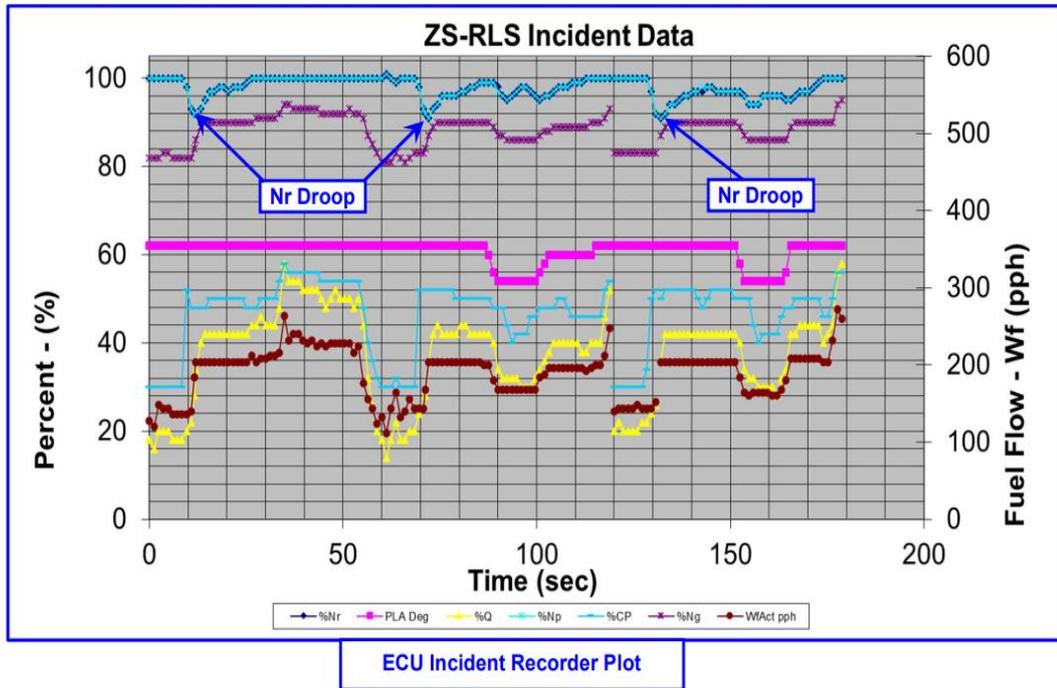
Incident Recorder Snapshot Data

The following graph shows the first 3 triggers (Nr Droop) occurring within the total recorded time in the IR (180 sec). These triggers did not occur during the accident flight:

At ground idle, the Ng speed on the M250-C47B engine is 63%. While in Auto mode, the automatic relight sequence will initiate from detection of flameout until the Ng speed decays to 50%. Once the Ng decays below 50% the ECU will no longer attempt to relight the engine. During the accident sequence, the rapidly decreasing Ng speed & rate of Ng deceleration (NDOTFilt) was so great (- 10.8 to -8.6%Ng/Sec), the ECU was incapable of performing a relight.
