LIMITED OCCURRENCE INVESTIGATION REPORT – FINAL

Reference Number	CA18/2/3/10420					
Classification	Accident	Date	15 February 2024	Time	0930Z	
Type of Operation	Training (Part 141)					
Location						
Place of Departure	Wonderboom Aerodrome (FAWB), Gauteng Province		Place of Intended Landing	Wonderboom Aerodrome (FAWB), Gauteng Province		
Place of Occurrence	Left of Runway 29 at Wonderboom Aerodrome (FAWB)					
GPS Co-ordinates	Latitude	25°39'19.11" S	Longitude	028°13'16.81" E	Elevation	4 095 ft
Aircraft Information						
Registration	ZS-JLF					
Make; Model; S/N	Piper Aircraft Corporation; PA-28-140 (Serial Number: 28-7525229)					
Damage to Aircraft	Substantial		Total Airframe Hours	15 091.58		
Pilot-in-command						
Licence Type	Student Pilot Licence (SPL)		Gender	Male	Age	21
Licence Valid	Yes	Total Hours	26.4	Total Hours on Type	25.3	
Total Hours 90 Days	22.7		Total Flying Hours on Type Past 90 Days	22.7		
People On-board	1 + 0	Injuries	0	Fatalities	0	Other (on the ground) 0

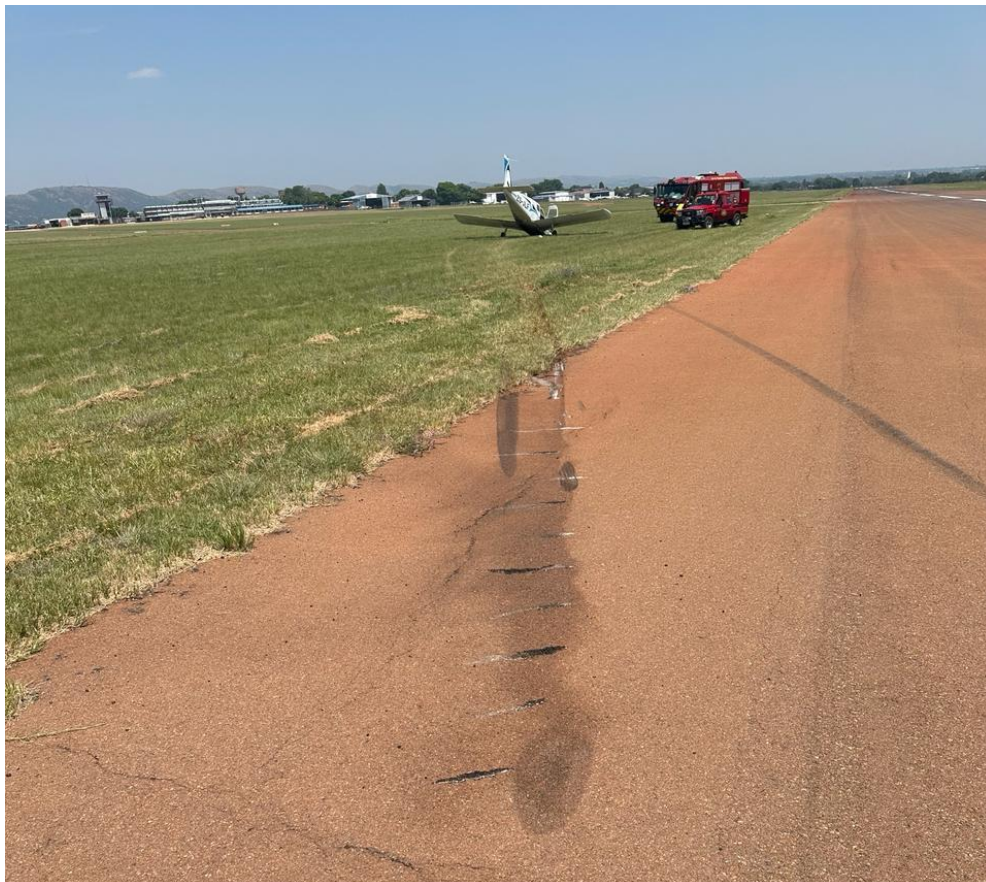
The student pilot stated that because of poor performance of the engine, he intended to perform a full stop landing, but as he was already cleared by ATC for the touch-and-go on Runway 29, he opted to proceed with the exercise. The wind was 290° at 12 knots. At 80 miles per hour (mph), the student pilot commenced with the flare but realised that the indicated airspeed was bleeding off fast, therefore, he pushed the nose forward to prevent the aircraft from stalling but realised that he had not gained any height and was close to the runway surface. As a result, the propeller struck the runway and the student pilot became *"a bit unconscious and lost control for a moment"*. The nose landing gear strut collapsed as the aircraft veered off the runway to the left. The ATC activated the crash alarm and the Aerodrome Rescue and Firefighting (ARFF) personnel responded to the scene. Several propeller strike markings were visible on the runway surface (see Figure 1).

Figure 1: Propeller strike markings on the edge of the runway. (Source: ARFF)

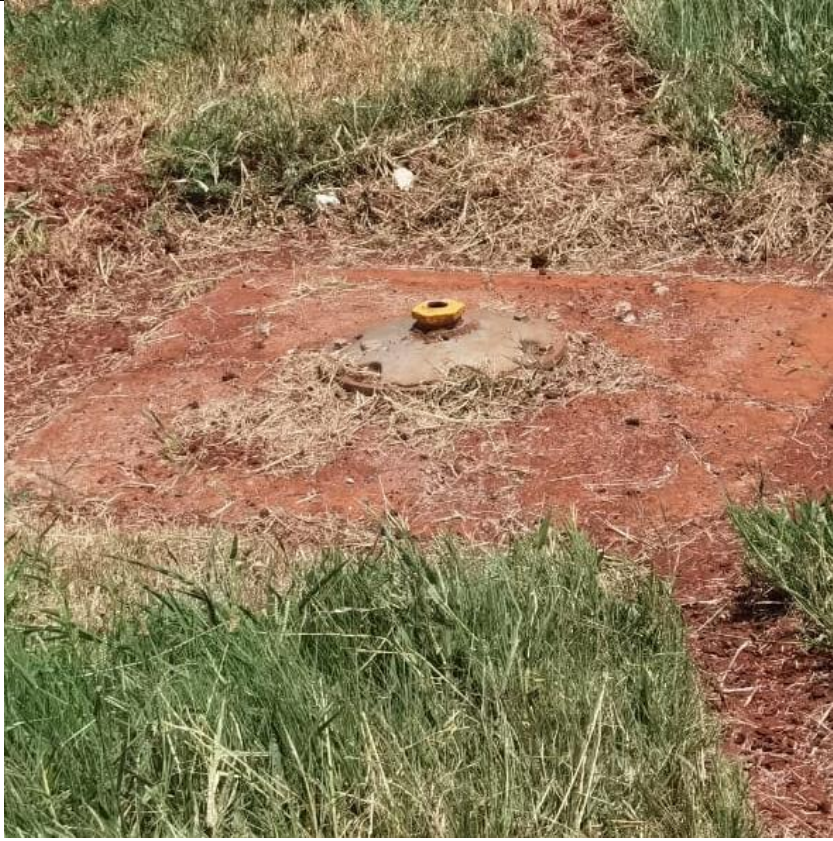
No person was injured during the accident. The aircraft sustained substantial damage. One of the runway lights was severed as the aircraft veered off the runway.

Figure 2: The severed runway light. (Source: ARFF)

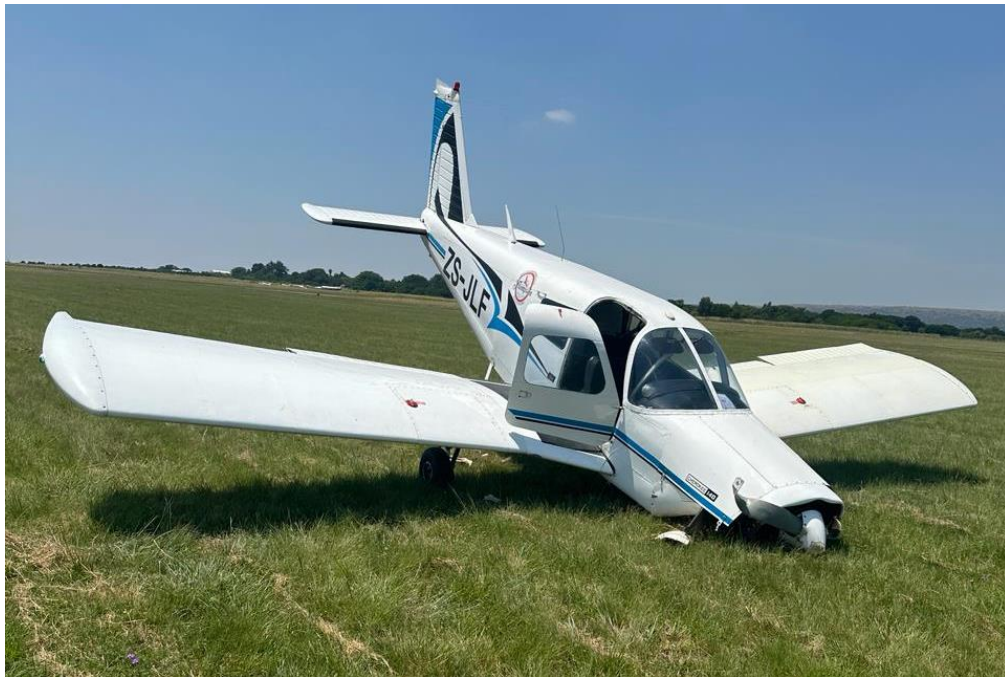
Figure 3: The aircraft as it came to rest next to the runway. (Source: ARFF)

The aircraft touched down hard in a nose-down attitude towards the left of the runway centreline, and the aircraft veered off the runway.

- (i) Insufficient use of rudder to maintain directional control.
- (ii) Density altitude at the time could have impaired the aircraft's performance.

The student pilot is set to undergo additional training at the ATO before he is considered to fly solo again.

"The student will be re-briefed on approach and landings, and he will be sent back to the simulator for additional training. He will also receive additional circuit training. No solo flights on ZS-JLF due to the lack of performance during high-density altitude conditions. His next solo check will be done by the CFI."

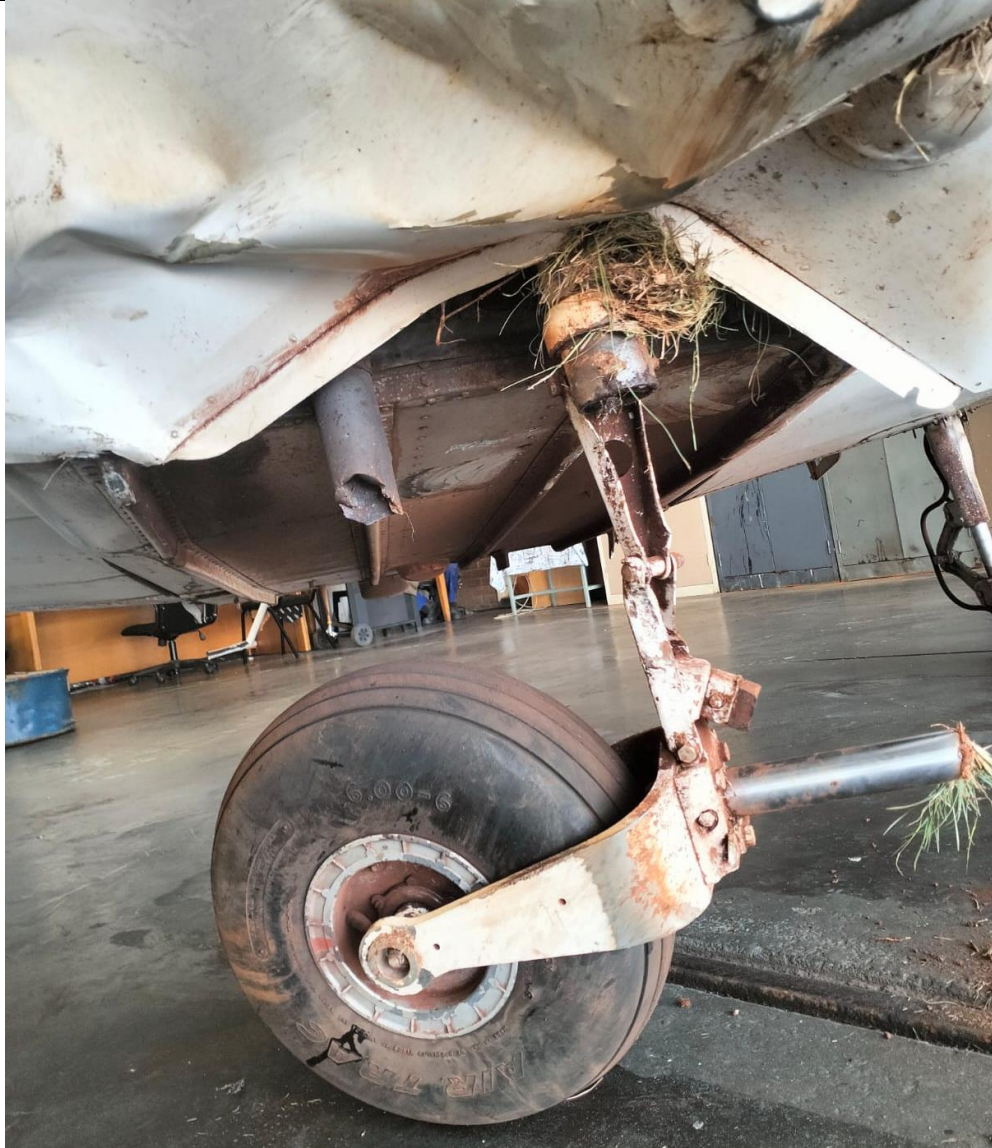
Figure 4: Damage to the nose landing gear oleo and aircraft structure.
