**LIMITED OCCURRENCE INVESTIGATION REPORT – FINAL**

<b>Reference Number</b>	CA18/2/3/10421						
<b>Classification</b>	Accident	<b>Date</b>	16 February 2024		<b>Time</b>	0815Z	
<b>Type of Operation</b>	Private (Part 91)						
<b>Location</b>							
<b>Place of Departure</b>	Hoedspruit Civil Airport (FAHT), Limpopo Province		<b>Place of Intended Landing</b>	Nelspruit Airport (FANS), Mpumalanga Province			
<b>Place of Occurrence</b>	Runway 22 at Nelspruit Airport (FANS)						
<b>GPS Co-ordinates</b>	<b>Latitude</b>	25°29'56.96"S	<b>Longitude</b>	030°54'52.18"E	<b>Elevation</b>	2901 ft	
<b>Aircraft Information</b>							
<b>Registration</b>	ZS-MBT						
<b>Make; Model; S/N</b>	Textron Aviation; Beach Baron 58 (Serial Number: TH-129)						
<b>Damage to Aircraft</b>	Substantial		<b>Total Aircraft Hours</b>	6366.7			
<b>Pilot-in-command</b>							
<b>Licence Type</b>	Commercial Pilot Licence (CPL)		<b>Gender</b>	Male	<b>Age</b>	52	
<b>Licence Valid</b>	Yes	<b>Total Hours</b>	6792.4	<b>Total Hours on Type</b>	4.1

**This report is issued by:  
Accident and Incident Investigations Division  
South African Civil Aviation Authority  
Republic of South Africa**

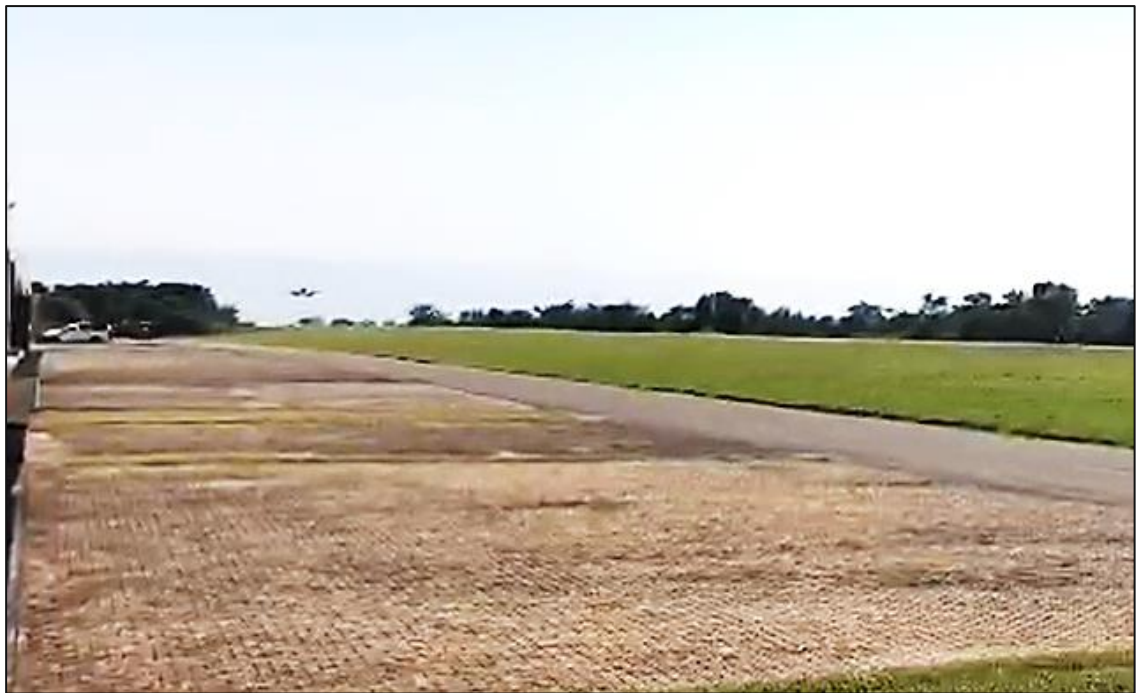
**Figure 2:** The aircraft during approach at a low height with the landing gear retracted. (Source: Still video footage)

The investigation revealed that the aircraft approached the runway with the landing gears retracted. If the landing gears were selected but not locked, the gear indication in the cockpit would have remained red and not indicate green. This is evidenced by the actuator quadrant arm which had not rotated to the full 180° thus, making it impossible for the landing gear indicator lights in the cockpit to have turned to green. There was no report of landing gear problems during approach, and there was no attempt to use the emergency landing gear extension system. Therefore, the investigation revealed that there were no landing gear system problems.

6. The aircraft was on final approach with the landing gears retracted. It is likely that when an audio warning sounded, it was only then that the pilot realised the landing gears were not selected to the 'down and locked' position. Instead of executing a go-around, the pilot extended the landing gears (selected them to the down position) which resulted in the aircraft touching down whilst the landing gears were transitioning to the down position and, thus, collapsed.

<b>Safety Message and/or Safety Recommendation/s</b>
Pilots should conduct a go-around when the aircraft is not properly configured for the final approach and landing.
<b>About this Report</b>
<p><i>The decision to conduct a limited investigation is based on factors, including whether the cause is known and the evidence supporting the cause is clear, the level of safety benefit likely to be obtained from an investigation, and that will determine the scope of an investigation. For this occurrence, a limited investigation has been conducted, and the Accident and Incident Investigations Division (AIID) has relied on the information submitted by the affected person/s and organisation/s to compile this limited report. The report has been compiled using information supplied in the initial notification, as well as from follow-up desktop inquiries to bring awareness of potential safety issues to the industry in respect of this occurrence, as well as possible safety action/s that the industry might want to consider in preventing a recurrence of a similar occurrence.</i></p> <p><i>All times given in this report are Co-ordinated Universal Time (UTC) and will be denoted by (Z). South African Standard Time is UTC plus 2 hours.</i></p>

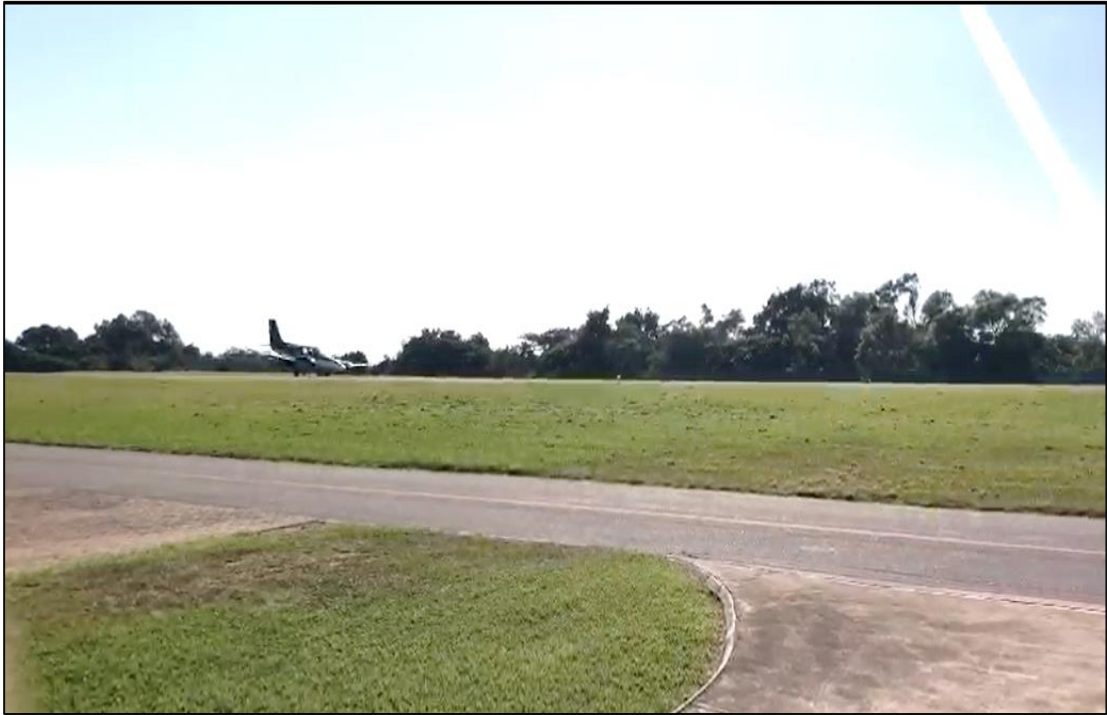
**Figure 3:** The aircraft undercarriage collapses. (Source: Still video footage)

7. Evidence from the AMO stated that *"the actuator arm show that it had not rotated to the full 180° with a visible ±15° remaining for a further travel for it to be fully extended and that indicated that landing gears touched down whilst they were in transition and not fully extended and locked"*.

The landing gears were extended late during final approach and the aircraft touched down whilst the landing gears were transitioning and, thus, collapsed.

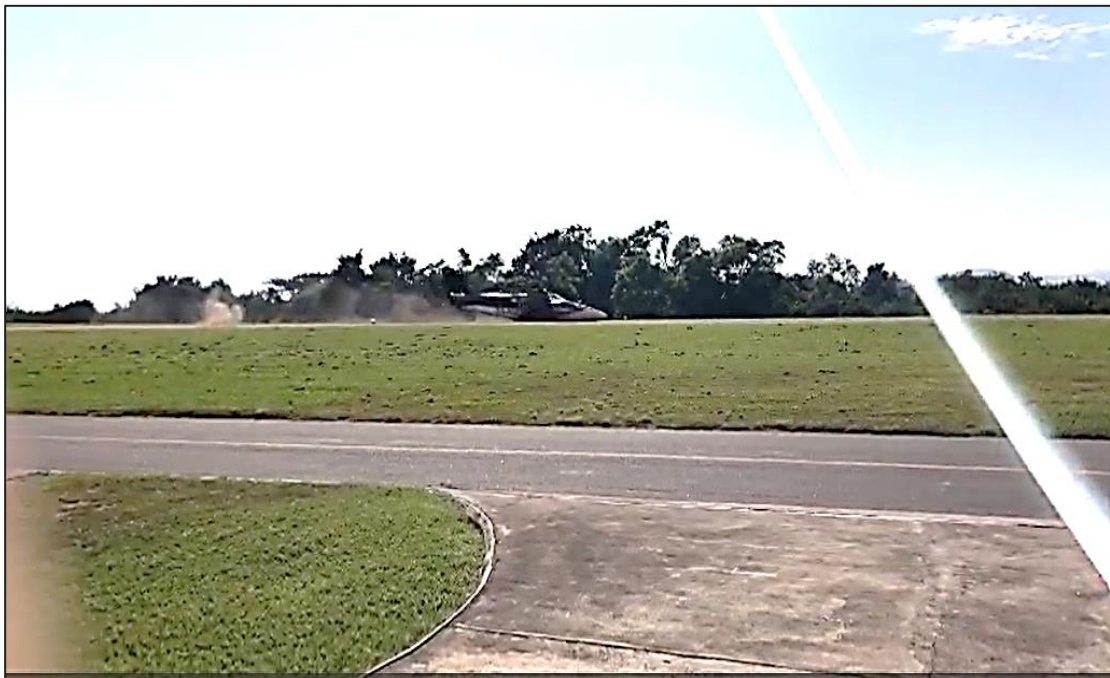
**Figure 4:** The aircraft scrapes along the runway as it veers off to the left. (Source: Still video footage)
