LIMITED OCCURRENCE INVESTIGATION REPORT – FINAL

Reference Number		CA18/2/3/10422					
Classification	Accident	Date	19 February 2024		Time	1140Z	
Type of Operation	Aerial Works – Game Culling (Part 137)						
Location							
Place of Departure	Doornhaag Farm near Vryburg, North West Province		Place of Intended Landing	Elandsheuwel Farm near Potchefstroom, North West Province			
Place of Occurrence	5.3 nm south-east of Potchefstroom Aerodrome (FAPS) in Elandsheuwel Farm, North West Province						
GPS Co-ordinates	Latitude	26° 44' 40.3" S	Longitude	27° 11' 15.0" E	Elevation	4 641 feet	
Aircraft Information							
Registration	ZT-RBZ						
Make; Model; S/N	Robinson; R44 Raven II (Serial Number: 0873)						
Damage to Aircraft	Substantial		Total Aircraft Hours	2 245.2			
Pilot-in-command							
Licence Type	Commercial Pilot Licence (CPL)		Gender	Male	Age	29	
Licence Valid	Yes	Total Hours	2 605.5	Total Hours on Type	2 300		
Total Hours 30 Days	76.8		Total Flying on Type Past 90 Days	102.9

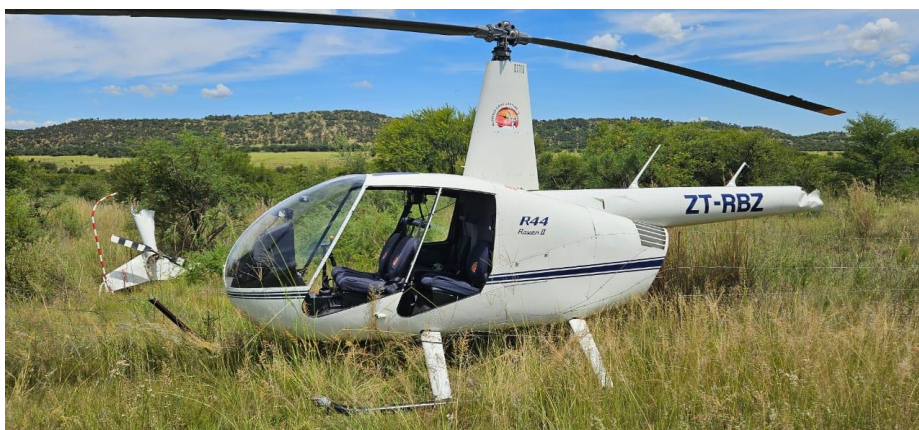
helicopter landed hard and the main rotor blades severed the tail boom. The helicopter rested in an upright position next to a fence. None of the occupants was injured.

Figure 1: The helicopter after it had stopped. (Source: Pilot)

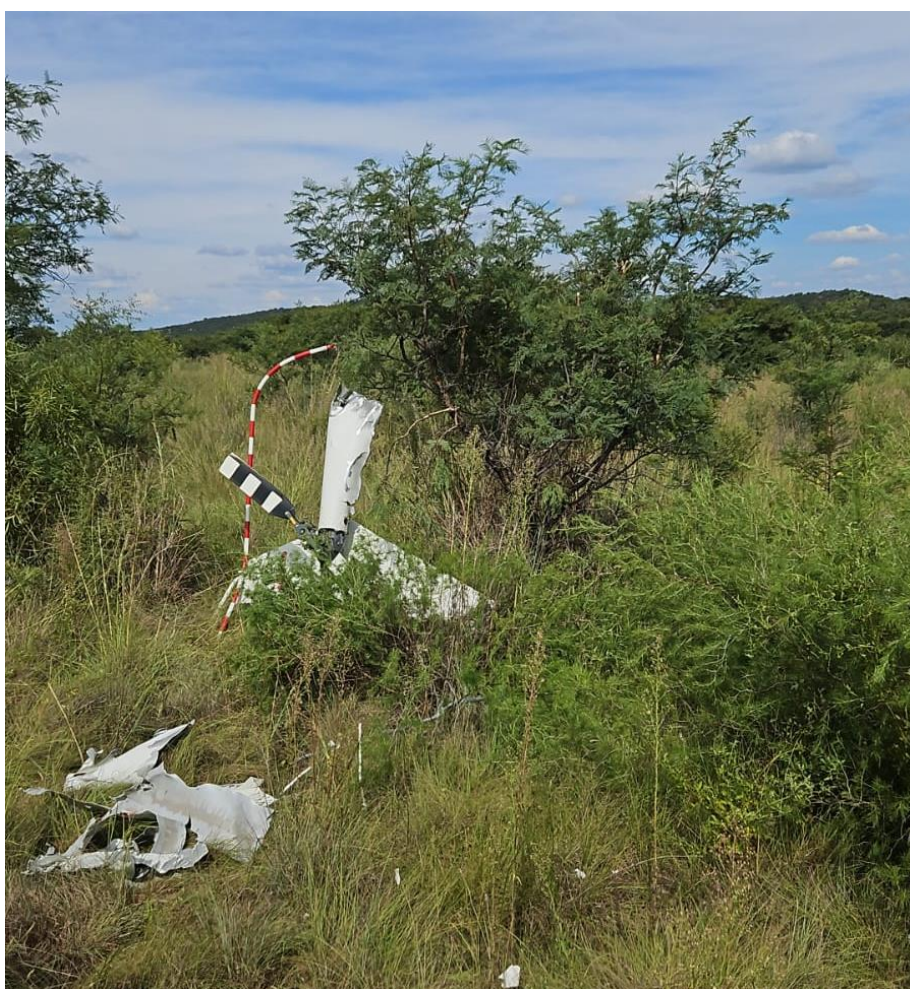
Figure 2: The severed tail of the helicopter. (Source: Pilot)

Findings
<ol style="list-style-type: none"> 1. The pilot was initially issued a Commercial Pilot Licence (CPL) Helicopter on 17 December 2020. The licence was renewed on 17 December 2023 with an expiry date of 31 December 2024. 2. The pilot had a Class 1 aviation medical certificate that was issued on 24 November 2023 with an expiry date of 30 November 2024 with no restrictions. The pilot was medically fit to conduct the flight. 3. The last mandatory periodic inspection (MPI) conducted on the helicopter was on 26 January 2024 at 2 211.6 Hobbs hours. The helicopter was issued a Certificate of Release to Service (CRS) on 26 January 2024 with an expiry date of 25 January 2025 or at 2 309.84 Hobbs hours, whichever occurs first. The helicopter accrued 33.6 hours since the last MPI. 4. The helicopter had a valid Certificate of Airworthiness (C of A) which was initially issued on 31 January 2018. The C of A was last renewed on 1 February 2024 with an expiry date of 28 February 2025. The helicopter's Certificate of Registration (C of R) was issued to the owner on 22 November 2017. 5. The aircraft maintenance organisation (AMO) that was responsible for the maintenance of the helicopter had a valid certificate of approval that was issued on 31 October 2023 with an expiry date of 30 November 2024. 6. The operator had a valid Air Operating Certificate (AOC) and the helicopter was listed on the operation specifications (OpSpecs) that was issued on 31 January 2024 with an expiry date of 31 January 2025. 7. The pilot repositioned the helicopter when it was 50ft AGL at a speed of 30 kt, which is in the shaded area of the velocity height diagram. This resulted in loss of rotor speed. 8. According to the density altitude chart, the required power exceeded the power available; this resulted in a drop in the rotor RPM. The pilot elected to perform a forced landing (and did not recover the RPM by rolling the throttle, lowering the collective and applying aft cyclic as required in the POH). The main rotor blades reached a critical stall region which caused them to drop and sever the tail boom.

Probable Cause(s)
Loss of rotor RPM during manoeuvre, followed by the main rotor stall which caused them (main rotor) to sever the tail boom and, thus, the resultant hard landing.
Contributing Factor(s)
Failure to consider the effects of high-density altitude. Operating in the shaded area of the velocity height diagram range which is prohibited.
Safety Action(s)
None.
Safety Message and/or Safety Recommendation/s
Pilots who operate in areas of high altitude must always ensure that the effects of high-density altitudes are considered before commencing flight.

In the interest of safety, it is recommended that the manufacturer updates the safety notices and add game and culling operations to be read together with Safety Notices 10, 24 and 34 because flights during these types of operation had, in the past, resulted in serious injuries and damage to aircraft.

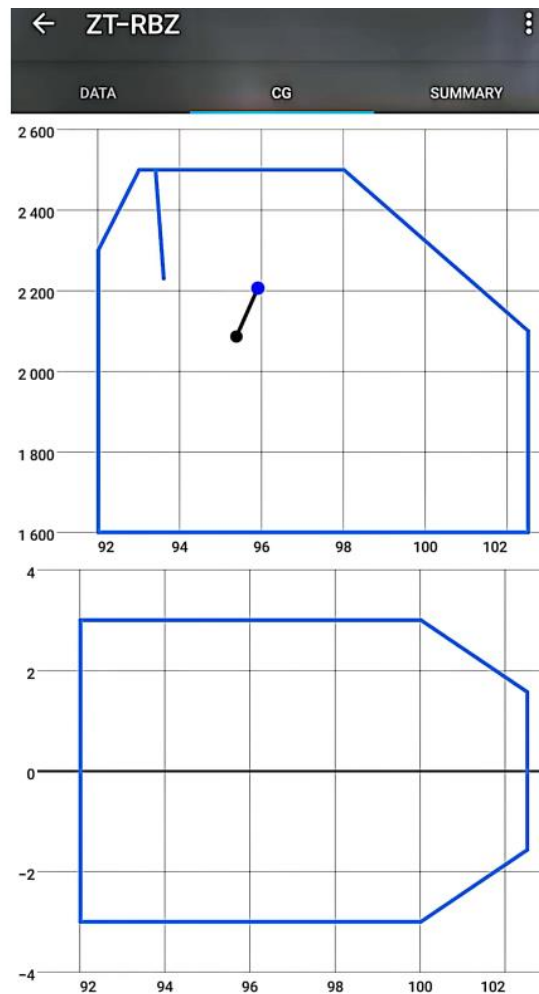
Chart 1: The Centre-of-gravity chart. (Source: Pilot)

According to the POH, the maximum allowable take-off weight is 2 400 lbs. The weight and balance provided by the pilot was 2 206.2 lbs, which was within limits.

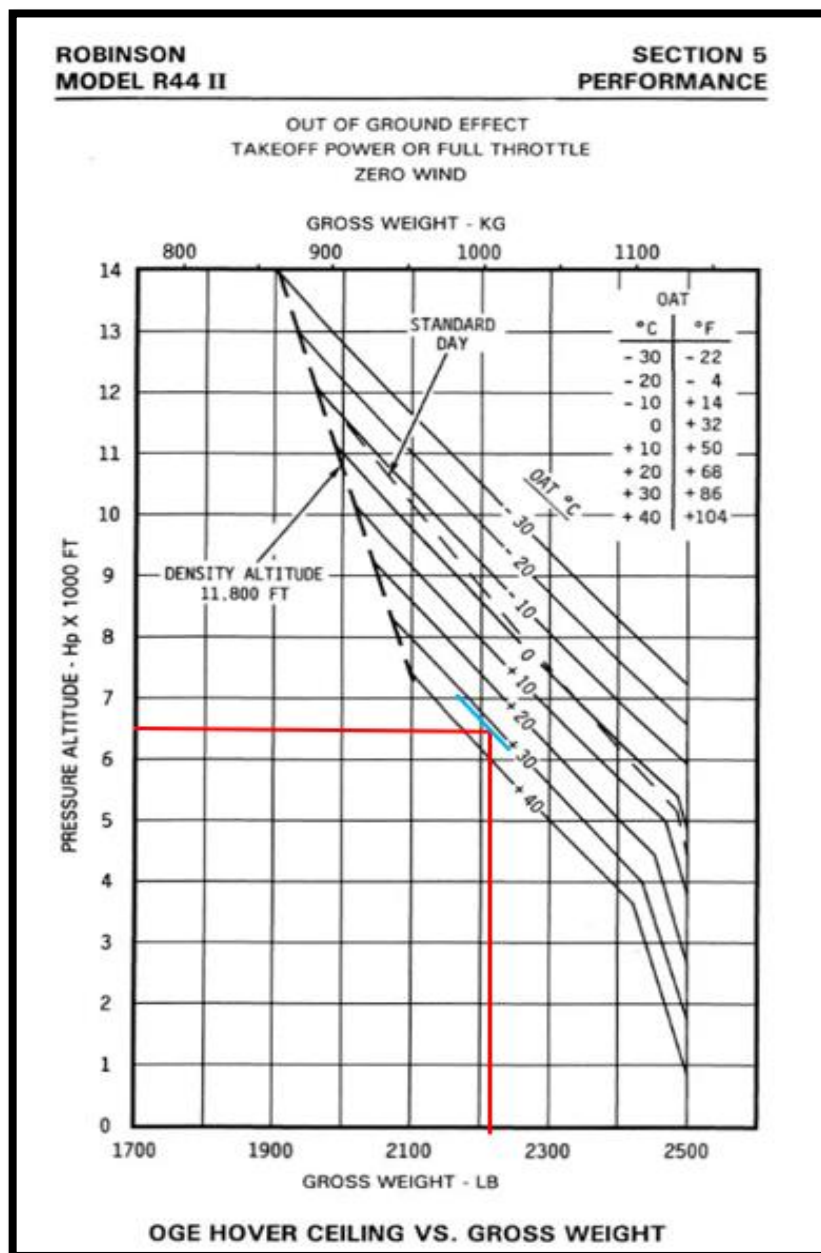
Chart 2: Out-of-ground effect (OGE) hover vs. gross weight. (Source: Pilot's Operating Handbook)

Considering the out-of-ground effect (Chart 2) vs. gross weight (Table 1), the pilot calculated the weight of the helicopter at 2 206.3 pounds (lbs) and the temperature at 32°C at the time of the flight. The helicopter could hover at a pressure altitude of approximately 6 500 ft.

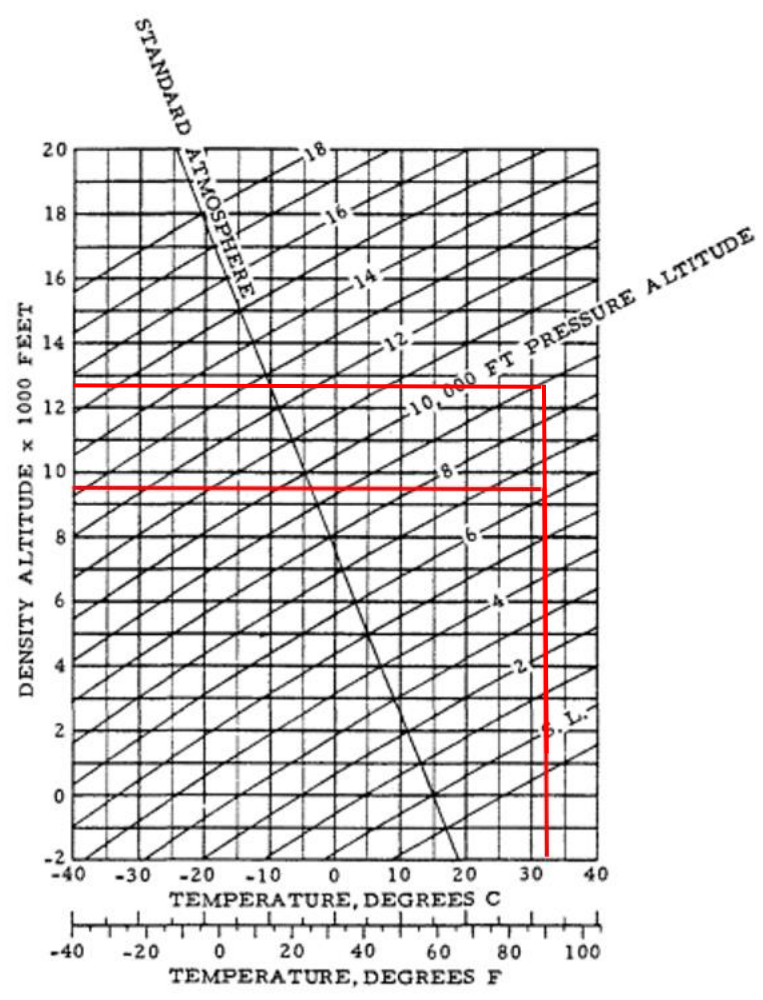
Chart 3: Density altitude chart. (Source: Pilot's Operating Handbook)

The above density altitude chart was used to determine the density altitude. When plotted against the pressure altitude of 6 500 lbs and the temperature of 32°C, the density altitude was determined to be approximately 9 600 ft.

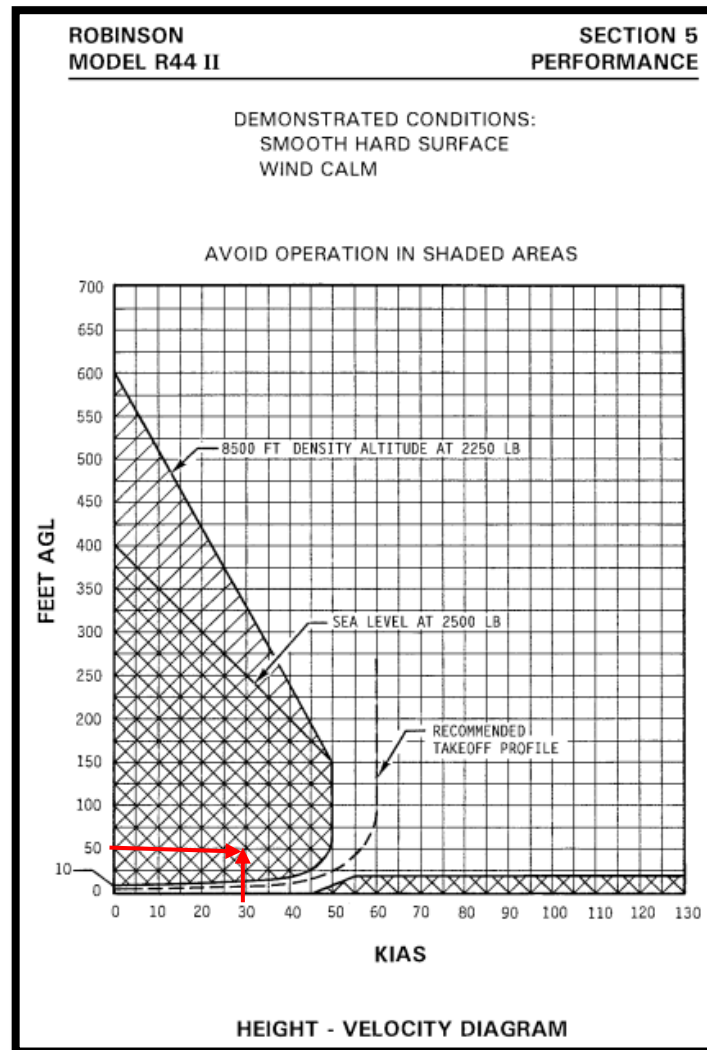
Chart 4: Velocity vs height. (Source: R44 Pilot’s Operating Handbook)

During take-off, pilots pay attention to avoid the shaded area (shown in Chart 4). Moreover, the rate of climb must be limited to a maximum 500 feet per minute (ft/min) below 100 ft above ground level (AGL) to limit loss of rotor speed in the event of power failure. The Pilot’s Operating Handbook (POH) states that the shaded area in Chart 4 should be avoided. The height velocity (Chart 4) calculations were in the shaded area when the helicopter was being repositioned at 50ft AGL at a speed of 30 kt.
