LIMITED OCCURRENCE INVESTIGATION REPORT – FINAL

Reference Number	CA18/2/3/10423						
Classification	Accident	Date	20 February 2024	Time	1420Z		
Type of Operation	Training Flight (Part 141)						
Location							
Place of Departure	Grand Central Airport (FAGC), Gauteng Province		Place of Intended Landing	Grand Central Airport (FAGC), Gauteng Province			
Place of Occurrence	Grand Central Airport (FAGC), Gauteng Province						
GPS Co-ordinates	Latitude	25°42'16"S	Longitude	27°49'33"E	Elevation	4 065 feet	
Aircraft Information							
Registration	ZS-LPM						
Make; Model; S/N	Piper; PA 34-220T (Serial Number: 34-8133133)						
Damage to Aircraft	Substantial		Total Aircraft Hours	5 430.1			
Pilot-in-command							
Licence Type	Airline Transport Pilot Licence (ATPL), Aeroplane		Gender	Male	Age	32	
Licence Valid	Yes	Total Hours	4 938.9		Total Hours on Type	37.3	
Total Hours 30 Days	24.5		Total Flying on Type Past 90 Days		3.1		
People On-board	2 + 0	Injuries	0	Fatalities	0	Other (on ground)	0

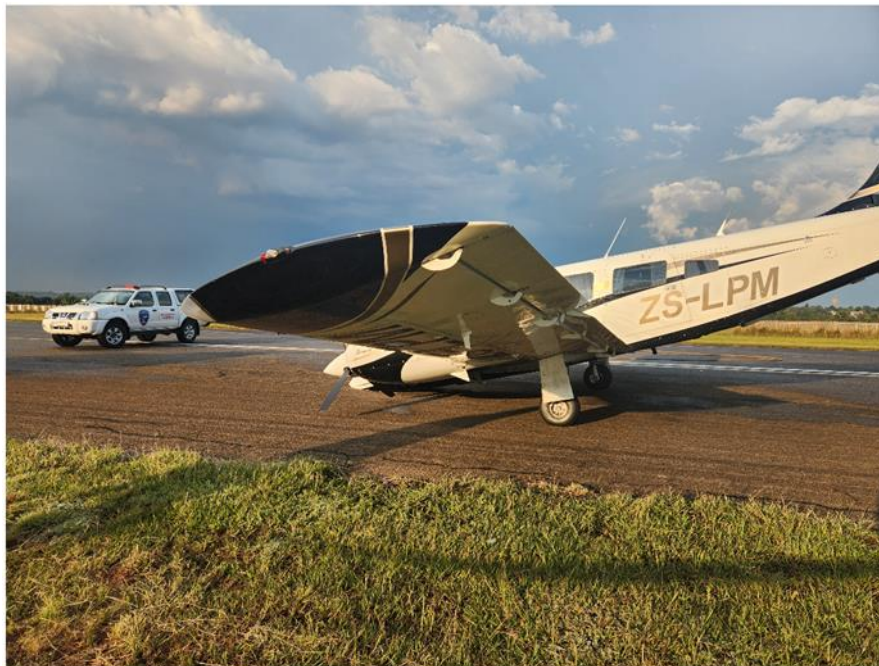
Firefighting (ARFF) personnel by phone. The crew requested the personnel to check the position of the nose gear, which they confirmed was retracted. The crew continued to conduct basic troubleshooting during which several attempts to lower the nose gear were made. They then decided to follow the emergency gear extension procedures as outlined in the Pilot's Operating Handbook (POH), but still with no success. The crew remained in the air for approximately 15 minutes to lower the nose gear by rocking the aircraft from side-to-side, and they were still unsuccessful. The crew then opted to land the aircraft with only the main landing gears extended. During the landing roll on Runway 35, the crew reduced the speed and switched off the engines before they lowered the nose (section). The aircraft skidded on its nose cone for approximately 239 metres before it stopped. The aircraft was substantially damaged, and none of the occupants was injured.

Figure 1: The aircraft's final position on the runway.

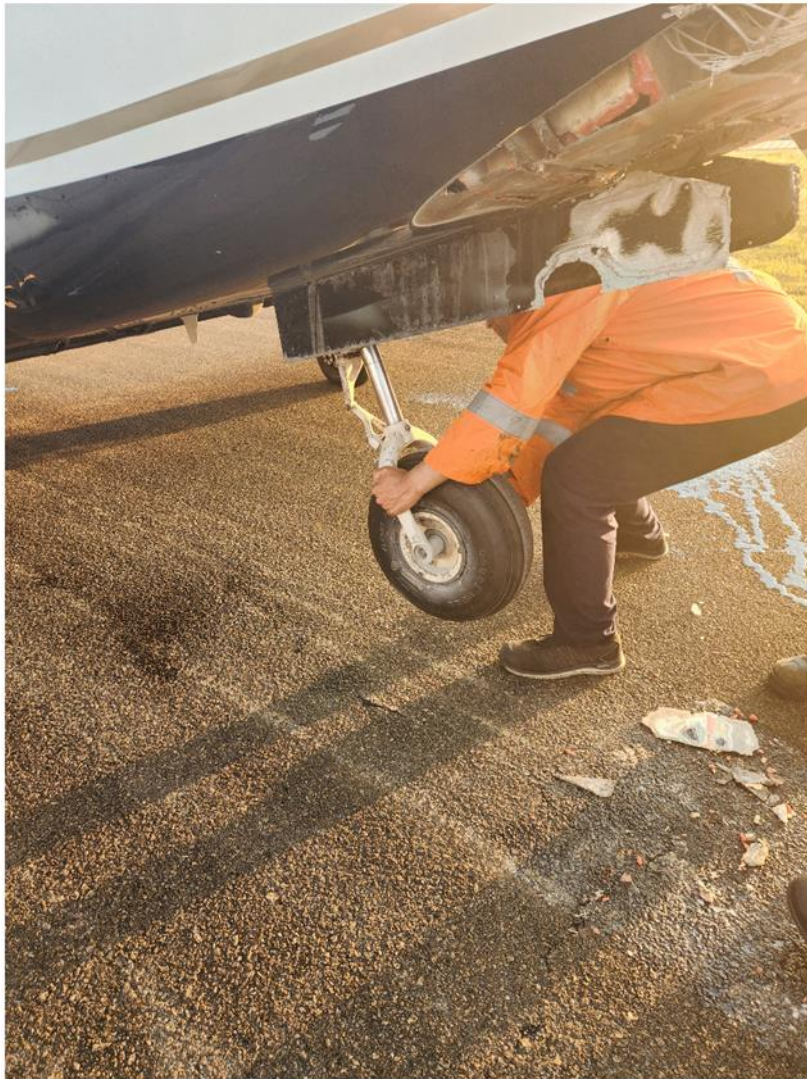
Figure 2: The nose landing gear during post-accident manual extension.

During the post-accident inspection, the aircraft's tail was pulled down towards the ground to lift the nose section off the ground. The aircraft maintenance engineer (AME) manually opened the nose gear doors and the nose landing gear extended and locked into position. The nose gear doors were damaged due to skidding on the runway. It could not be determined what could have caused them not to release (open).

It is possible that the nose gear doors failed to open because of the bolt head jam on the aft tube assembly-nose gear door actuation. This failure is due to a hex-head bolt on the nose gear centering spring rod-end to the nose gear strut that could have contacted the nose gear door actuation aft tube assembly.

The electrical wires that were damaged during landing were repaired, the landing gear was retracted and extended to test it, and it was serviceable. The emergency extension system was also tested and found serviceable. The tests were conducted without the nose gear doors fitted as the hinges were damaged during the landing roll.
