AIRCRAFT ACCIDENT REPORT AND EXECUTIVE SUMMARY

Reference:		CA18/2/3/10424	
Aircraft Registration	ZS-FJU	Date of Accident	21 February 2024		Time of Accident	1450Z	
Type of Aircraft	Cessna 172K		Type of Operation		Training (Part 141)		
Pilot-in-command Licence Type	Commercial Pilot Licence (CPL) A		Age	31	Licence Valid	Yes	
Pilot-in-command Flying Experience	Total Flying Hours		366		Hours on Type	266	
Last Point of Departure	Rand Airport (FAGM), Gauteng Province						
Next Point of Intended Landing	Baragwanath Aerodrome (FASY), Gauteng Province						
Damage to Aircraft	Destroyed						
Location of the accident site with reference to easily defined geographical points (GPS readings if possible)							
Approximately 211 metres (m) to the left of Runway 13 threshold at GPS co-ordinates 26°20'41.61"S 27°46'25.59"E elevation 5 124 feet (ft)							
Meteorological Information	Surface Wind 290° at 09kts; Visibility 9999m; Cloud Cover Nil; Temperature 29°C Dew Point 13°C; QNH 1019

Probable Cause							
The flight instructor and the student pilot lost control of the aircraft after a wingover manoeuvre during circuit training.							
Contributory Factor							
Disregard of HASELL checklist.

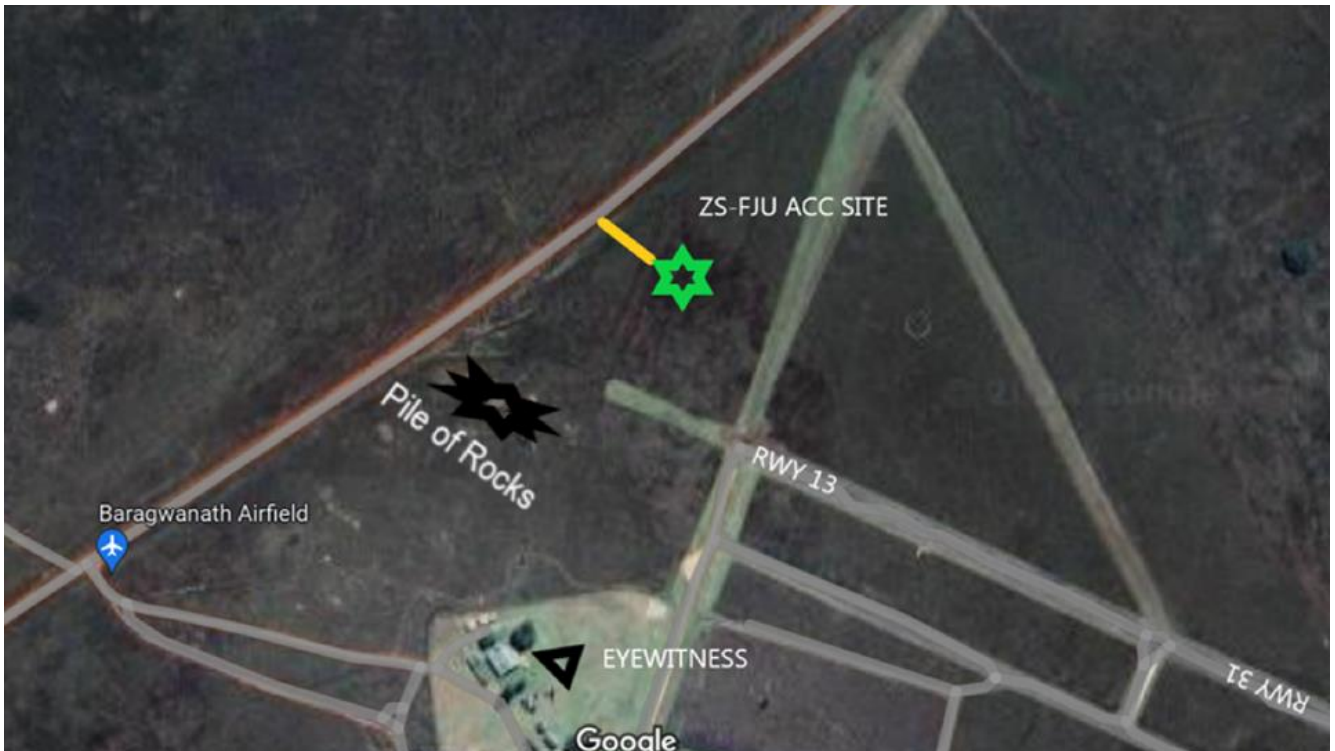
Figure 1: Aerial view of the accident site. The yellow line depicts the skid marks from the point of impact, about 15m from the edge of the gravel road.

1.12.1. The aircraft impacted the edge of a gravel road that ran from east to west before it came to rest facing north. The FI was ejected out of the aircraft and the SP remained trapped in the aircraft. Jaws of life were used to free the SP.

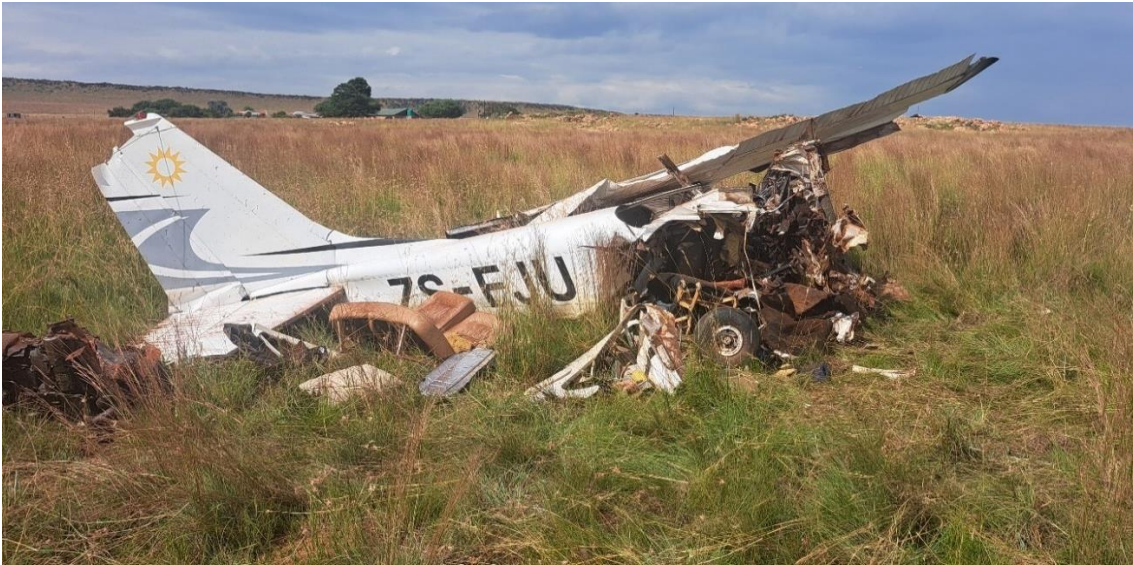
1.3.1. The aircraft was destroyed.

Figure 2: The aircraft at the accident site.

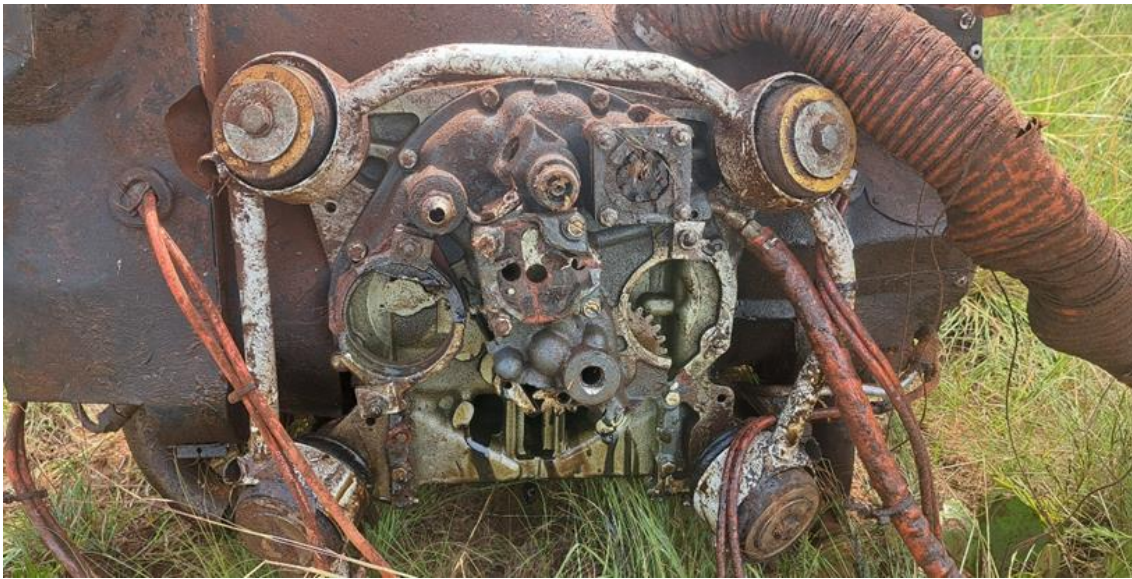
Figure 3: The engine separated from the airframe; the engine mount is still attached.

- 2.2.10 The damage sustained by the aircraft indicate that the impact forces were too great for their survival. The engine separated from the airframe and the propeller hub also separated from the engine. Examination of the propeller indicated that the engine was producing a substantial amount of power on impact. The amount of power produced could not be determined.

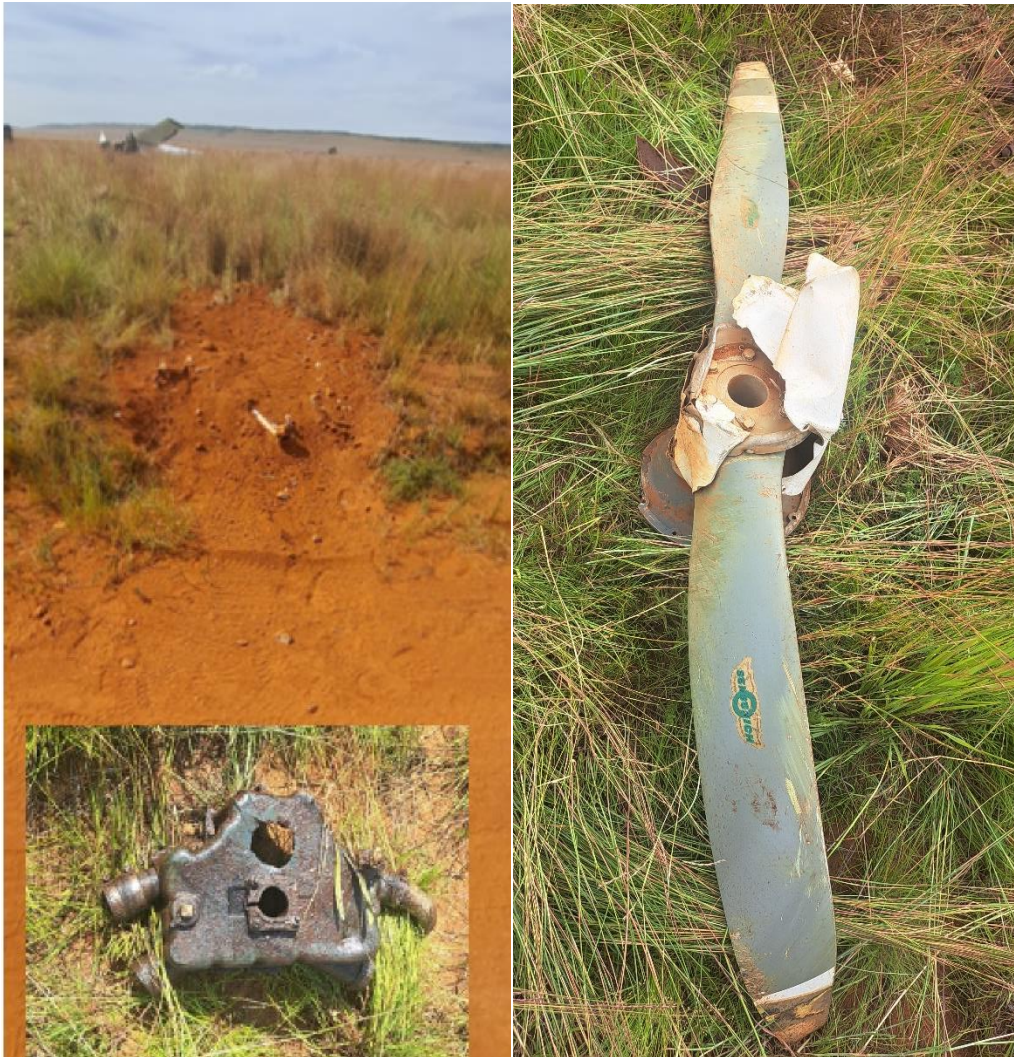
1.12.2. The witness marks on the ground revealed that the nose wheel was the first to impact the ground, and the nose gear strut broke off. The main landing gears sustained serious damage. The propeller broke off from the flange. The engine cowlings (top and bottom) and the engine as well as one of the doors separated from the airframe; they were found a few metres from the main wreckage. The oil sump or reservoir separated from the bottom of the engine and all the oil spilled out from the first point of impact; the oil covered the main wreckage. Examination of the propeller indicated that the engine was producing a substantial amount of power at the time of the accident.

Figure 4: First point of impact (inset: oil reservoir). **Figure 5:** The twisted propeller indicates a substantial amount of power at impact.

1.16.2. The propeller was found to have separated from the hub. The engine also separated from its mountings. Examination of the propeller indicated that the engine was producing a substantial amount of power on impact (Figure 5). The amount of power produced could not be determined.

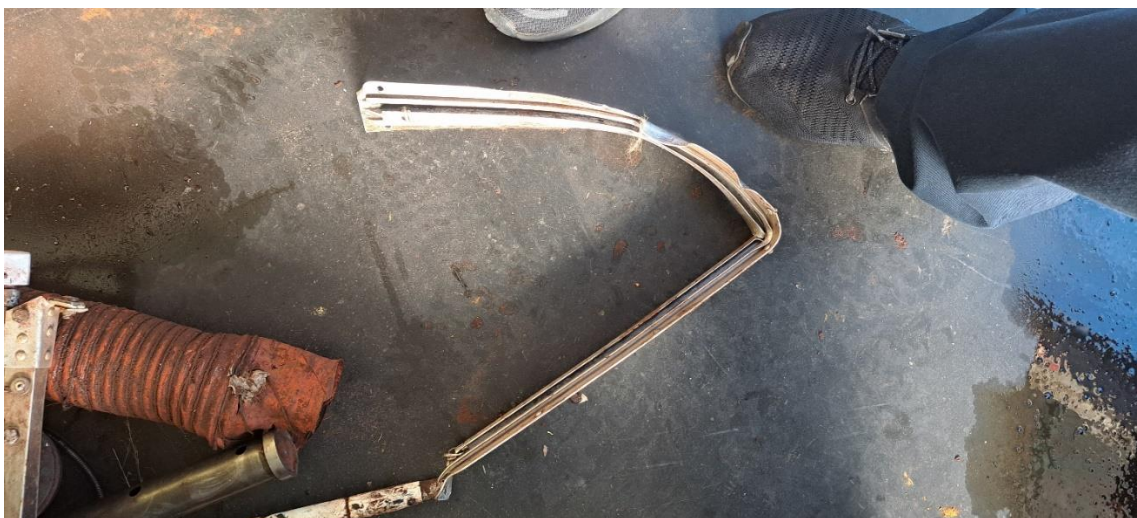
Figure 6: One of the railings that had detached from the airframe with forward bent signature beyond 90°.

- 2.2.11 The cockpit area and instrument panel were destroyed; many instrument parts were found broken in the airframe. Two of the seat railings were bent more than 90° towards the front; this meant that during impact, the airframe folded onto itself, thus, destroying the cabin area.

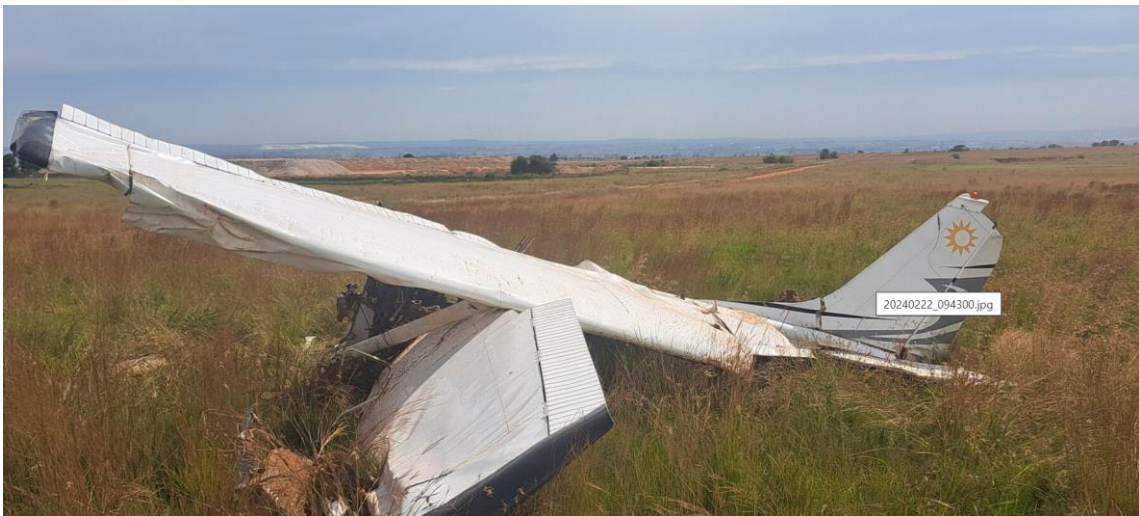
1.12.3. The right-side wing was severed from the mainframe and fuel spillage of unspecified amount was observed. The main cabin was destroyed with most of the instruments. The

left- and right-side wings exhibited compression loads and buckling on the leading edges. Flight control continuity could not be established due to impact-related damage.

Figure 7: The damage to the top and left side of the right wing.
