**LIMITED OCCURRENCE INVESTIGATION REPORT – FINAL**

<b>Reference Number</b>	CA18/2/3/10425						
<b>Classification</b>	Accident	<b>Date</b>	23 February 2024	<b>Time</b>	0825Z		
<b>Type of Operation</b>	Private (Part 91)						
<b>Location</b>							
Place of Departure	Garonga Airfield (in Makalali Game Reserve), Limpopo Province		Place of Intended Landing	Zandspruit Bush & Aero Estate, Limpopo Province			
Place of Occurrence	Runway 35 at Zandspruit Bush & Aero Estate						
GPS Co-ordinates	Latitude	24°22'23" S	Longitude	030°55'39" E	Elevation	1700 feet (ft)	
<b>Aircraft Information</b>							
Registration	F-PAFR						
Make; Model; S/N	Murphy Rebel Elite (Serial Number: 746)						
Damage to Aircraft	Substantial		Total Aircraft Hours	765			
<b>Pilot-in-command</b>							
Licence Type	Airline Transport Pilot Licence (ATPL)		Gender	Male		Age	73
Licence Valid	Yes	Total Hours	17 494		Total Hours on Type	765	
Total Hours past 30 Days	0.3		Total Flying Hours on Type Past 90 Days	20

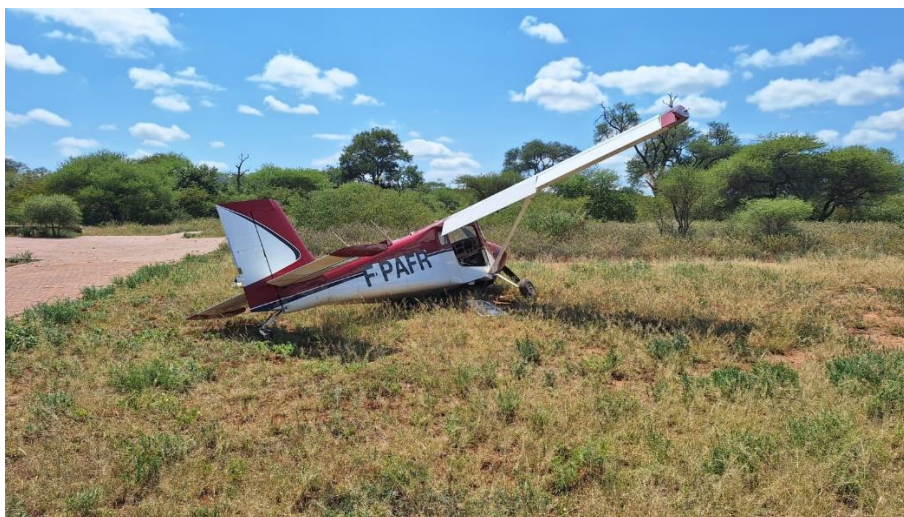
runway and he was unable to steer the aircraft back to the runway centreline. The aircraft ground looped and came to rest with the left wing touching the ground.

**Figure 2:** The aircraft as it came to rest. (Source: Pilot)

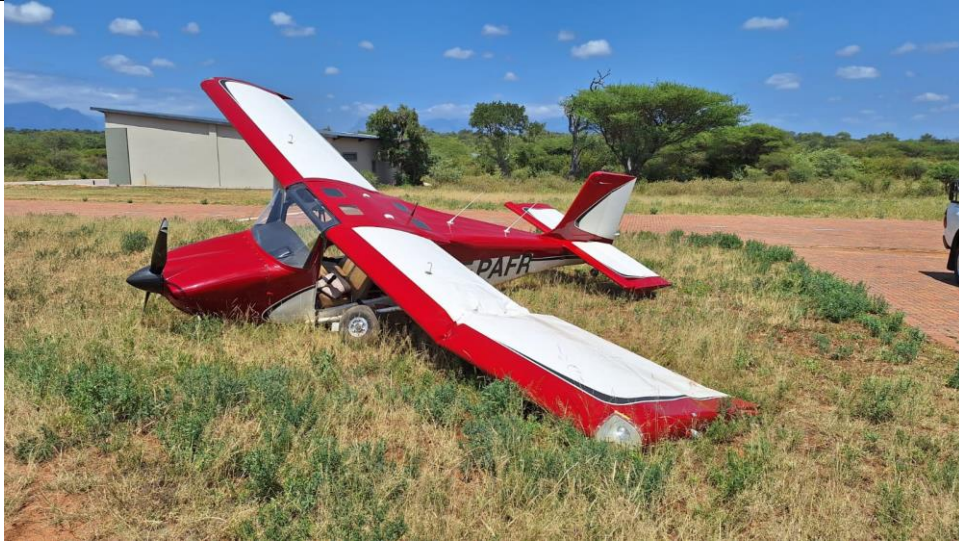
Both the pilot and the passenger disembarked from the aircraft; they were uninjured. The aircraft sustained substantial damage to the left wing, propeller and left landing gear.

**Figure 3:** The damaged wing, propeller and landing gear. (Source: Pilot)

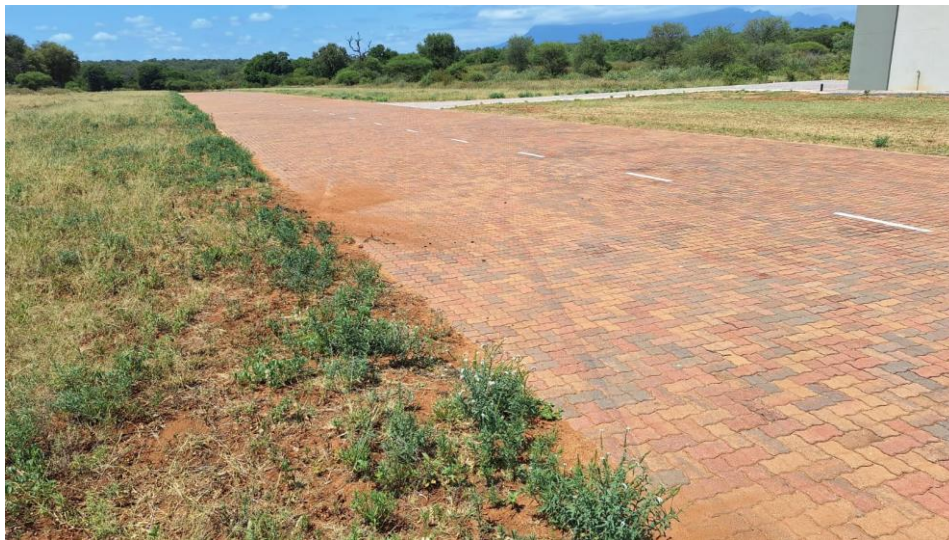
**Figure 4:** Tyre marks as the aircraft veered off to the left of the runway. (Source: Pilot)

7. The weather was not a factor to this accident.
8. There were tyre marks of the aircraft's landing gear as it veered off to the right of the runway.
9. The aircraft was written off by an insurance company after the accident, therefore, there was no technical report as the aircraft was not inspected.
10. The aircraft was likely unstable on approach; upon landing, the pilot lost directional control and the aircraft veered off to the right of the runway and ground looped.

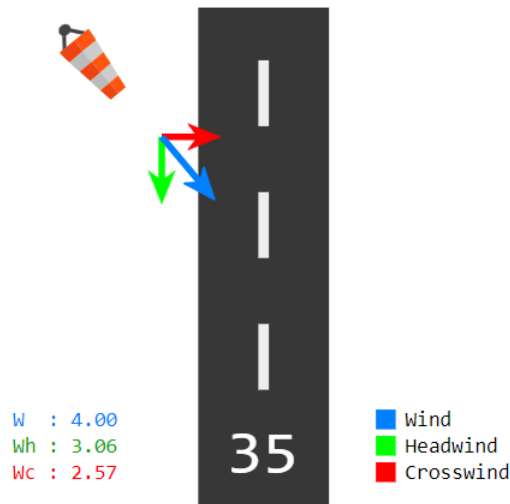
Wind Direction	310°	Wind Speed	4 knots	Visibility	9999
Temperature	29°C	Cloud Cover	FEW	Cloud Base	2500
Dew Point	20°C	QNH	1017

**Figure 5:** The wind component at the time of the accident.  
(Source: <https://e6bx.com/wind-components/>)
