**AIRCRAFT ACCIDENT REPORT AND EXECUTIVE SUMMARY**

<b>Reference:</b>		CA18/2/3/10426	
<b>Aircraft Registration</b>	ZU-IBN	<b>Date of Accident</b>	24 February 2024		<b>Time of Accident</b>	0714Z	
<b>Type of Aircraft</b>	L39C Albatros		<b>Type of Operation</b>		Type (Part 94)		
<b>Pilot-in-command Licence Type</b>	Private Pilot Licence		<b>Age</b>	64	<b>Licence Valid</b>	Yes	
<b>Pilot-in-command Flying Experience</b>	<b>Total Flying Hours</b>		776.70		<b>Hours on Type</b>	71.6	
<b>Last Point of Departure</b>	Middleburg Airfield (FAMD), Mpumalanga Province						
<b>Next Point of Intended Landing</b>	Middleburg Airfield (FAMD), Mpumalanga Province						
<b>Damage to Aircraft</b>	Substantial						
<b>Location of the accident site with reference to easily defined geographical points (GPS readings if possible)</b>							
FAMB field at Global Positioning System (GPS) co-ordinates determined to be (S °40' 58", E 029° 26' 13.9"), at a field elevation of 4886 feet (ft)

**Reference Number** : CA18/2/3/10426  
**Occurrence Category** : Category 3  
**Type of Operation** : Private (Part) 94  
**Name of Operator** : Lovett R N  
**Aircraft Registration** : ZU-IBN  
**Aircraft Make and Model** :

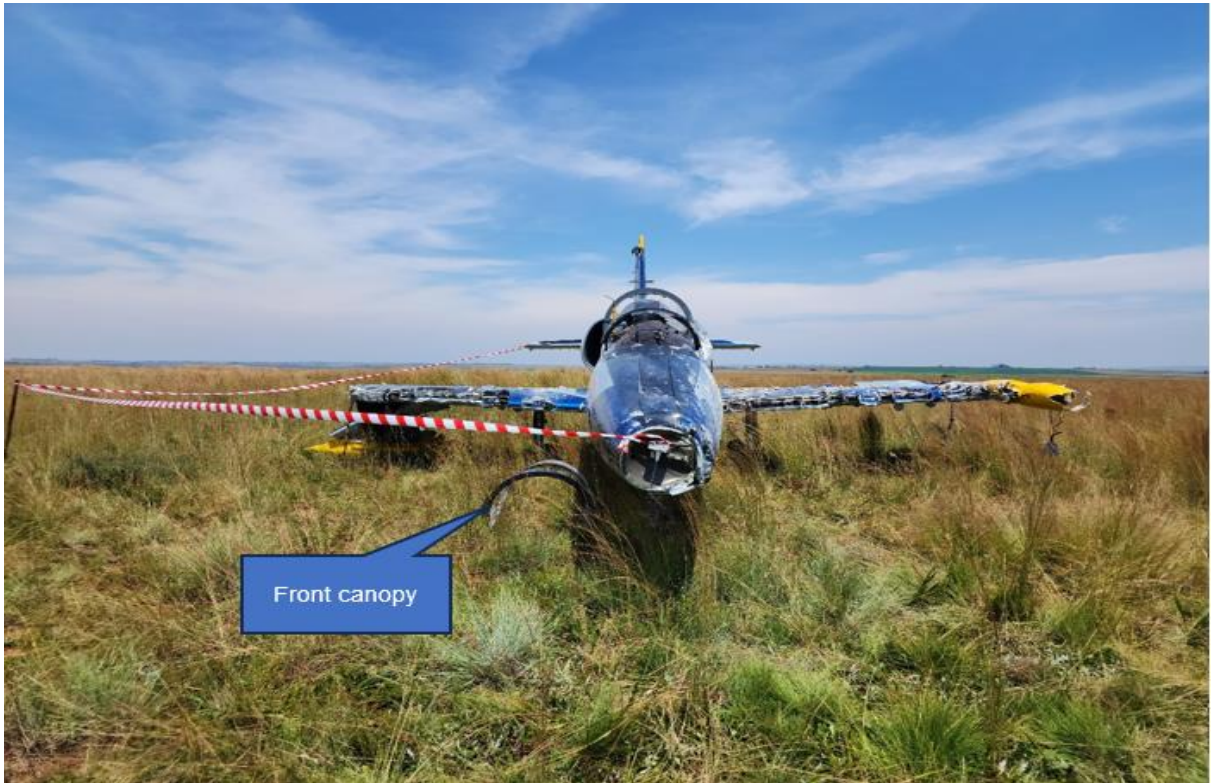
1.3.1. The aircraft sustained substantially damage to the nose section, both canopies, both wings, the vertical stabiliser and the horizontal stabilisers during the accident sequence.

Figure 2: The aircraft after the accident. (Source: Operator)

1.12.3. The aircraft's nose section, front canopy windshield, both wings and elevators sustained damage due to impact with the concrete barrier fence (Figure 2). Debris from the concrete barrier fence was found in the engine compartment, cockpit and on the surface of the wings.

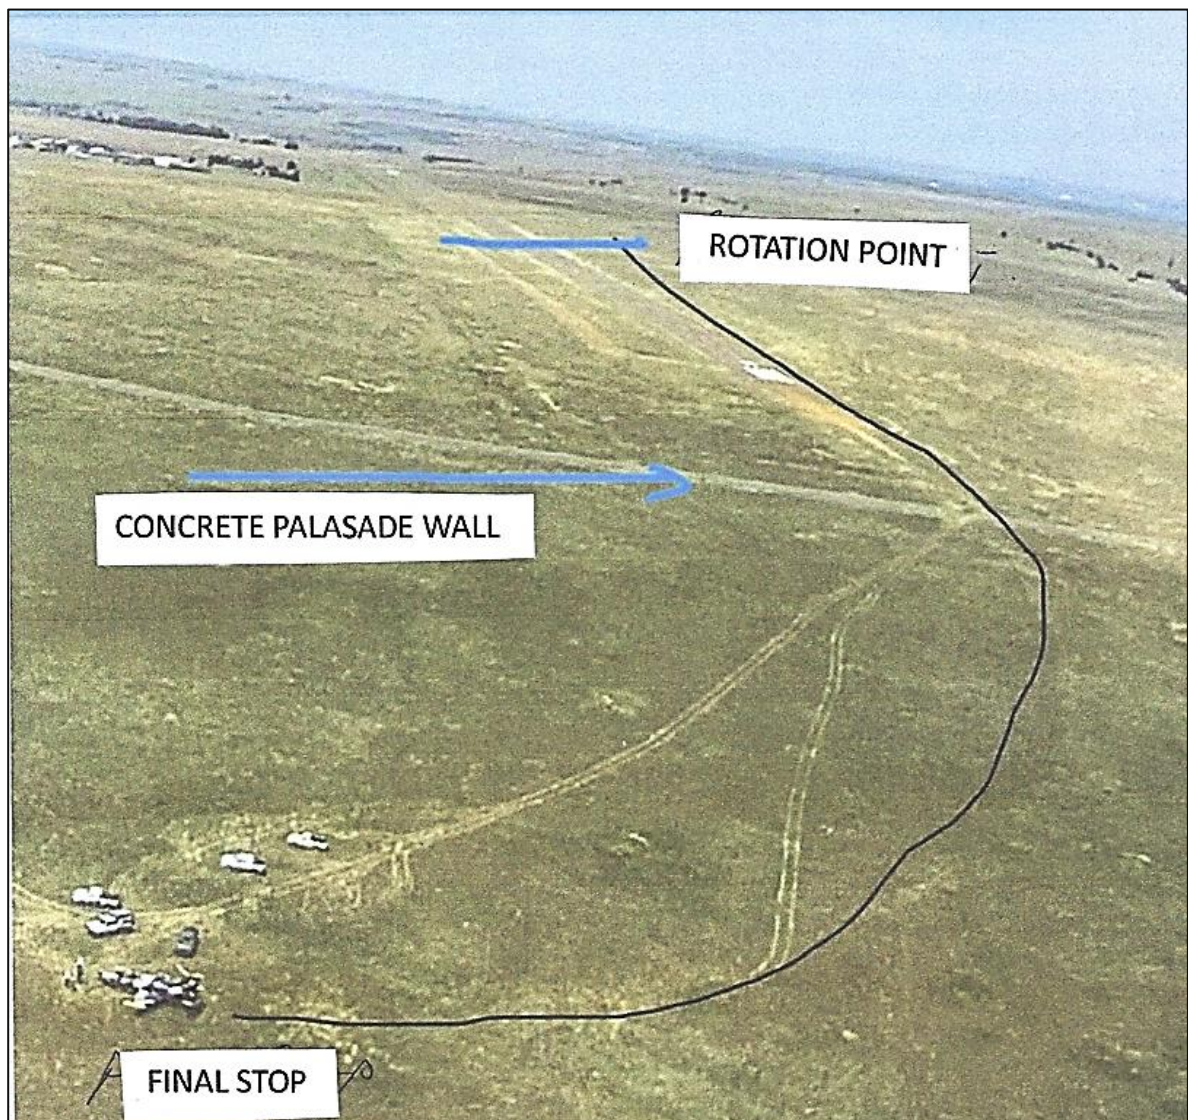
fence about 230m beyond the end of the runway and levelled it before it stopped approximately 80m outside of the airfield (see Figure 3). The area where the accident occurred had long grass.

**Figure 3:** The accident site. (Source: Operator)

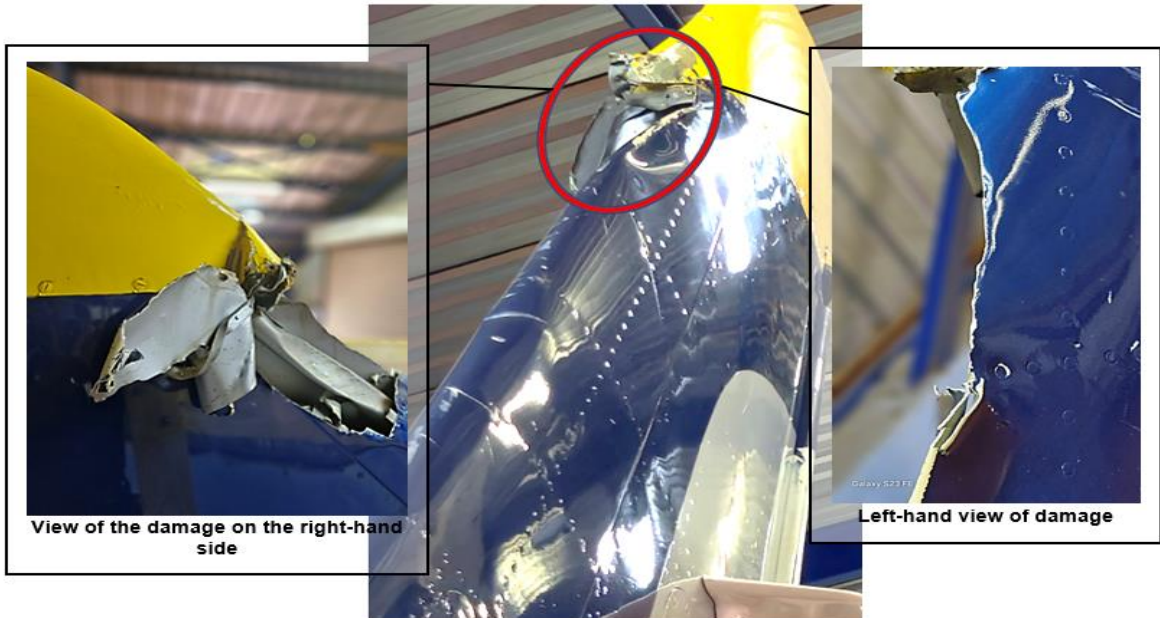
**Figure 4:** The damaged vertical stabiliser.

The investigation revealed that the rear canopy separated and impacted the vertical stabiliser and it disintegrated.

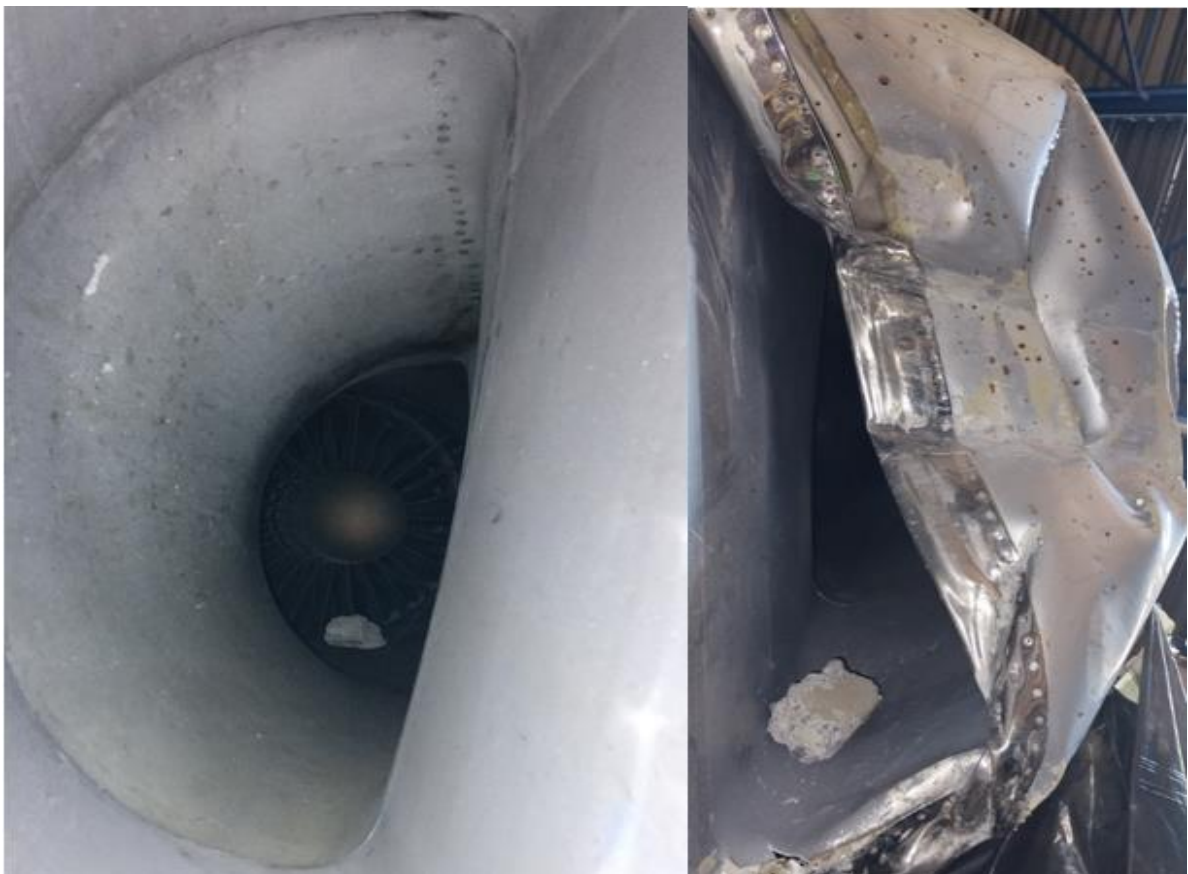
**Figure 5:** Left- and right-air intake with debris.

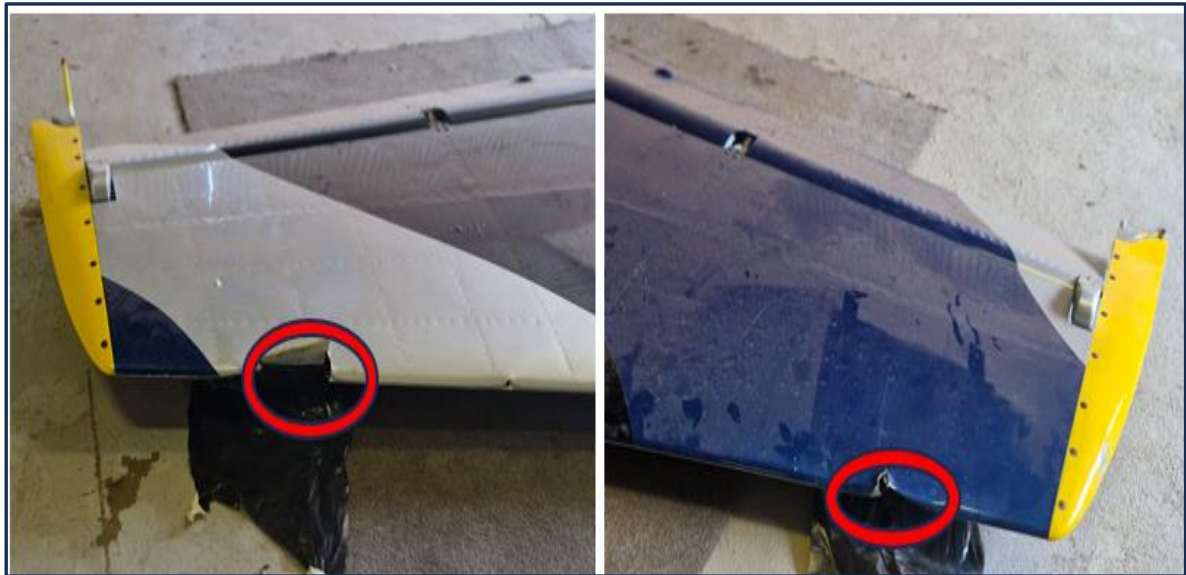
**Figure 6:** Damage to the horizontal stabiliser with evidence of concrete debris.

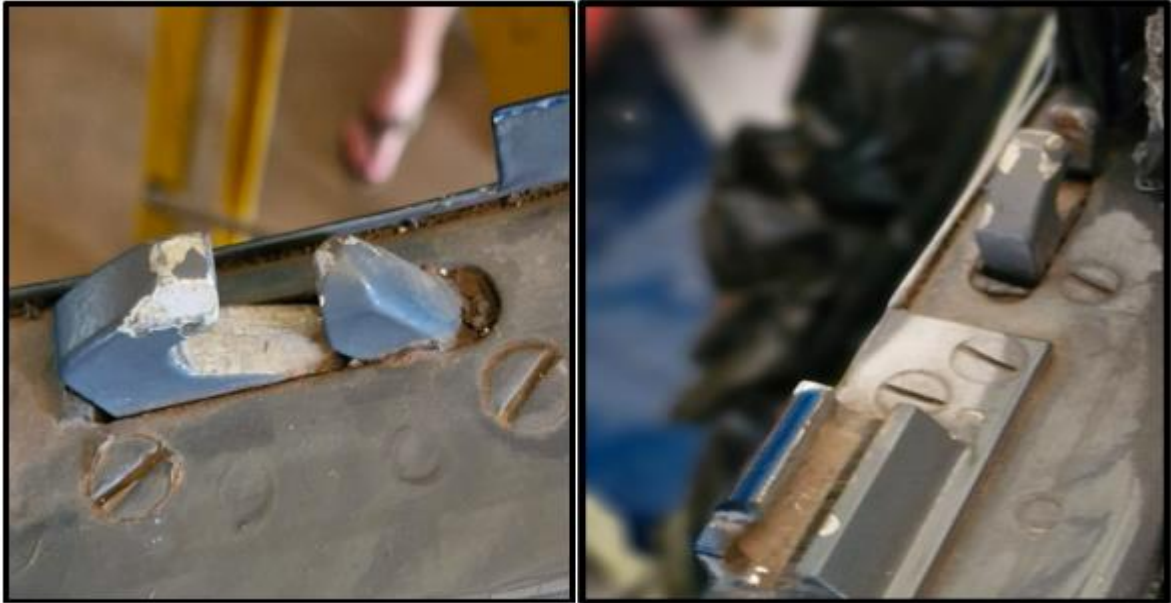
- 1.12.6. A post-accident, the canopy hinges and latch hooks on the hinge side (right side of the cockpit) were slightly damaged due to the opening and closing (operation) of the canopy over time. Three of the rear canopy latches were not damaged except for the left-side rear latch claw (see Figures 7 and 8); the claws had no signs of being forced open. The latches closed and locked properly; there was not enough space for the canopy pins to pull past the gap of the latch claws. The paint on the top of the latch claws was damaged when the latch system was checked. This is typically the point where the pins on the canopy side contact the top of the claws if the pins are not hooked in place and the canopy closing mechanism is already in the closed position. The canopy closing system, which is lever-operated, was inspected and no defects were found.

**Figure 7:** The chipped paint on the top side of both the right front latch claw and rear latch claw of the rear cockpit.

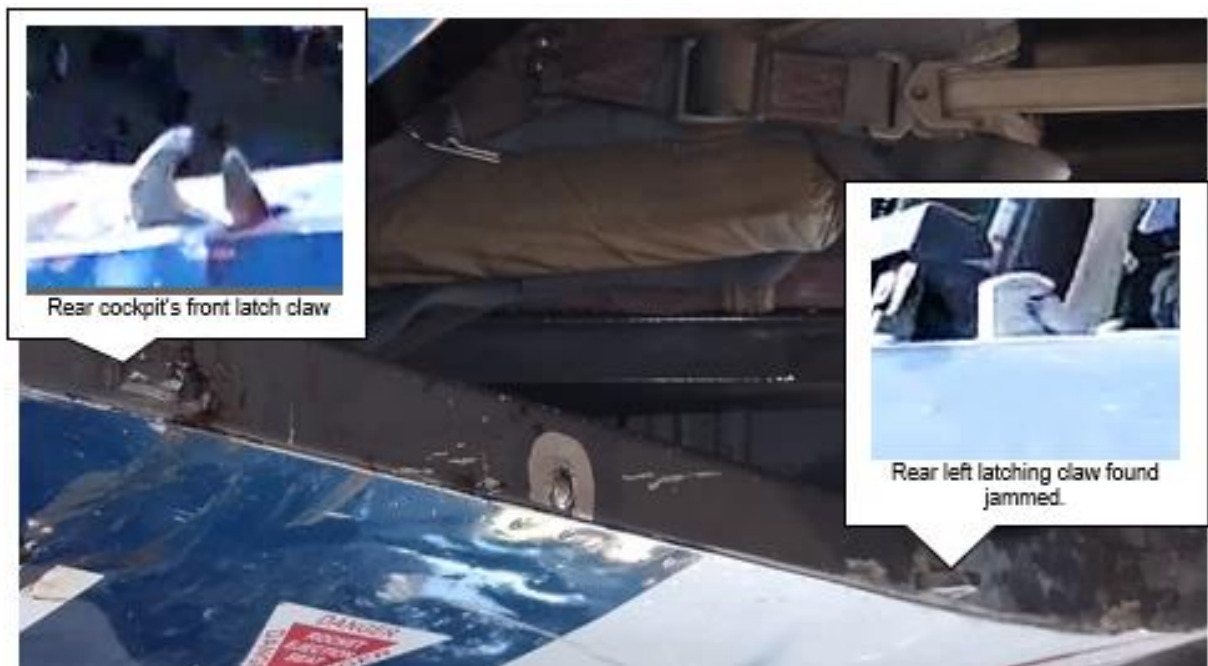
**Figure 8:** Rear cockpit left-side latch claws after the accident.

*The rear cockpit latches (right front and rear) and the left-side front latch claw were found in good condition, and they operated as expected. However, the rear left latch claw had jammed in closed position and had scratch marks near it.*

- 3.2.7. The separation of the canopy was due to a malfunctioning latch mechanism which had a broken push rod link on the left rear latch. This failure rendered the remaining latches insufficient to hold the canopy in place and, as a result, led to its detachment.
