LIMITED OCCURRENCE INVESTIGATION REPORT – FINAL

Reference Number	CA18/2/3/10427						
Classification	Accident	Date	21 February 2024		Time	1400Z	
Type of Operation	Private (Part 94)						
Location							
Place of Departure	Ingwelala Aerodrome, Mpumalanga Province		Place of Intended Landing	Rhino Park Aerodrome, Gauteng Province			
Place of Occurrence	The right side of Runway 01 at Ingwelala Aerodrome						
GPS Co-ordinates	Latitude	24°09'41.58" S	Longitude	031°23'42.73" E	Elevation	1 108 feet	
Aircraft Information							
Registration	ZU-DKL						
Make; Model; S/N	Urban Air S.R.O., Samba XL (Serial Number: SA XL-10)						
Damage to Aircraft	Substantial		Total Aircraft Hours	657.4			
Pilot-in-command							
Licence Type	National Pilot Licence		Gender	Male		Age	53
Licence Valid	Yes	Total Hours	61.3		Total Hours on Type	49.0	
Total Hours 90 Days	29.4		Total Flying on Type Past 90 Days	29.4			
People On-board	1 + 1	Injuries	0	Fatalities	0	Other (on ground)	0

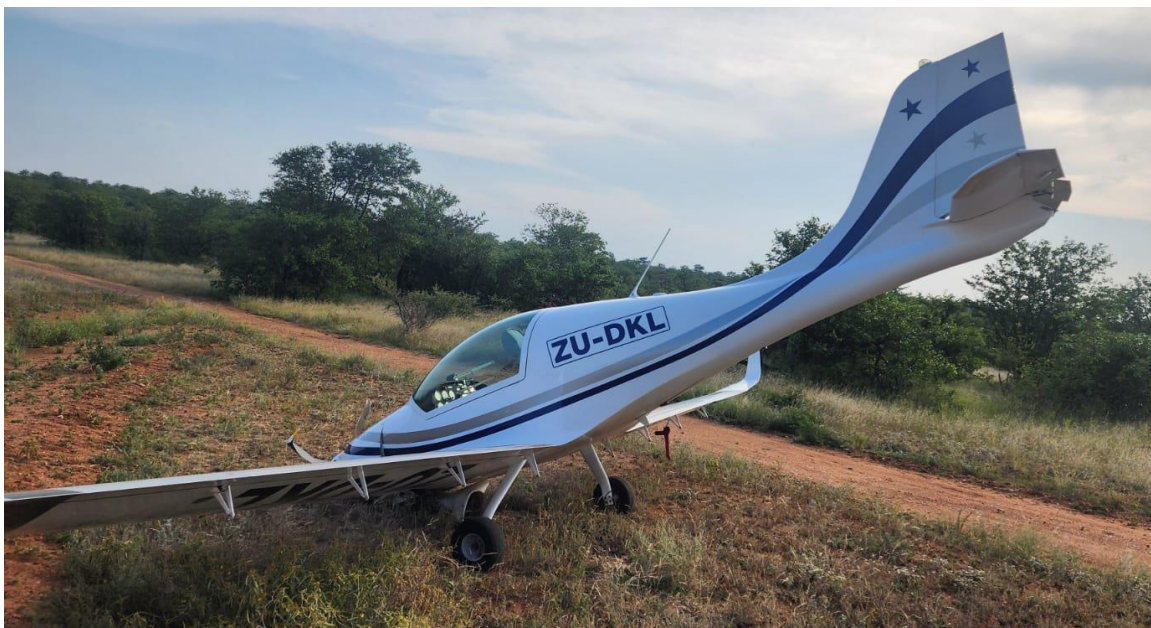
Figure 2: The aircraft as it came to rest next to the runway. (Source: Pilot)

The pilot lost directional control of the aircraft during landing as he was unable to centre the nose gear prior to the aircraft contacting the runway; the aircraft veered off to the right which led to the collapse of the nose landing gear.

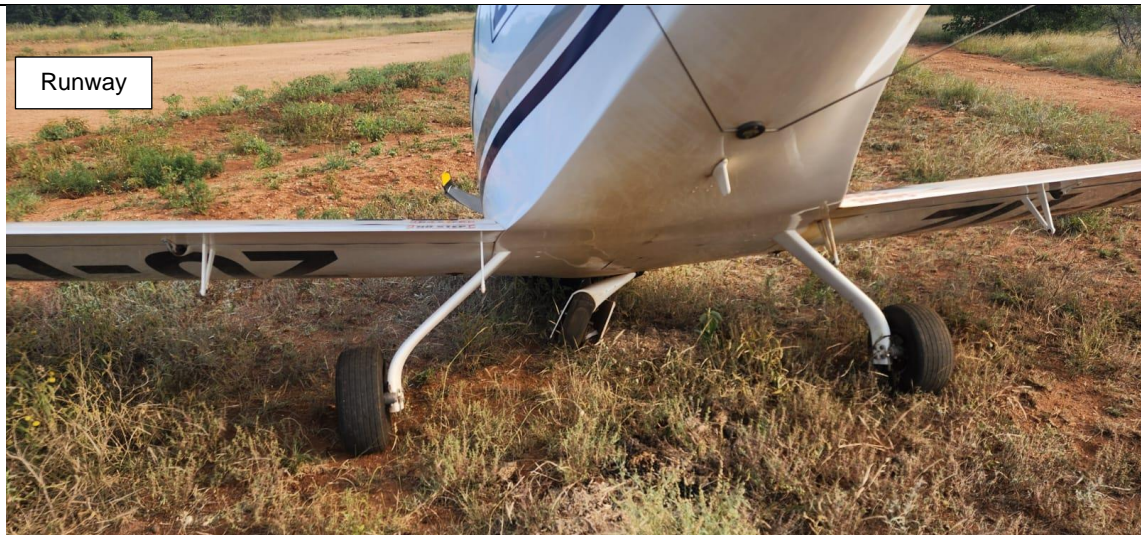
Figure 3: The aft view of the aircraft shows the collapsed nose gear. (Source: Pilot)

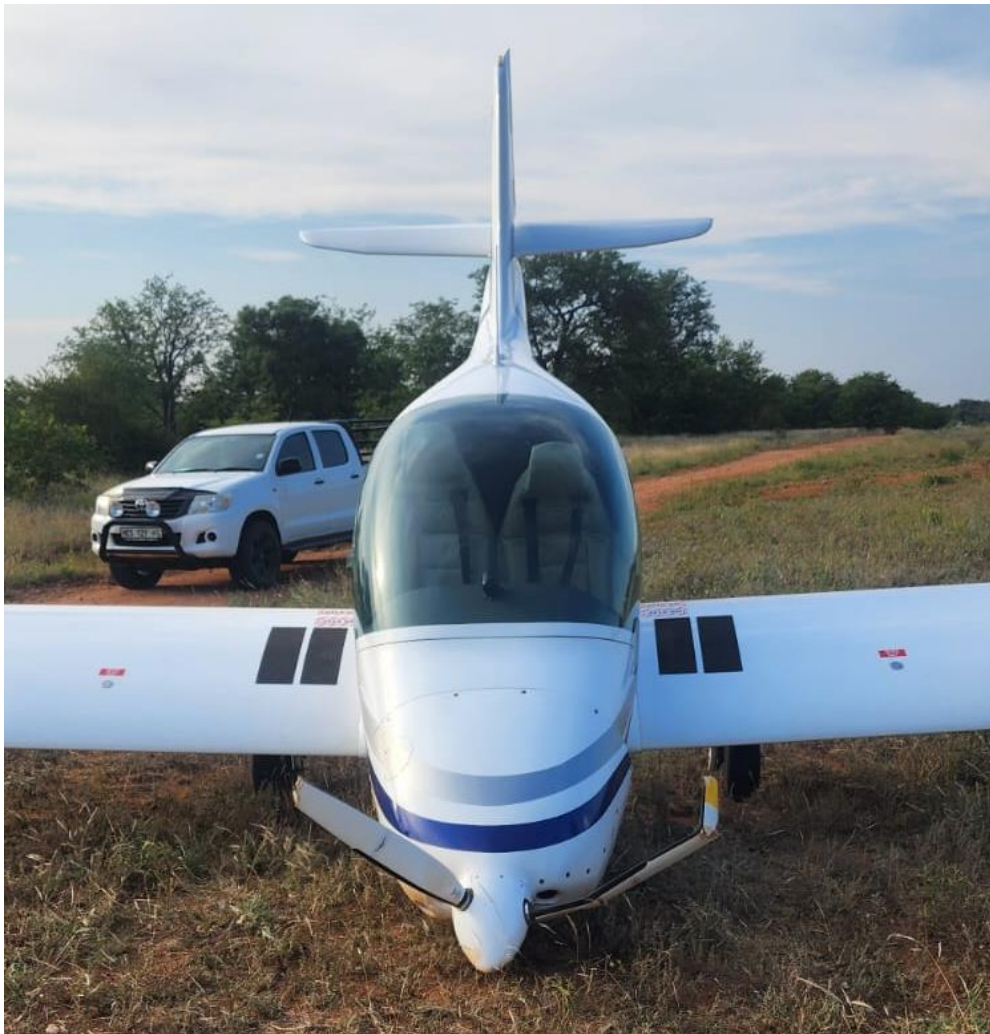
Figure 4: The front view of the aircraft shows the damaged propeller blades. (Source: Pilot)

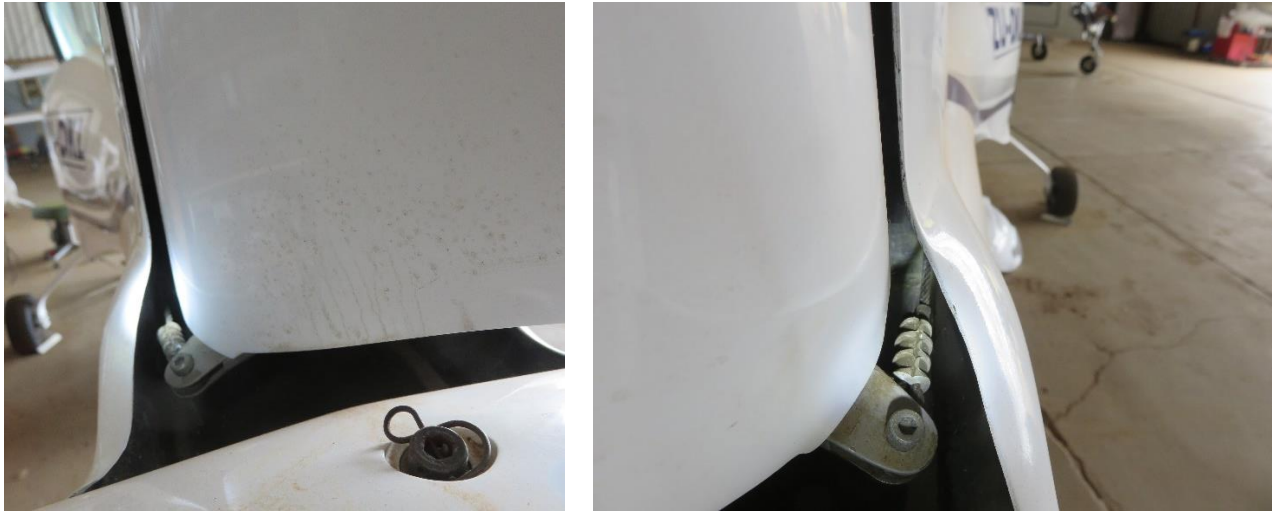
Figure 5(a) and 5(b): The left and right rudder cable connections (rudder side) were found intact.

- 2.5 No evidence could be found to support the pilot's statement that the rudder cable had failed during the final approach for Runway 01.
- 2.6 The aircraft was fitted with a Rotax 912-ULS engine with serial number 5643827.

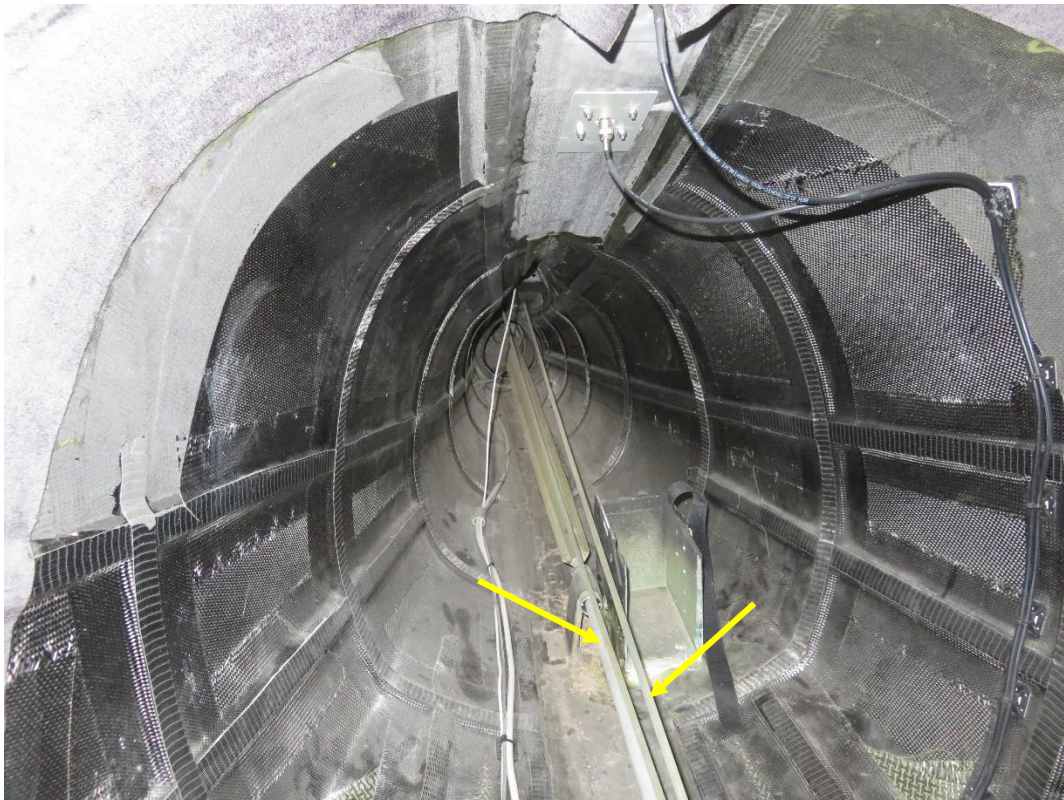
Figure 6: The left and right rudder cables in the boom area of the aircraft were in place and undamaged.

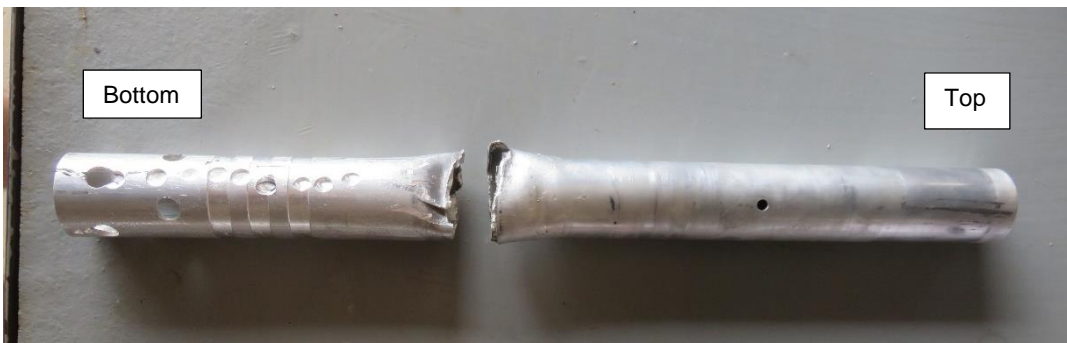
Figure 10: The failed nose gear strut.

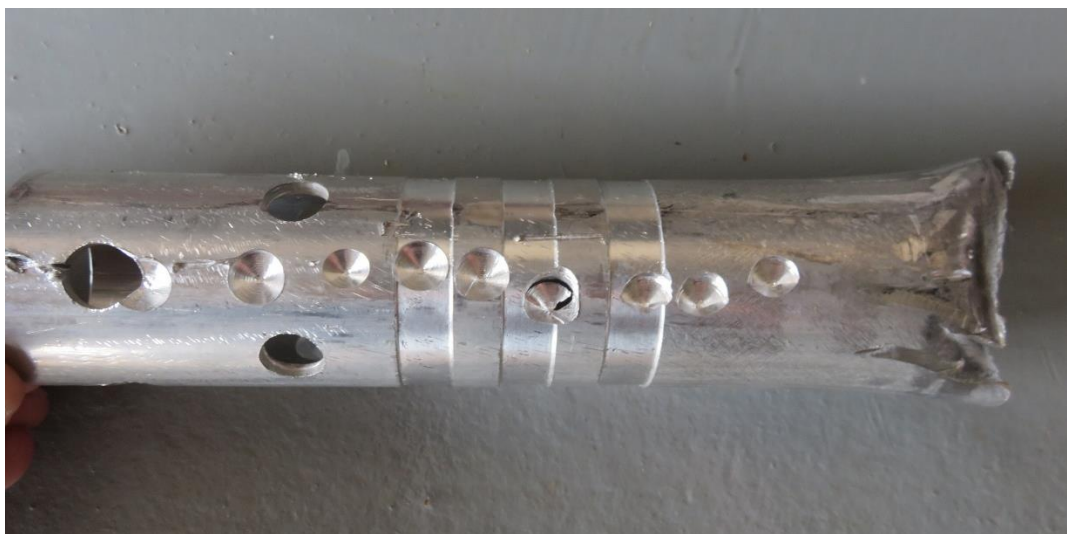
Investigation revealed that the aircraft was involved in an accident on 27 December 2009 in which the nose landing gear strut broke off. The nose gear strut assembly that was fitted to the aircraft at the time of the repairs displayed evidence of being sub-standard and/or of poor workmanship (see Figure 11).

Figure 11: The nose gear strut bottom section with drill holes.
