**LIMITED OCCURRENCE INVESTIGATION REPORT – FINAL**

<b>Reference Number</b>	CA18/2/3/10428						
<b>Classification</b>	Accident	<b>Date</b>	2 March 2024		<b>Time</b>	1335Z	
<b>Type of Operation</b>	Private (Part 94)						
<b>Location</b>							
<b>Place of Departure</b>	Klerksdorp Airfield (FAKD), North West Province		<b>Place of Intended Landing</b>		Bona-Bona Game Lodge Airfield, North West Province		
<b>Place of Occurrence</b>	Runway 17 at Bona-Bona Airfield						
<b>GPS Co-ordinates</b>	<b>Latitude</b>	27°01'06.03" S	<b>Longitude</b>	26°13'16.66" E	<b>Elevation</b>	4 605 ft	
<b>Aircraft Information</b>							
<b>Registration</b>	ZU-FNS						
<b>Make; Model; S/N</b>	Shadow Lite CC; Jabiru J430 (Serial Number: 791)						
<b>Damage to Aircraft</b>	Substantial			<b>Total Airframe Hours</b>	492.3		
<b>Pilot-in-command</b>							
<b>Licence Type</b>	Private Pilot Licence (PPL)		<b>Gender</b>	Male		<b>Age</b>	65
<b>Licence Valid</b>	Yes	<b>Total Hours</b>	199.24		<b>Total Hours on Type</b>	53.0

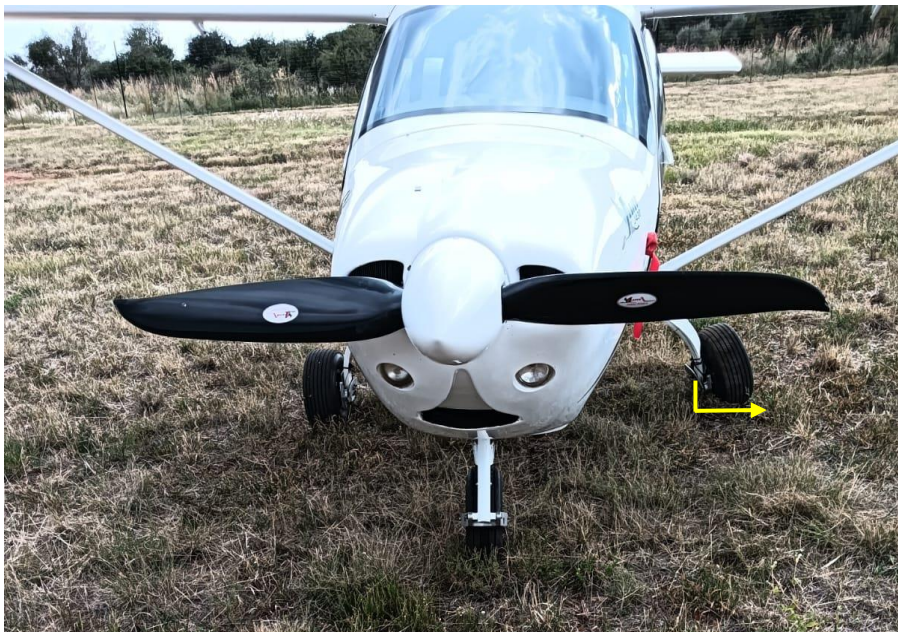
During that sequence, the left main wheel axle bent, and the propeller blade tips struck the ground. The aircraft came to a halt on the grass area, approximately 25m from the left edge of the runway. The aircraft sustained substantial damage; however, no injuries were reported.

**Figure 2:** The aircraft at the accident site with the damaged left main gear wheel axle. (Source: Pilot)

It is likely that the aircraft was unstable on final approach and landed hard, which caused the left main landing gear axle to bend. The pilot lost directional control of the aircraft and it veered off to the left of Runway 17.

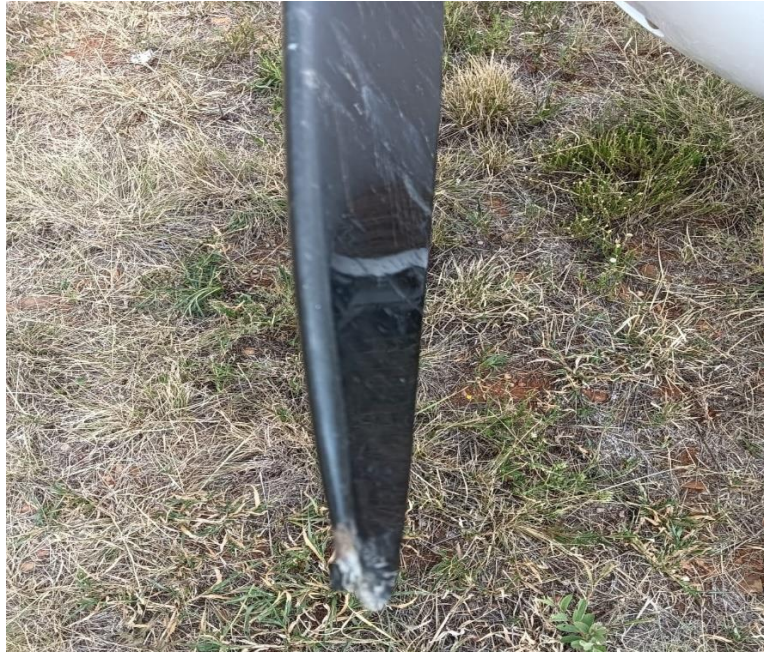
**Figure 3:** The damaged blade tip. (Source: Pilot)
