**LIMITED OCCURRENCE INVESTIGATION REPORT – FINAL**

<b>Reference Number</b>	CA18/2/3/10429						
<b>Classification</b>	Accident	<b>Date</b>	1 March 2024	<b>Time</b>	1215Z		
<b>Type of Operation</b>	Private (Part 91)						
<b>Location</b>							
<b>Place of Departure</b>	O.R. Tambo International Airport (FAOR), Gauteng Province		<b>Place of Intended Landing</b>	Kalahari Gold Mine Airstrip, North West Province			
<b>Place of Occurrence</b>	Runway (RWY) 02 Kalahari Gold Mine Airstrip						
<b>GPS Co-ordinates</b>	<b>Latitude</b>	26° 10'20" S	<b>Longitude</b>	025° 13'59" E	<b>Elevation</b>	4 087 feet	
<b>Aircraft Information</b>							
<b>Registration</b>	ZS-TKI						
<b>Make; Model; S/N</b>	Beechcraft; BE20 (Serial Number: BB1805)						
<b>Damage to Aircraft</b>	Minor		<b>Total Aircraft Hours</b>	3954.6			
<b>Pilot-in-command</b>							
<b>Licence Type</b>	Commercial Pilot Licence (CPL) A		<b>Gender</b>	Male	<b>Age</b>	67	
<b>Licence Valid</b>	Yes	<b>Total Hours</b>	4 034.2	<b>Total Hours on Type</b>	90.6

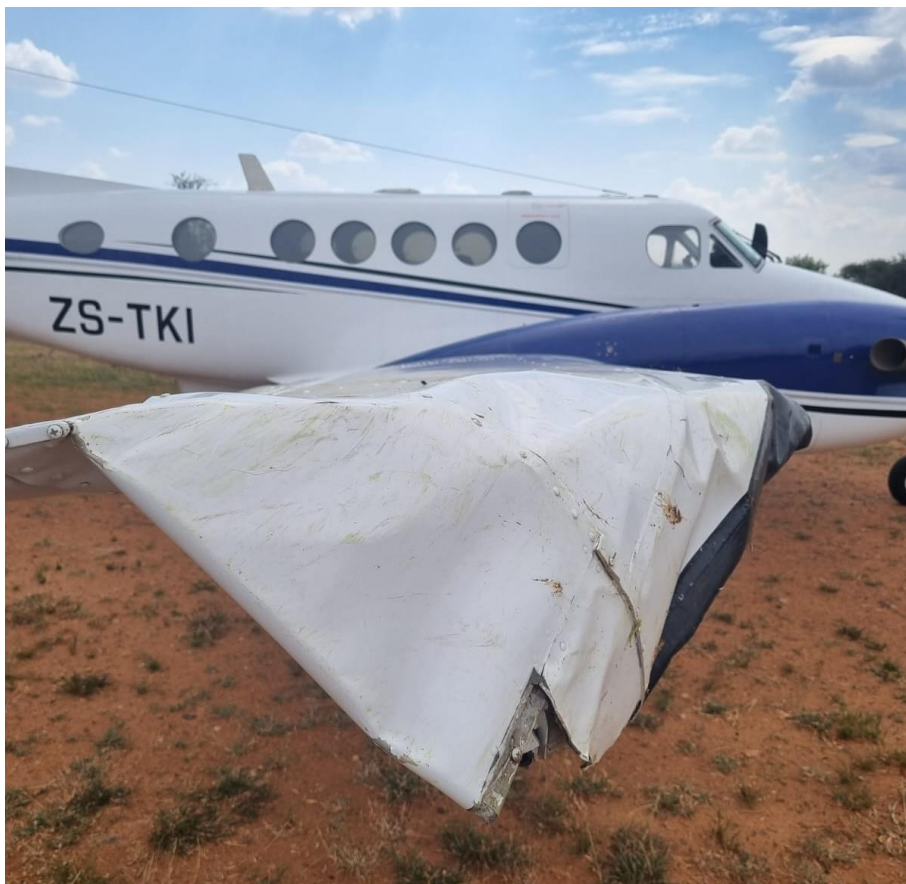
**Figure 2:** The damaged aircraft at the accident site. (Source: Pilot)

7. The aircraft's right-wing tip impacted a series of thorn bushes with overgrow branches that extended to the right of the runway edge during the landing roll.

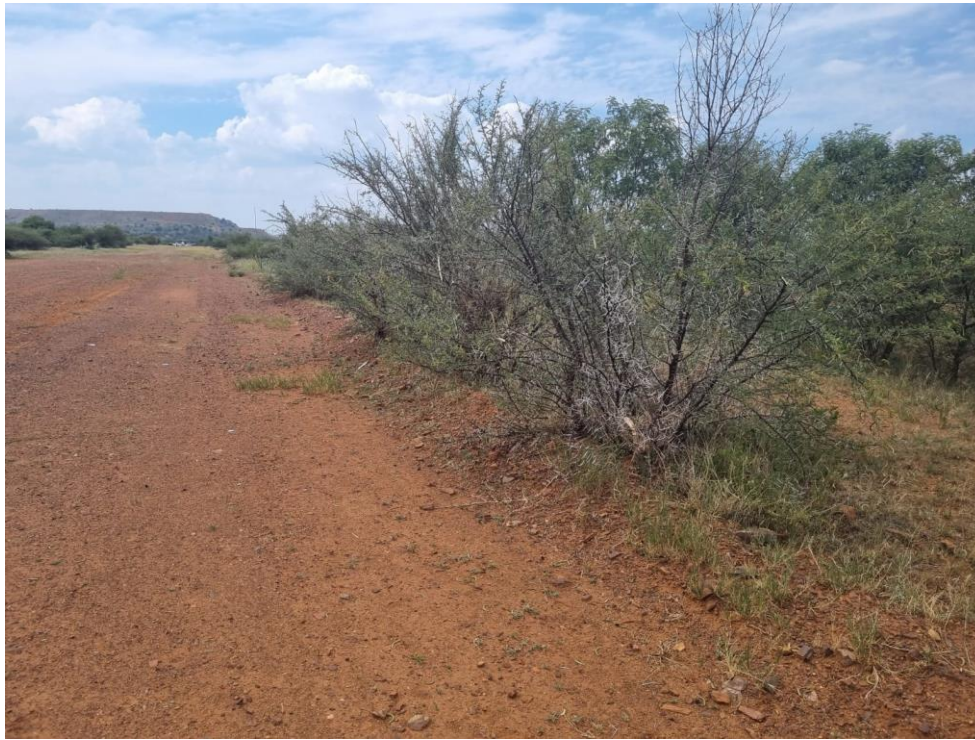
**Figure 3:** The thorn bushes the aircraft impacted at the edge of RWY02. (Source: Pilot)

It is likely that the aircraft landed more towards the right of the runway's centre which led to the right-wing tip impacting a series of thorn bushes on the right edge of RWY02 during the landing roll.

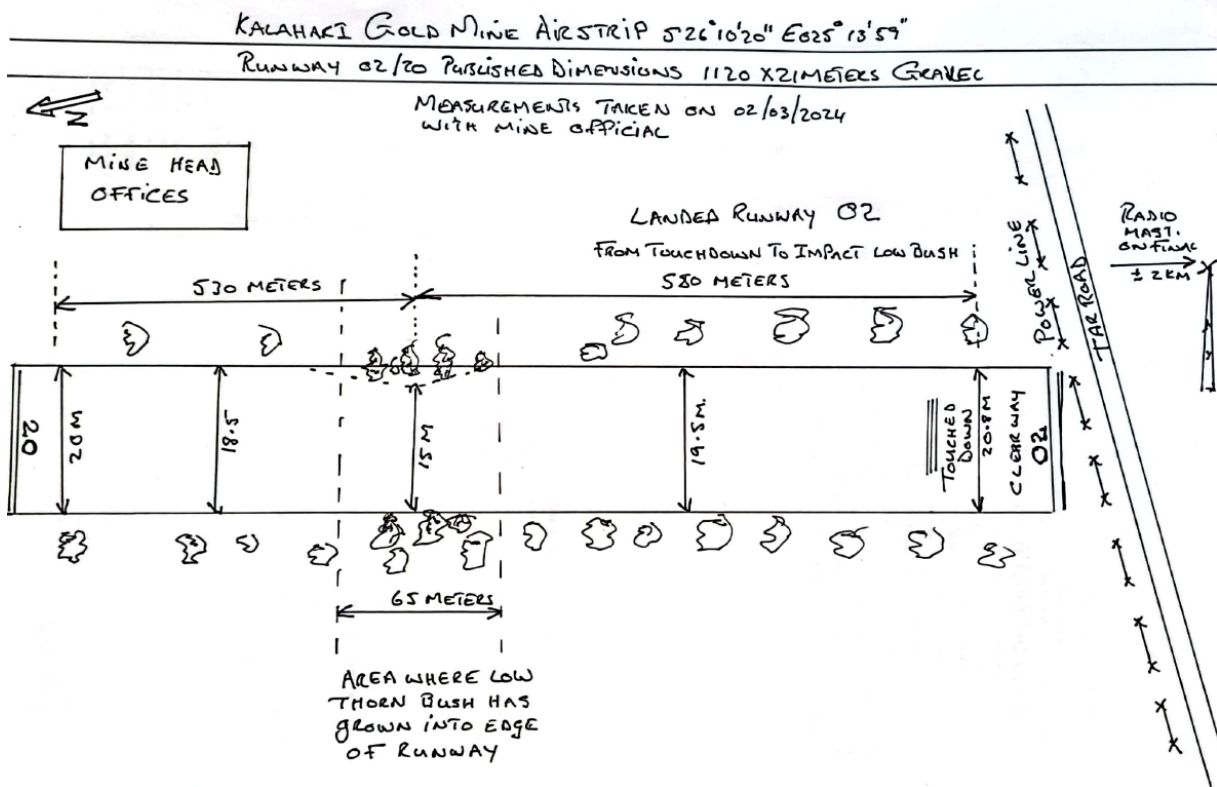
**Figure 4:** The runway sketch. (Source: Pilot)

RWY 02 is unpaved (gravel) and is 1 120 metres (m) long and 21m wide, according to EasyPlan flight planning system.

8. The runway used was RWY 02, which is unpaved (gravel); it is 1 120m long and 21m wide, according to EasyPlan flight planning system.
9. Airfield management did not alert the pilot about the overgrown bushes during the signing of the indemnity form.
10. The weather was not a factor to this accident.

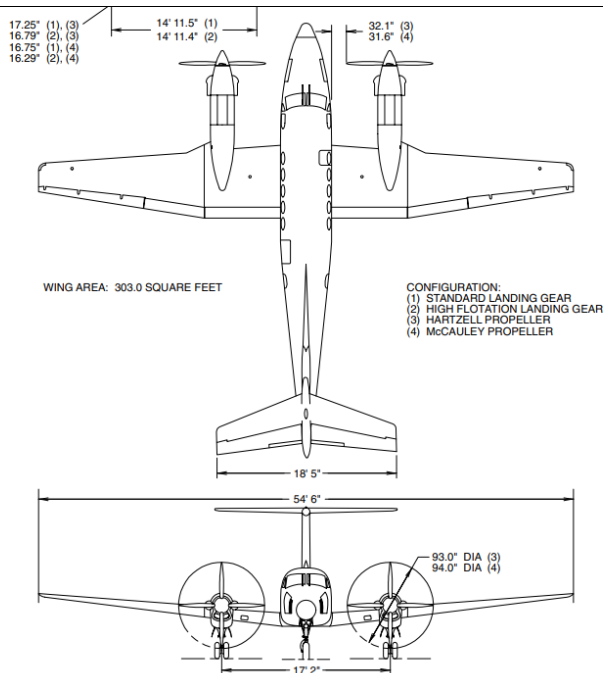
**Figure 5:** The aircraft dimensions. (Source: POH)

The King Air BE20 wingspan is 16.6m (54' 4" ft), according to the Pilot's Operating Handbook (POH).
