LIMITED OCCURRENCE INVESTIGATION REPORT – FINAL

Reference Number	CA18/2/3/1043					
Classification	Accident	Date	19 June 2023	Time	1122Z	
Type of Operation	Training (Part 141)					
Location						
Place of Departure	Grand Central Aerodrome (FAGC), Gauteng Province		Place of Intended Landing	Grand Central Aerodrome (FAGC), Gauteng Province		
Place of Occurrence	On Runway 35 at FAGC, Gauteng Province					
GPS Co-ordinates	Latitude	25°59'.35" S	Longitude	028°08'.39" E	Elevation	5 331 feet
Aircraft Information						
Registration	ZS-LXE					
Make; Model; S/N	Cessna Aircraft Company; 172K Skyhawk (Serial Number: 172-58473)					
Damage to Aircraft	Substantial		Total Aircraft Hours	23 860.5		
Pilot-in-command						
Licence Type	Student Pilot Licence (SPL)		Gender	Male		Age 19
Licence Valid	Yes	Total Hours	26.9		Total Hours on Type	26.9
Total Hours 90 Days	26.9		Total Flying on Type Past 30 Days		26.9	
People On-board	1 + 0	Injuries	0	Fatalities	0	Other (on ground) 0

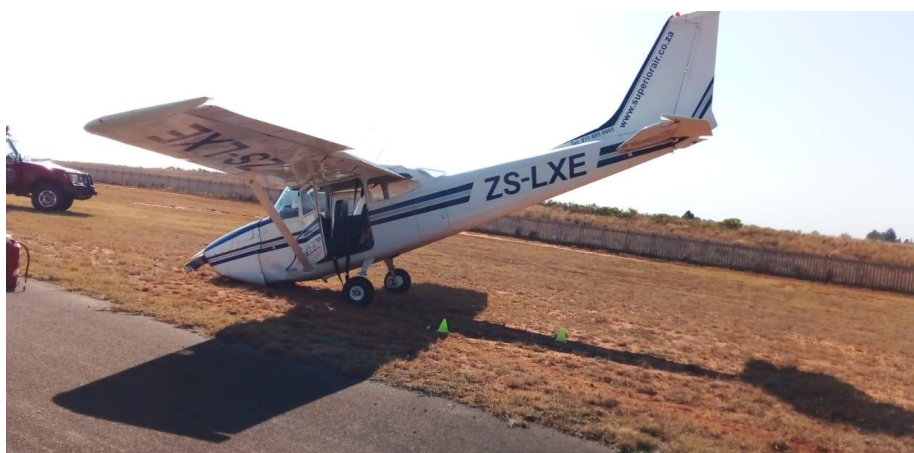
Figure 1: The aircraft next to Runway 35 with the flaps extended to 30°. (Source: Operator)

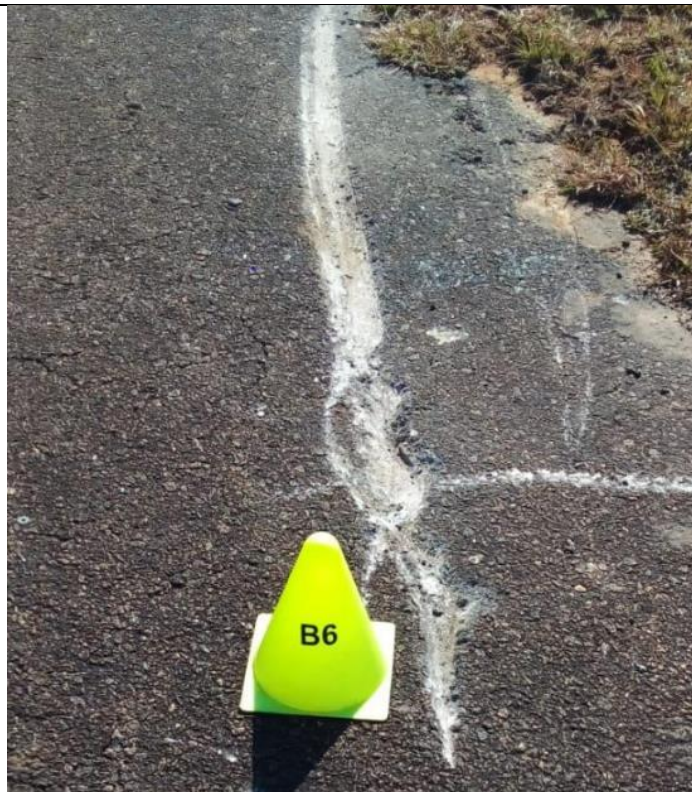
Figure 2: Skid marks on Runway 35. (Source: Operator)

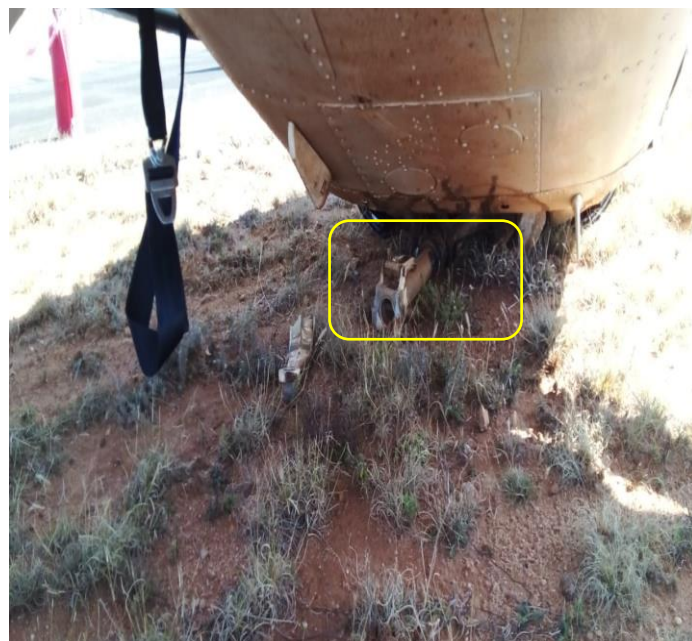
Figure 3: The rear of the aircraft showing a broken nose landing gear strut (yellow window). (Source: Pilot)

Probable Cause
The student pilot misjudged the flaring and released the back pressure prematurely before the main wheels settled on the runway surface, whereafter the nose wheel contacted the runway first which resulted in the nose gear fork and strut breaking off due to overload.
Contributing Factors
None.
Safety Action
None.
Safety Recommendation/Message
None.
About this Report
<p><i>The decision to conduct a limited investigation is based on factors including whether the cause is known and the evidence supporting the cause is clear, the level of safety benefit likely to be obtained from an investigation and that will determine the scope of an investigation. For this occurrence, a limited investigation has been conducted, and the Accident and Incident Investigations Division (AIID) has relied on the information submitted by the affected person/s and organisation/s to compile this limited report. The report has been compiled using information supplied in the initial notification, as well as from follow-up desk top enquiries to bring awareness of potential safety issues to the industry in respect of this occurrence, as well as possible safety action/s that the industry might want to consider in preventing a recurrence of a similar occurrence.</i></p> <p><i>All times given in this report are Co-ordinated Universal Time (UTC) and will be denoted by (Z). South African Standard Time is UTC plus 2 hours.</i></p>
