LIMITED OCCURRENCE INVESTIGATION REPORT – FINAL

Reference Number	CA18/2/3/10430						
Classification	Accident	Date	9 March 2024		Time	1530Z	
Type of Operation	Training (Part 141)						
Location							
Place of Departure	Mahikeng Aerodrome (FAMM), North West Province		Place of Intended Landing		Mahikeng Aerodrome (FAMM), North West Province		
Place of Occurrence	Runway 04 at Mahikeng Aerodrome (FAMM)						
GPS Co-ordinates	Latitude	25°47'54.4" S	Longitude	25°32'53.19" E	Elevation	4 181 ft	
Aircraft Information							
Registration	ZS-CJG						
Make; Model; S/N	Piper Aircraft Corporation; PA-28-180 Cherokee (Serial Number: 28-2761)						
Damage to Aircraft	Substantial			Total Airframe Hours	8 449.4		
Pilot-in-command							
Licence Type	Student Pilot Licence (SPL)		Gender	Male		Age	18
Licence Valid	Yes	Total Hours	59.4		Total Hours on Type	40.8	
Total Hours 30 Days	40.8		Total Flying Hours on Type Past 90 Days		40.8		
People On-board	1 + 0	Injuries	0	Fatalities	0	Other (on the ground)	0

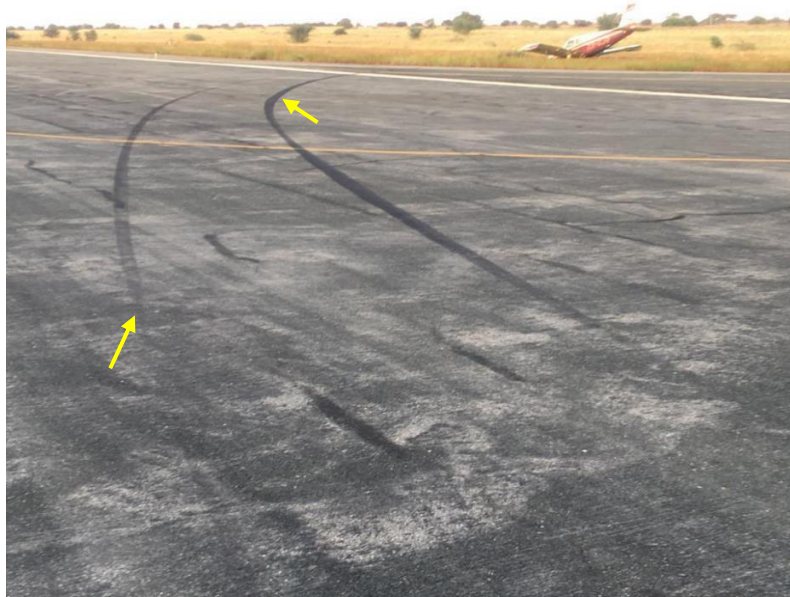
The aircraft was stable on final approach, and the flaps were extended to 40 degrees (°). The aircraft touched down on Runway 04. In preparation for another take-off, the SP retracted the flaps to 10° and opened the throttle to 2 700 RPM. During this process, the aircraft drifted to the right. The SP tried to recover the aircraft back to the centreline without success. As the aircraft continued to drift to the right, he applied the brakes excessively and the aircraft came to a halt on the grass beside the runway. The aircraft sustained substantial damage to the nose landing gear strut and propeller. The SP was not injured.

Figure 1: The main wheel tyre marks on the runway surface. (Source: Pilot)

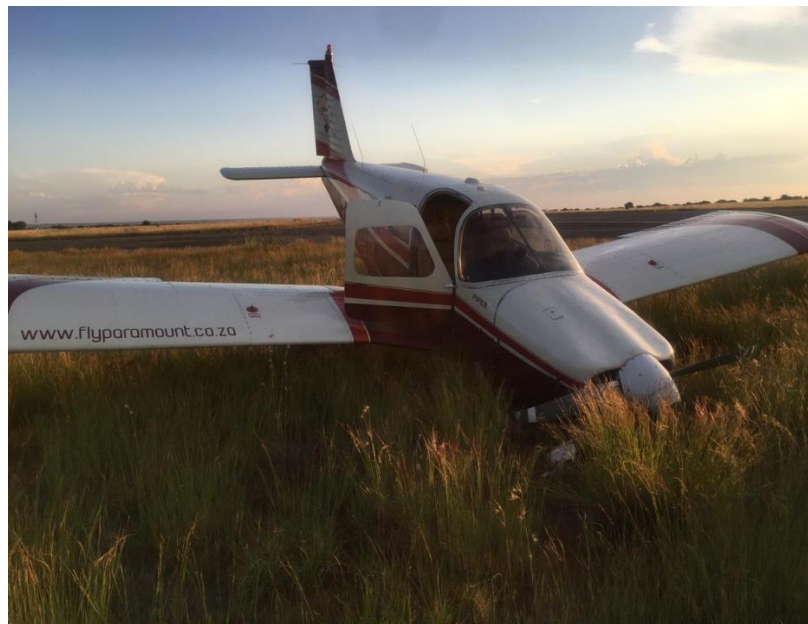
Figure 2: The aircraft as it came to rest on the right side of the runway. (Source: Pilot)

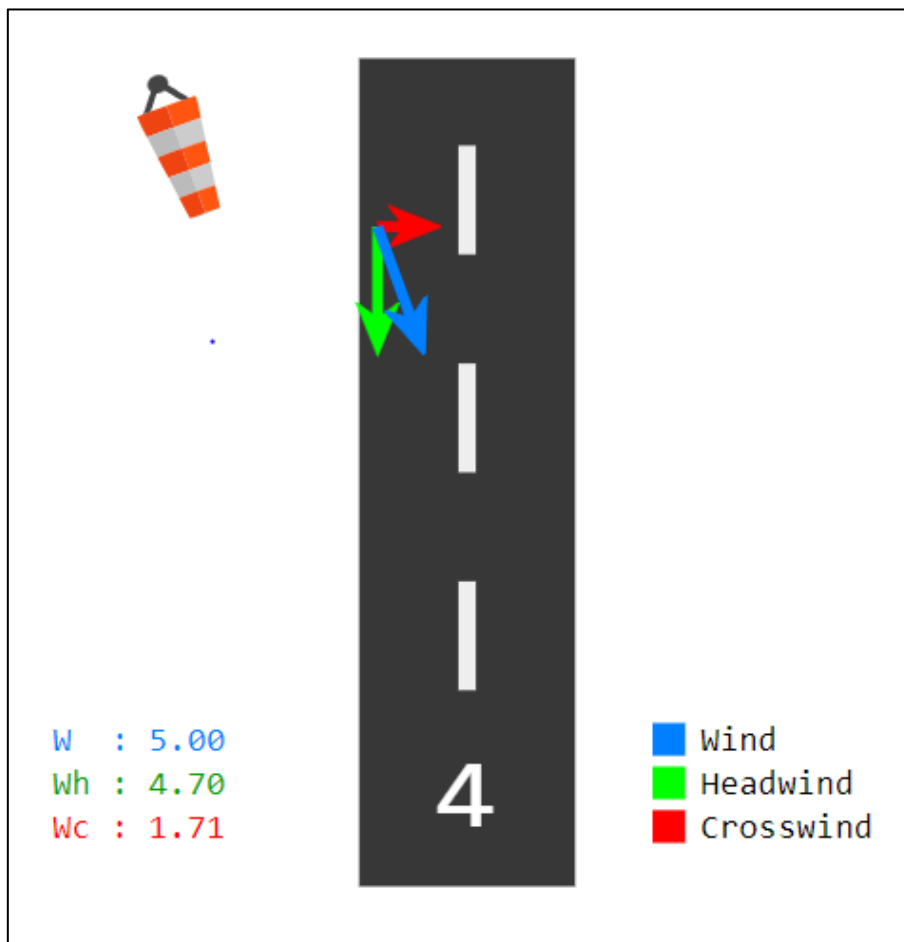
The crosswind component at the time of the flight was calculated to be 1.71 knots from the left. A Piper PA-28-180 Cherokee aircraft has a maximum crosswind velocity of 17 knots at full (40°) flaps setting.

Figure 3: Calculated crosswind component.
