**LIMITED OCCURRENCE INVESTIGATION REPORT – FINAL**

<b>Reference Number</b>	CA18/2/3/10431						
<b>Classification</b>	Accident	<b>Date</b>	10 March 2024	<b>Time</b>	0831Z		
<b>Type of Operation</b>	Private (Part 94)						
<b>Location</b>							
Place of Departure	Springbok Aerodrome (FASB), Northern Cape Province		Place of Intended Landing	Morning Star Aerodrome, Western Cape Province			
Place of Occurrence	Elandsbaai Nature Reserve, Western Cape Province						
GPS Co-ordinates	Latitude	32°16'18.70" S	Longitude	018°23'35.99" E	Elevation	450 ft	
<b>Aircraft Information</b>							
Registration	ZU-URI						
Make; Model; S/N	Jabiru J430 (Serial Number: 995)						
Damage to Aircraft	Substantial			Total Aircraft Hours	57.9		
<b>Pilot-in-command</b>							
Licence Type	Commercial Pilot Licence (CPL) Aeroplane		Gender	Male		Age	80
Licence Valid	Yes	Total Hours	1802.2		Total Hours on Type	49.7	
Total Hours 30 Days	5.9		Total Flying on Type Past 90 Days	11.4			
<b>People On-board</b>	1+1	<b>Injuries</b>	0	<b>Fatalities</b>	0	<b>Other (on ground)</b>	0

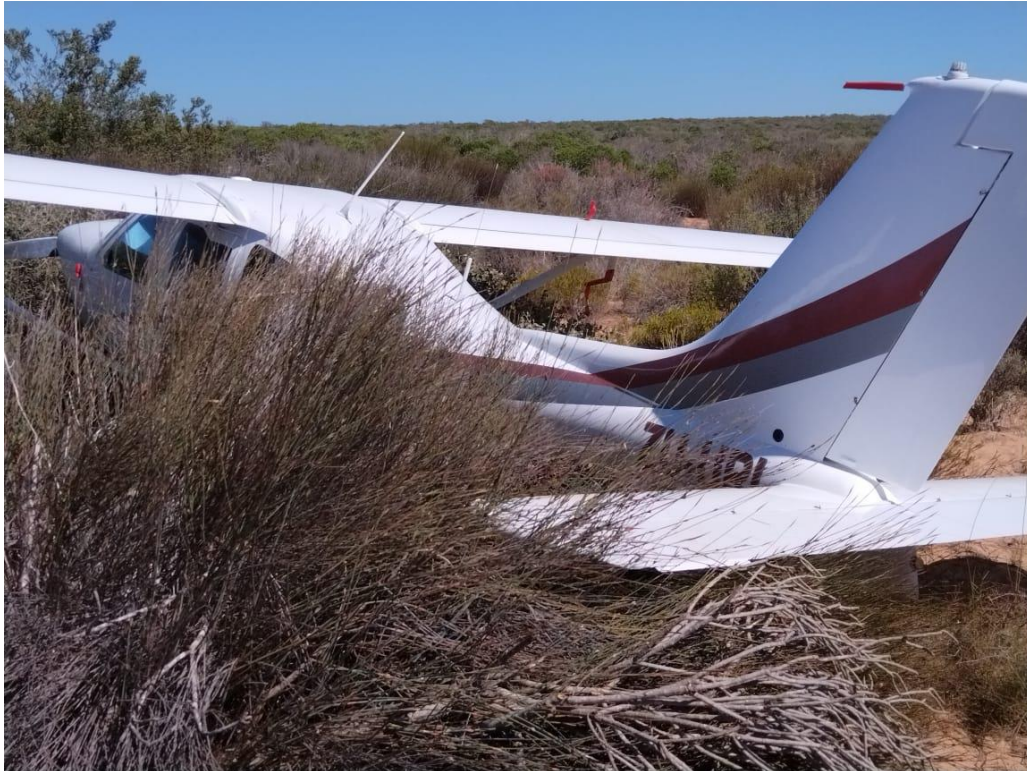
**Figure 1:** The aircraft came to rest on a bushy area. (Source: Operator)

- Nose leg and main undercarriage was damaged and broken.
- Quite a substantial amount of fuel had leaked out of the wing tanks.
- Fuel was drained from wing tank including the header tank.
- Approximately 30 litres of fuel was recovered.
- No damages to the propeller.
- Main fuel tap in cabin was on off position.
- An inspection of the Carburettor float bowl was conducted, no evidence of water or dirt found.
- The engine was removed and placed on a test bench.
- The engine started immediately, and power checks were conducted.
- The engine achieved all the power settings.
- Blow byes was then performed.  
1)72/80 2)74/80 3)72/80  
4)74/80 5)74/80 6)76/80

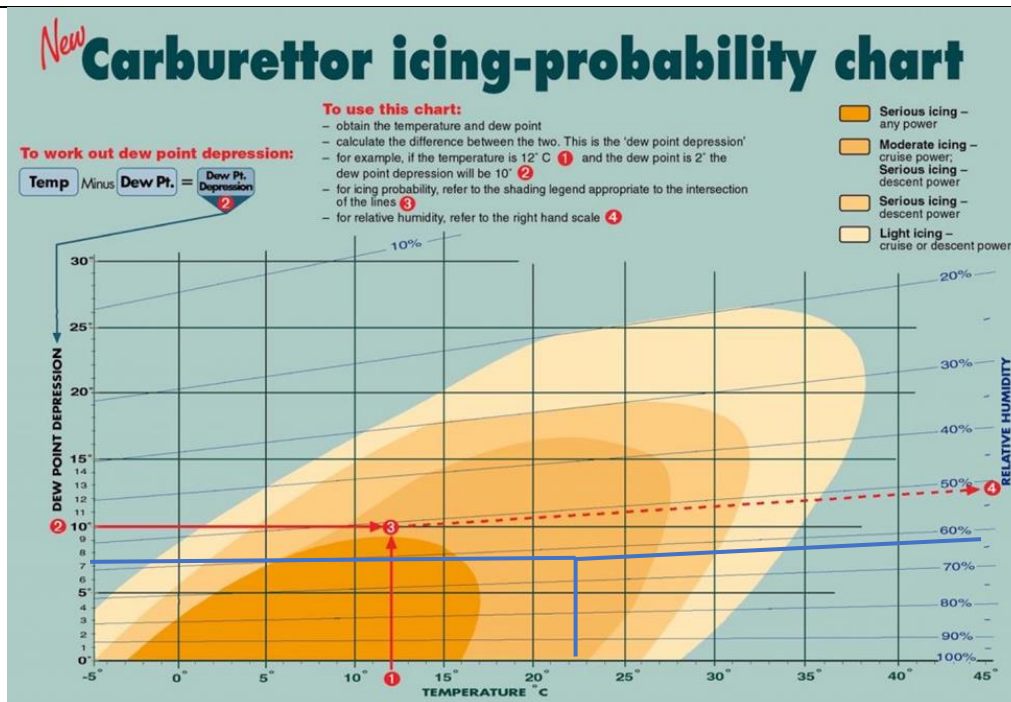
Figure 4: Carburettor icing chart. (Source: <https://www.dmi.dk/fileadmin>)

The dew point depreciation is calculated at 7°C and temperature at 23°C; the relative humidity is calculated at 64%. A 64% humidity will result in moderate icing on cruise power and serious icing on decent power.

4. The Certificate of Registration was issued on 1 August 2022.
5. The probability chart (Figure 4) indicated that there was a possibility of icing as the temperature was 23°C and the dew point was 16°C. The relative humidity was 64%. The chart plot indicated moderate icing in cruise power and serious icing in descent power.

The engine carburetor experienced moderate icing before it lost power and failed. Attempts to restore power resulted in an unsuccessful precautionary landing and damage to the aircraft.
