LIMITED OCCURRENCE INVESTIGATION REPORT – FINAL

Reference Number	CA18/2/3/10432					
Classification	Accident	Date	18 March 2024	Time	0930Z	
Type of Operation	Private (Part 94)					
Location						
Place of Departure	Karoo Gateway Aerodrome (FABW), Beaufort West, Western Cape Province		Place of Intended Landing	New Tempe Aerodrome (FATP), Bloemfontein, Free State Province		
Place of Occurrence	Karoo Gateway Aerodrome (FABW)					
GPS Co-ordinates	Latitude	32°18'6.12" S	Longitude	022°39'54.36" E	Elevation	2932 ft
Aircraft Information						
Registration	ZU-DSH					
Make; Model; S/N	Yakovlev; Yak 55 (Serial Number: 880501)					
Damage to Aircraft	Substantial		Total Aircraft Hours	370.5		
Pilot-in-command						
Licence Type	Commercial Pilot Licence		Gender	Male		Age 24
Licence Valid	Yes	Total Hours	860		Total Hours on Type	35
Total Hours 30 Days	24		Total Flying on Type Past 90 Days	20		
People On-board	0	Injuries	0	Fatalities	0	Other (on ground) 0
What Happened

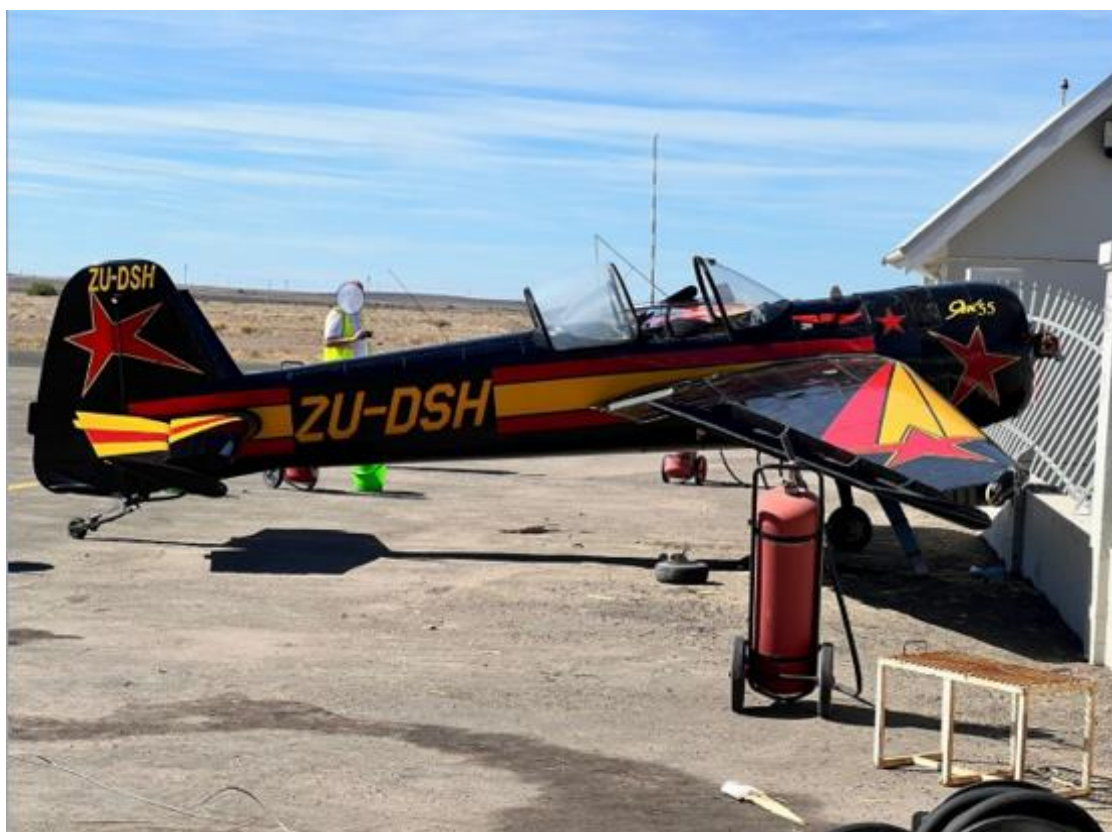
<p>On Monday morning, 18 March 2024, a pilot on a Yak 55 aircraft with registration ZU-DSH had planned to conduct a private flight from Karoo Gateway Aerodrome (FABW) in Beaufort West, Western Cape province, to New Tempe Aerodrome (FATP) in Bloemfontein, Free State province. Visual meteorological conditions (VMC) by day prevailed at the time of the flight. The flight was planned to be conducted under the provisions of Part 94 of the Civil Aviation Regulations (CAR) 2011 as amended.</p> <p>The pilot stated that he completed the pre-flight inspection on the aircraft with no anomalies found. He then refuelled the aircraft to full capacity in preparation for the flight. Upon pre-setting the aircraft for an engine pre-start procedure, the pilot asked two people to assist him to exert power on the aircraft to keep it in position; this was to prevent it from moving as soon as the engine starts. The pilot intended to start the engine using the propeller hand-cranking method. This was due to an existing defect on the aircraft's engine start system. <i>The pilot stated that the method was taught to him as an alternative to start the engine should he experience a challenge.</i> At this stage, no person was on-board the aircraft, and the aircraft's parking brakes were not engaged. Moreover, there were no chocks placed on the main wheels to prevent the aircraft from rolling. The pilot successfully started the engine but because there was no person on-board the aircraft to control it, it rolled forward and impacted the fuel bay perimeter fence before the pilot had an opportunity to climb in and take control. The aircraft sustained substantial damage to the propeller, right main gear and the right-wing tip. No person was injured. The fuel bay perimeter fence was also damaged.</p>

Figure 2: The aircraft after the accident. (Source: Pilot)

8. The aircraft (with no person on-board, the parking brake not engaged, and the wheel chocks not placed on wheels) was started using an unapproved procedure which resulted in the aircraft rolling forward and impacting the fuel bay perimeter fence.

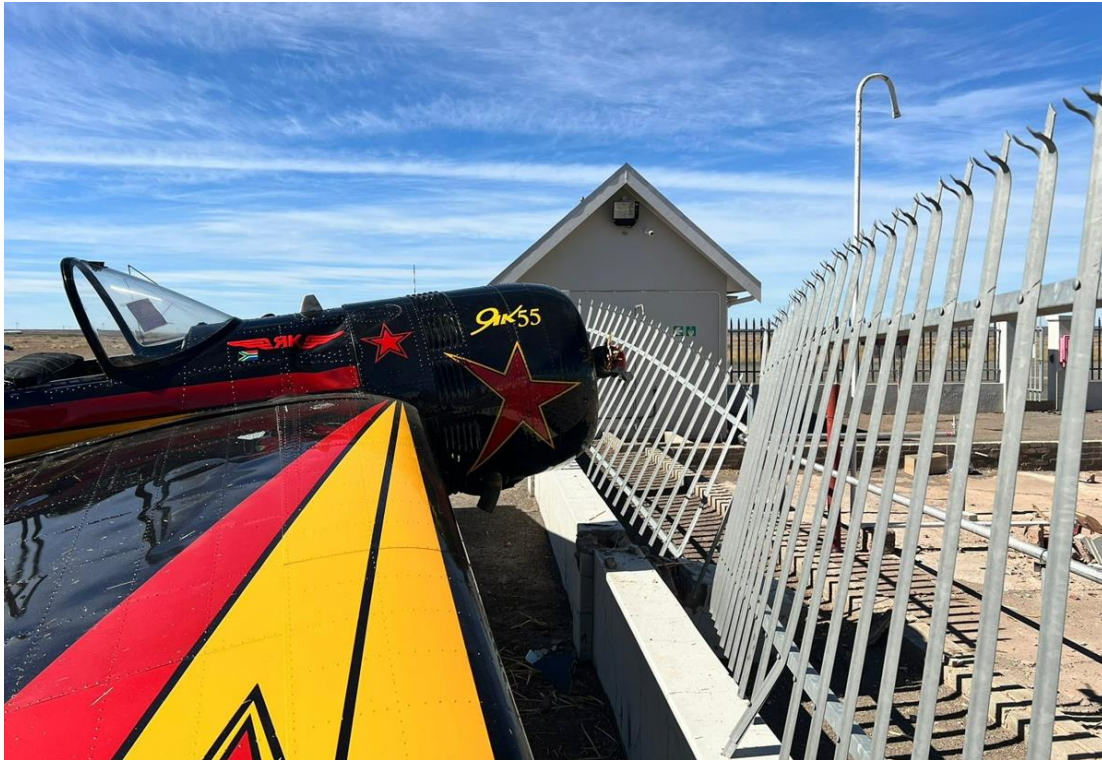
Figure 3: The damaged propeller and the perimeter fence.

Probable Cause(s)
The aircraft's engine was started using an unapproved procedure which resulted in the aircraft rolling forward and impacting the fuel bay perimeter fence.
Contributing Factor(s)
<ol style="list-style-type: none"> 1. The landing gear brakes were not engaged as per the engine start procedure. 2. The cockpit was not occupied at the time of engine start. 3. Disregard of the regulations and the manufacturer-approved aircraft starting procedures.
Safety Action(s)
None.
Safety Message
In the interest of safety and to avoid injuries or damage to property, pilots are encouraged to follow the regulations and manufacturer-approved procedures.
About this Report
<p><i>The decision to conduct a limited investigation is based on factors, including whether the cause is known and the evidence supporting the cause is clear, the level of safety benefit likely to be obtained from an investigation, and that will determine the scope of an investigation. For this occurrence, a limited investigation has been conducted, and the Accident and Incident Investigations Division (AIID) has relied on the information submitted by the affected person/s and organisation/s to compile this limited report. The report has been compiled using information supplied in the initial notification, as well as from follow-up desktop inquiries to bring awareness of potential safety issues to the industry in respect of this occurrence, as well as possible safety action/s that the industry might want to consider in preventing a recurrence of a similar occurrence.</i></p> <p><i>All times given in this report are Co-ordinated Universal Time (UTC) and will be denoted by (Z). South African Standard Time is UTC plus 2 hours.</i></p>
