**LIMITED OCCURRENCE INVESTIGATION REPORT – FINAL**

<b>Reference Number</b>	CA18/2/3/10434						
<b>Classification</b>	Accident	<b>Date</b>	20 March 2024		<b>Time</b>	0740Z	
<b>Type of Operation</b>	Training (Part 141)						
<b>Location</b>							
Place of Departure	Lanseria International Airport (FALA), Gauteng Province		Place of Intended Landing	Lanseria International Airport (FALA), Gauteng Province			
Place of Occurrence	On Runway 07 at Lanseria International Airport (FALA), Gauteng Province						
GPS Co-ordinates	Latitude	26°56'19" S	Longitude	027°55'34" E	Elevation	4 520 ft	
<b>Aircraft Information</b>							
Registration	ZS-MLF						
Make; Model; S/N	Piper Cherokee, PA-28 -140 (Serial Number: 28-20248)						
Damage to Aircraft	Substantial			Total Aircraft Hours	9882.1		
<b>Pilot-in-command</b>							
Licence Type	Student Pilot Licence (SPL)		Gender	Female		Age	20
Licence Valid	Yes	Total Hours	59		Total Hours on Type	59	
Total Hours Past 30 Days	6.7		Total Flying Hours on Type Past 90 Days	28.5

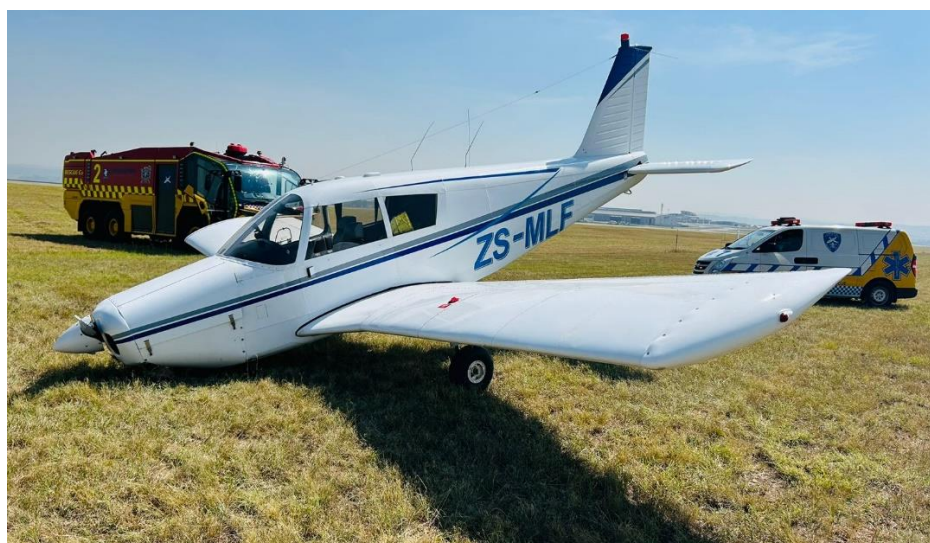
damage. Post-accident and after reviewing the pilot's questionnaire, it was found that the landing speed was between 85 miles per hour (MPH) and 90MPH.

**Figure 2:** The aircraft after the accident. (Source: Pilot)

The aircraft's speed was high during the approach and landing phase which resulted in loss of control before the aircraft veered off the runway.

Incorrect approach speed as it was too high.

Safety recommendations to the ATOs: Always adhere to the requirements of the CARs 2011 as amended by having the student pilot evaluated by the chief flight instructor (CFI) and designated flight examiner (DFE).
