LIMITED OCCURRENCE INVESTIGATION REPORT – FINAL

| Reference Number | CA18/2/3/10435 | | | | | | |
| Registration | ZS-GNK | | | | | | |
| Make; Model; S/N | Alexander Schleicher GMBH & CO., ASW-20F (Serial Number: 20-190) | | | | | | |

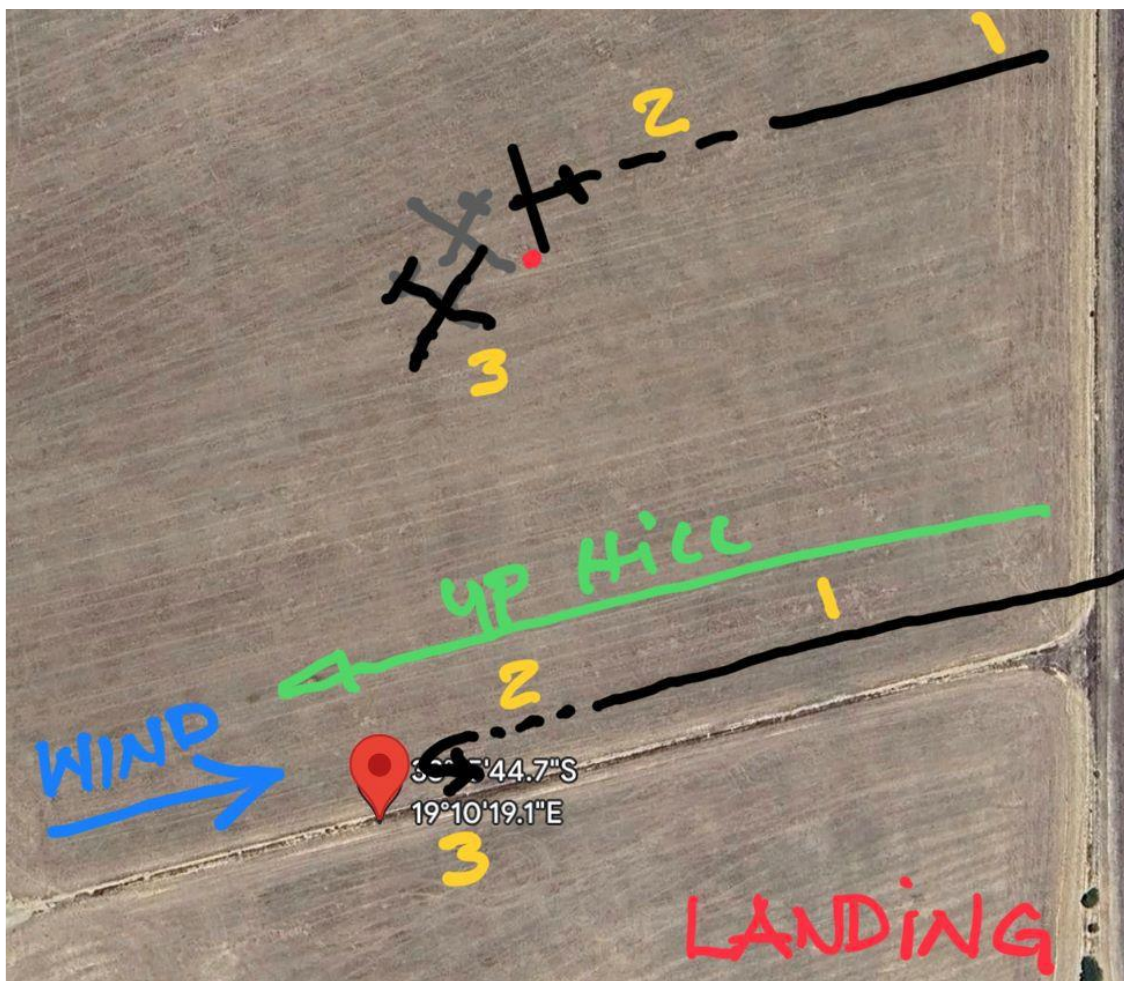
Figure 1: The red pin marks the spot where the glider rested. (Source: Pilot)

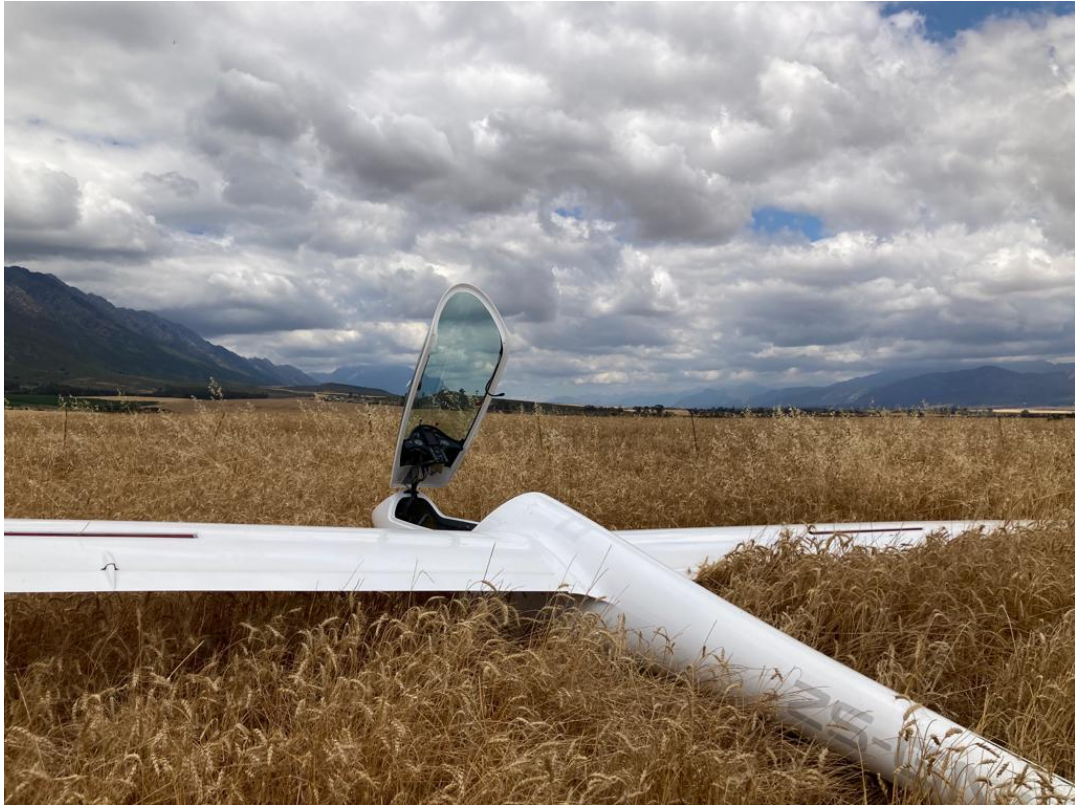
The glider sustained structural damage to its tail boom, lower left wing and aileron (which required major repairs). No person was injured.

Figure 2: The glider as it came to rest. (Source: Pilot)

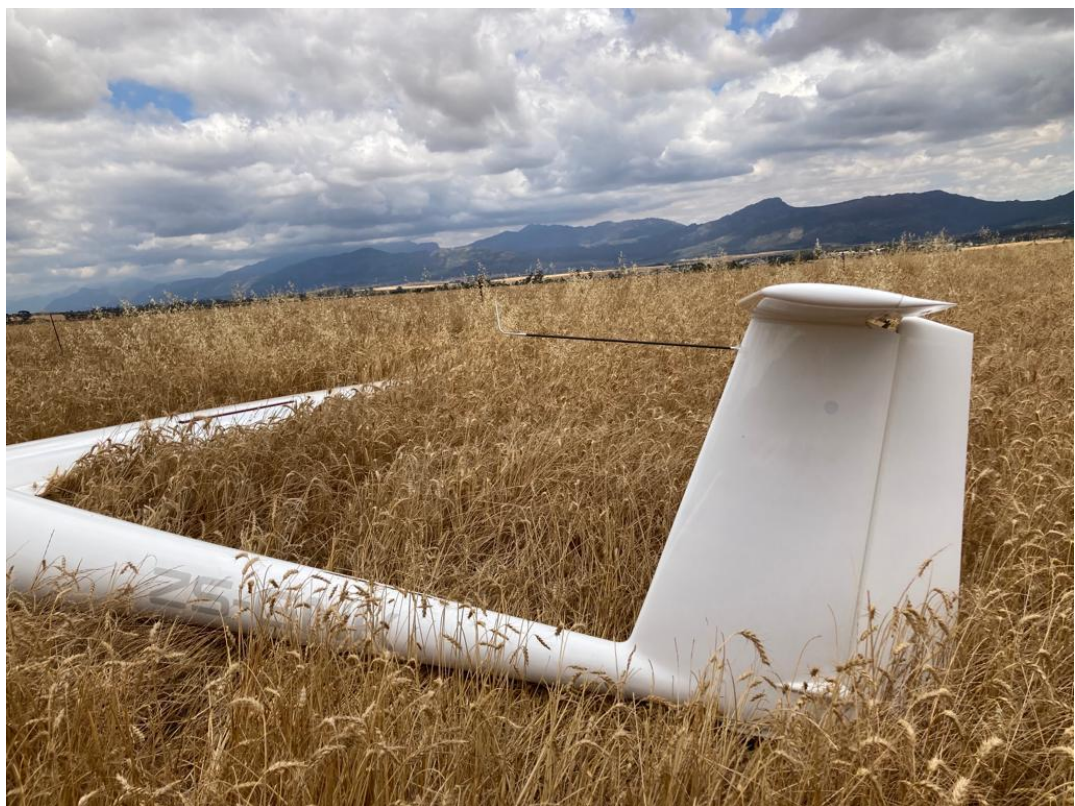
Figure 3: Aft view of the glider at the accident site. (Source: Pilot)

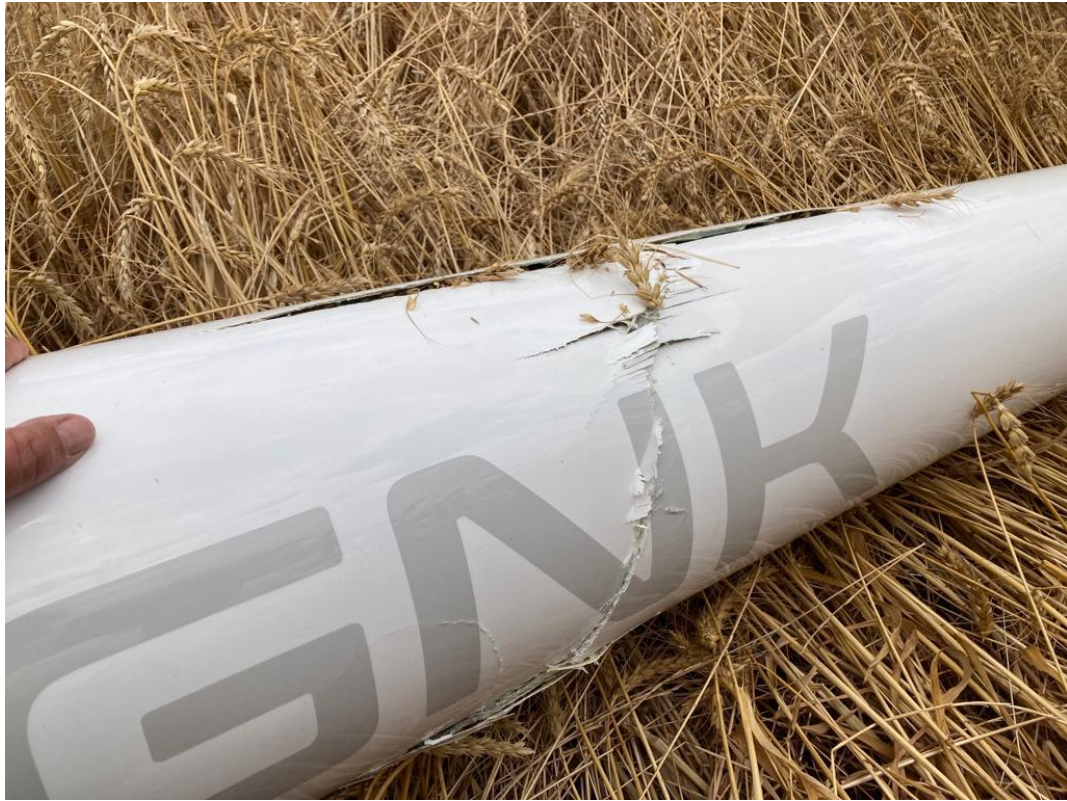
Figure 4: The damaged tail boom of the glider. (Source: Pilot)

The glider could not sustain flight due to the absence of thermals which resulted in loss of height. The pilot conducted a field landing, and during the landing process, the left wing was caught by vegetation and the glider ground looped. The glider sustained substantial structural damage.
