LIMITED OCCURRENCE INVESTIGATION REPORT – FINAL

Reference Number	CA18/2/3/10436						
Classification	Accident	Date	29 March 2024		Time	0845Z	
Type of Operation	Private (Part 94)						
Location							
Place of Departure	Eagle's Creek Aviation Estate, Gauteng Province		Place of Intended Landing	Eagle's Creek Aviation Estate, Gauteng Province			
Place of Occurrence	Grass area on the edge of N14 close to Runway 26 at Eagle's Creek Aviation Estate						
GPS Co-ordinates	Latitude	25°54'25.53" S	Longitude	028°02'9.9" E	Elevation	4 700 feet (ft)	
Aircraft Information							
Registration	ZU-DYE						
Make; Model; S/N	Aeroprakt Ltd; A22 (Serial Number: 317-14358)						
Damage to Aircraft	Substantial		Total Aircraft Hours	460.4			
Pilot-in-command							
Licence Type	National Pilot Licence (NPL)		Gender	Male		Age	56
Licence Valid	Yes	Total Hours	849		Total Hours on Type	24.6	
Total Hours past 30 Days	2.0		Total Flying Hours on Type Past 90 Days	12			
People On-board	1 + 0	Injuries	0	Fatalities	0	Other (on ground)	0

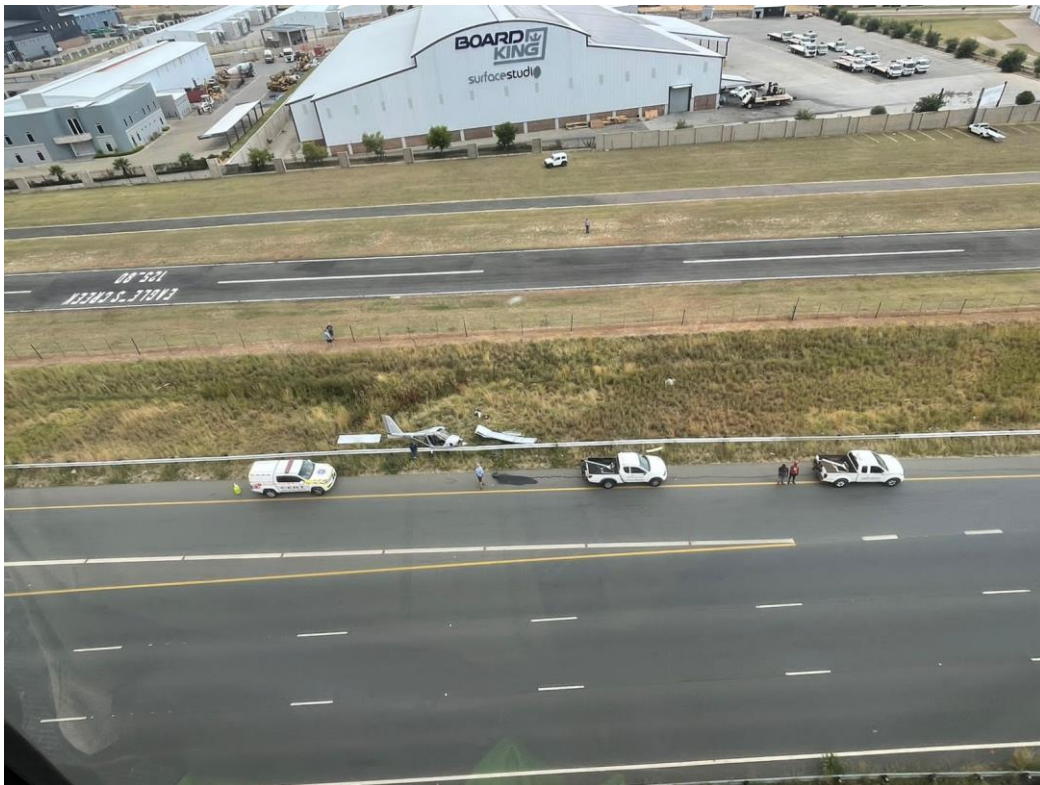
What Happened							
<p>On Friday morning at approximately 0745Z, a pilot on-board the Aeroprakt A22 aircraft with registration ZU-DYE took off on a private flight from Eagle's Creek Aviation Estate in Centurion, Gauteng province, to the general flying area (GFA). The flight was conducted under visual meteorological conditions (VMC) by day and under the provisions of Part 94 of the Civil Aviation Regulations (CAR) 2011 as amended.</p> <p>The pilot stated that the flight to and from the GFA was uneventful. When he was on short final for landing on Runway 26 at Eagle's Creek Aviation Estate before touchdown, he flared the aircraft. However, a gust of wind from his right-hand side lifted the aircraft and caused it to drift to the left. The pilot increased power to conduct a go-around with the flaps fully extended but the aircraft stalled and crashed on the left side of the N14 highway barrier. It came to a stop with the right-side wing sticking out onto the highway.</p> <p>The pilot was not injured. The aircraft sustained substantial damage to the wings, landing gear and propeller blades.</p>

Figure 2: The aircraft as it came to rest. (Source: Pilot)

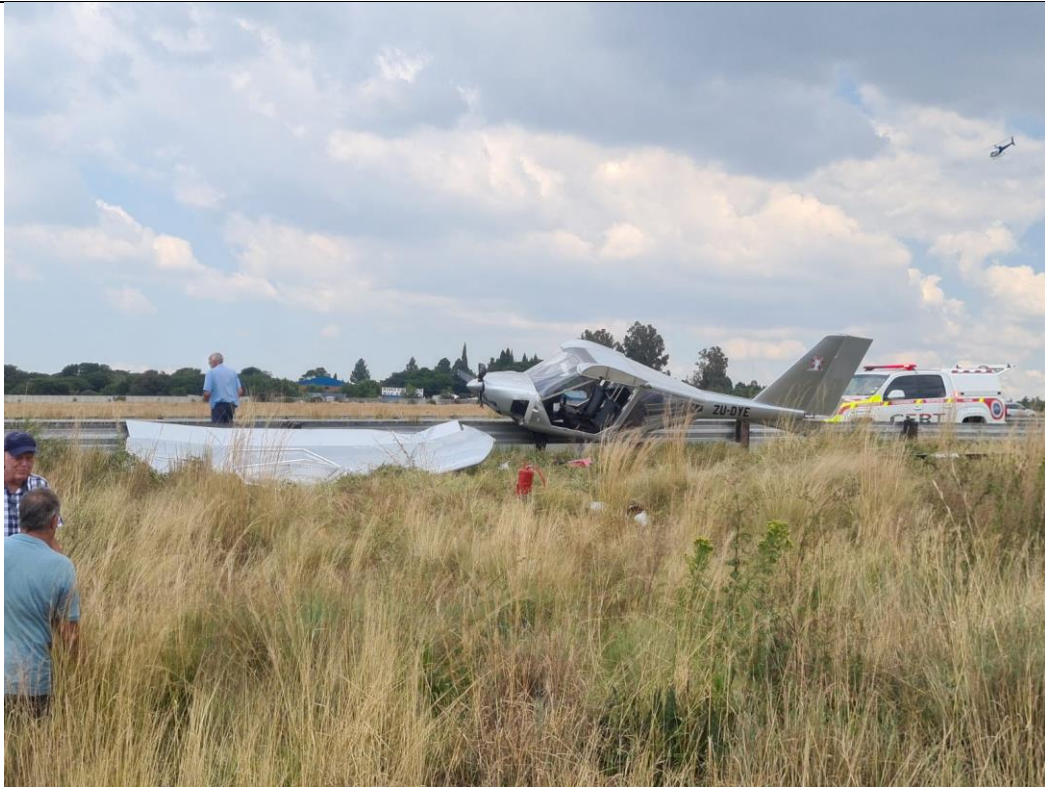
Figure 3: The aircraft on the guard rail of the N14 highway. (Source: Pilot)

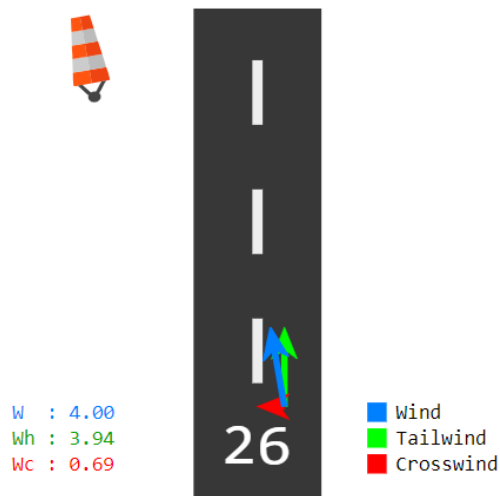
Figure 4: Wind component. (Source: e6bx.com/wind-components/)

7. The crosswind component of the aircraft is 14 knots. The aircraft did not exceed its crosswind component on this flight.

Although there was a gust of wind from the right, the wind did not exceed the crosswind component of the aircraft.
