**LIMITED OCCURRENCE INVESTIGATION REPORT – FINAL**

<b>Reference Number</b>	CA18/2/3/10437						
<b>Classification</b>	Accident	<b>Date</b>	31 March 2024		<b>Time</b>	0922Z	
<b>Type of Operation</b>	Private (Part 91)						
<b>Location</b>							
<b>Place of Departure</b>	Goodside Private Airfield, Lydenburg, Mpumalanga Province			<b>Place of Intended Landing</b>	Hoedspruit Civil Airfield, Limpopo Province		
<b>Place of Occurrence</b>	30 metres from the end of Runway 30 at Goodside Private Airfield						
<b>GPS Co-ordinates</b>	<b>Latitude</b>	25°0'31.17" S	<b>Longitude</b>	30°27'51.14" E	<b>Elevation</b>	4 537ft	
<b>Aircraft Information</b>							
<b>Registration</b>	ZS-LLY						
<b>Make; Model; S/N</b>	Cessna; 172 RG (Serial Number: 172RG-0025)						
<b>Damage to Aircraft</b>	Substantial			<b>Total Aircraft Hours</b>	6 194.4 hours		
<b>Pilot-in-command</b>							
<b>Licence Type</b>	Private Pilot Licence (PPL)		<b>Gender</b>	Male		<b>Age</b>	63
<b>Licence Valid</b>	Yes	<b>Total Hours</b>	372.5		<b>Total Hours on Type</b>	6.3

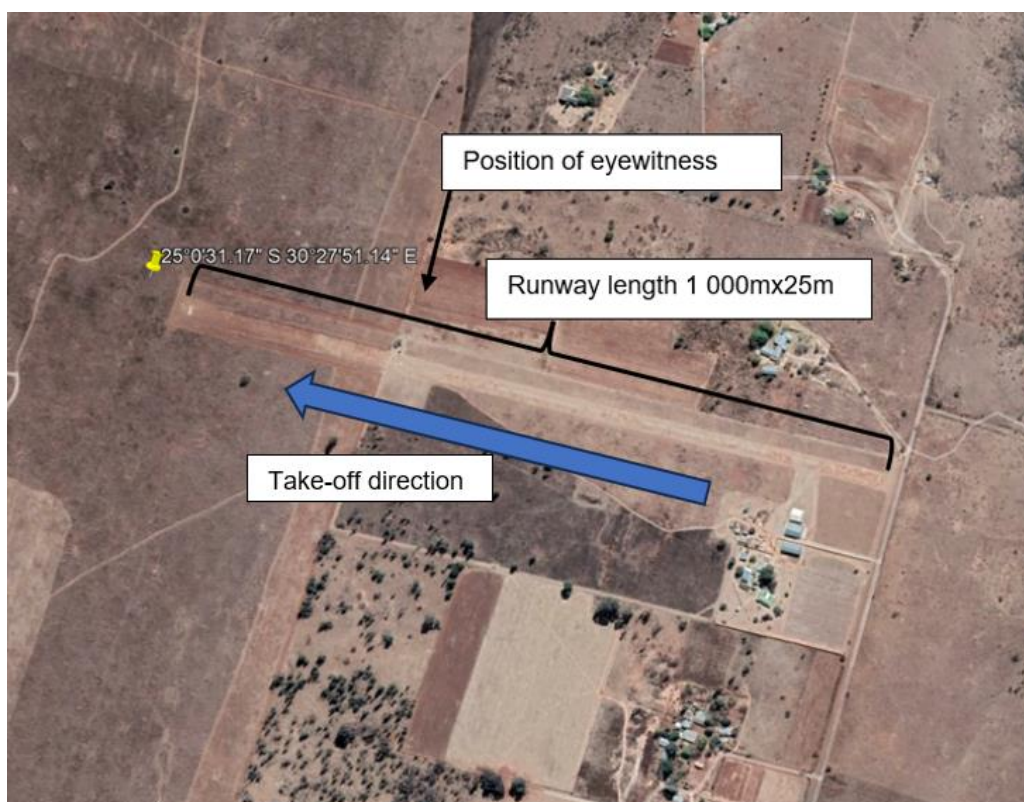
**Figure 1:** Overlay of the accident site. (Source: Google Earth)

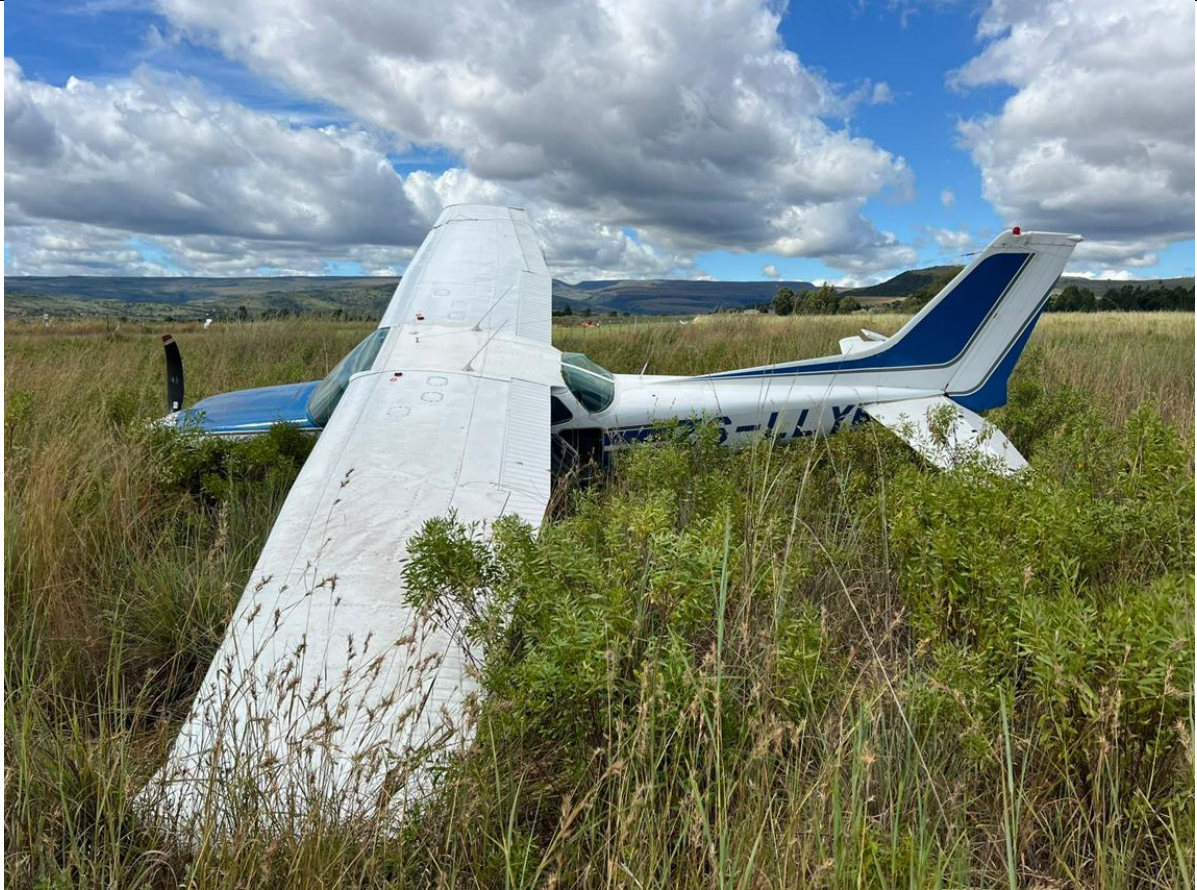
**Figure 2:** Position of aircraft after the accident. (Operator)

The aircraft had difficulty accelerating to the required speed during take-off due to high density altitude and the pilot aborted take-off after the 700m mark of the 1000m runway. This resulted in the aircraft overshooting the runway and impacted the fence.

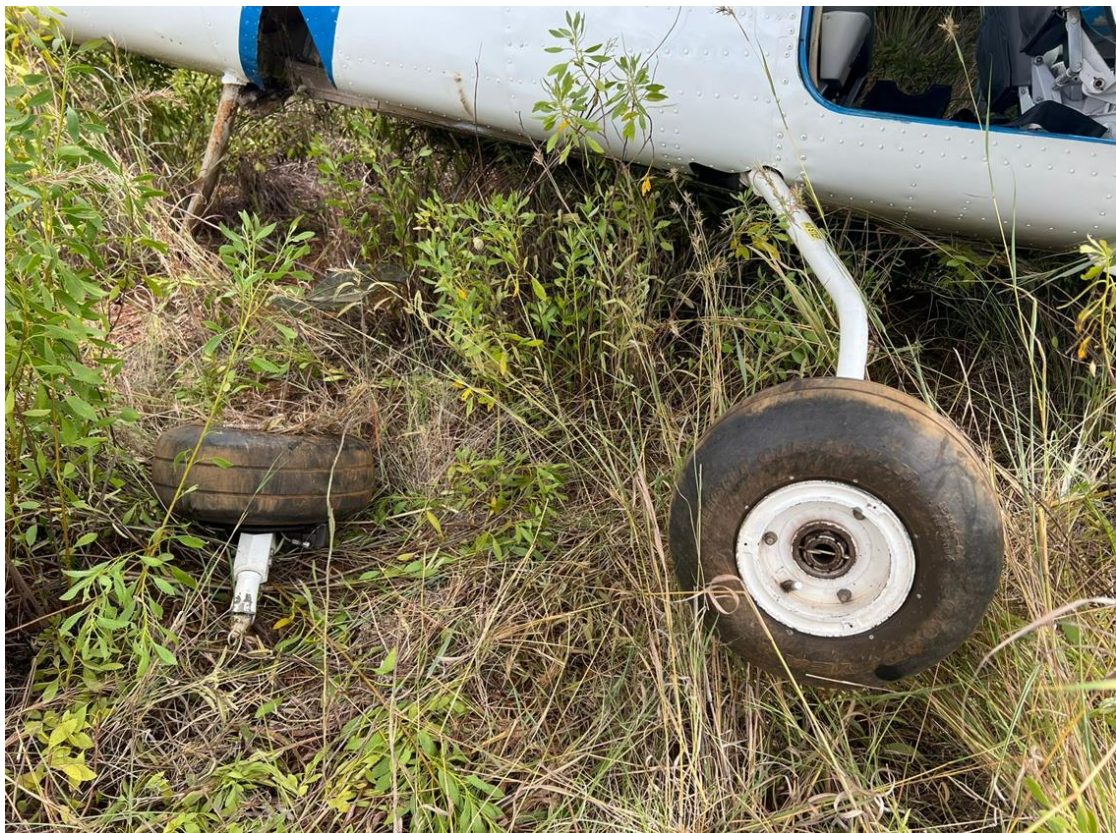
The aircraft sustained substantial damage; the occupants were not injured.

**Figure 3:** The left main landing gear that broke off. (Source: Operator)

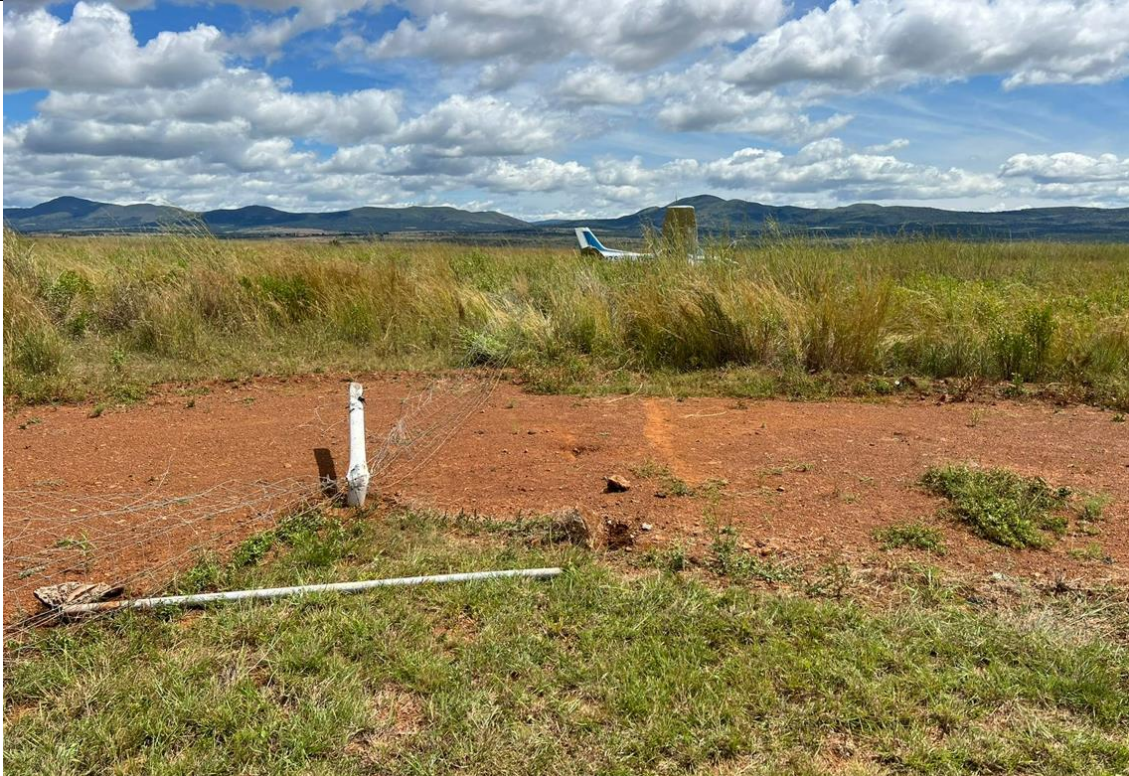
**Figure 4:** The damaged perimeter fence. (Source: Operator)
