LIMITED OCCURRENCE INVESTIGATION REPORT – FINAL

Reference Number	CA18/2/3/10438					
Classification	Accident	Date	2 April 2024		Time	0515Z
Type of Operation	Private (Part 91)					
Location						
Place of Departure	Groutville Airfield KwaZulu-Natal Province		Place of Intended Landing		New Tempe Airfield (FATP), Free State Province	
Place of Occurrence	On Runway 05 at Grootville Airfield in Ballito, KwaZulu-Natal Province					
GPS Co-ordinates	Latitude	29°24'36.5"S	Longitude	31°16'46.0" E	Elevation	235 ft
Aircraft Information						
Registration	ZS-ZZZ					
Make; Model; S/N	Cirrus Design Corporation; SR22 (Serial Number: 4602)					
Damage to Aircraft	Destroyed		Total Aircraft Hours	663.2		
Pilot-in-command						
Licence Type	Private Pilot Licence (PPL)		Gender	Male	Age	55
Licence Valid	Yes	Total Hours	1305.6	Total Hours on Type	1147.34	
Total Hours 30 Days	6.8		Total Flying on Type Past 90 Days		33.8	
People On-board	1+3	Injuries	0	Fatalities	0	Other (on the ground) 0

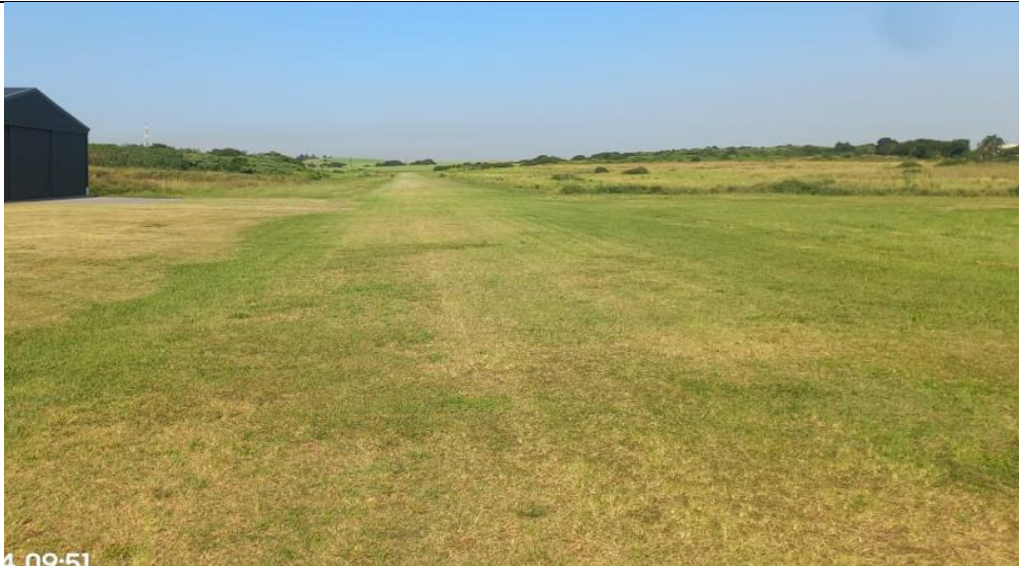
The pilot reported that the runway surface was rough and had overgrown grass. The operator who is also based at the same airfield and uses the same runway daily, sent the investigator the photo of the runway on the day of the accident and reported the following: *“the runway was impeccably maintained, ensuring a smooth path for the aircraft. The surface was flawlessly kept, and the grass on the runway was neatly trimmed to a height of 2 centimetres (cm). These measures ensured minimal obstruction to aircraft operations and met all safety standards and operational requirements”* (see Figure 2).

Figure 2: The Groutville runway surface. (Source: Operator)

8. Despite the pilot's statement regarding the unevenness of the runway and overgrown grass, it was determined that the condition of the runway (Figure 2) did not contribute to this accident and the aircraft can be operated in any condition of the runway. During the initial climb, the pilot stalled the aircraft and lost control because of the increased angle-of-attack which resulted in reduced rate of climb and speed.

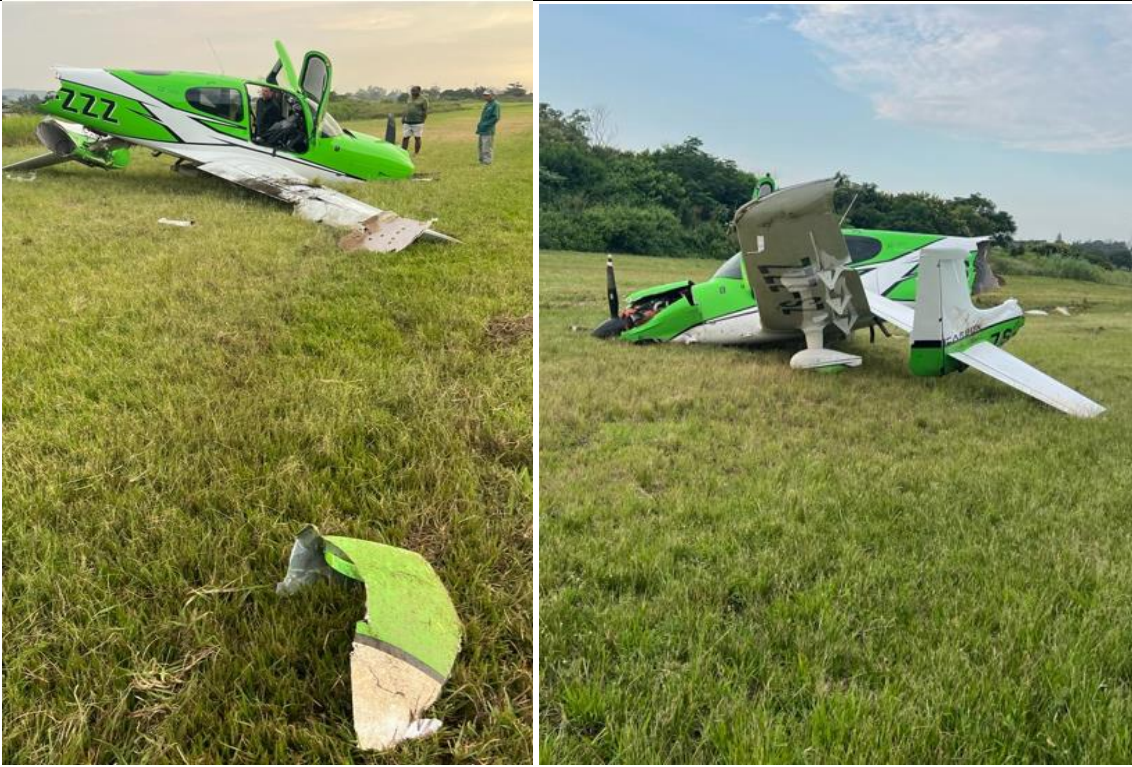
What Happened						
<p>On 2 April 2024, a pilot and three passengers on-board a Cirrus SR22 aircraft with registration ZS-ZZZ took off on a private flight from Groutville Airfield in KwaZulu-Natal province to New Tempe Airfield (FATP) in the Free State province. Visual meteorological conditions (VMC) by day prevailed at the time of the flight which was conducted under the provisions of Part 91 of the Civil Aviation Regulations (CAR) 2011 as amended.</p> <p>The pilot reported that the aircraft was refuelled with 80 litres (l) of Avgas 100LL. According to the Pilot's Operating Handbook (POH), the fuel capacity of the aircraft is 318l with 8 hours endurance under normal operation. The pilot stated that he conducted a pre-flight inspection with no anomalies found. The aircraft was lined up on Runway 05 for take-off. The runway surface was rough and covered in grass which was overgrown. The aircraft generated normal power and accelerated on the runway, thereafter, the pilot gently pulled back on the elevator control to lift off the nose wheels. The aircraft took off at a speed of 70 knots indicated airspeed (KIAS) with the flaps set at 50%. According to the POH, <i>the take-off speed for Cirrus SR22 is 80 KIAS, with the flaps set at 50% during standard operating procedures; for short-field take-offs, the indicated airspeed (KIAS) should be 78 knots with the flaps set at 50%.</i></p> <p>The pilot reported that after take-off, the stall warning activated, and the aircraft stalled due to low-speed take-off. The pilot immediately pushed the control stick forward to lower the nose and gain speed, however, the aircraft's response was sluggish due to slow speed, this was followed by the drop of the right wing. The pilot tried to correct the anomaly without success, and thus, the right wing impacted the runway surface. The pilot lost control of the aircraft; it came to a stop facing east of the runway.</p> <p>During the accident sequence, the nose landing gear collapsed, the right main landing gear separated, the engine mount separated, the propeller struck the ground, and the empennage</p>

separated from the fuselage. The aircraft was destroyed; however, the pilot and the passengers were unharmed.

Figures 3 and 4: The aircraft as it came to rest after the accident. (Source: Pilot).

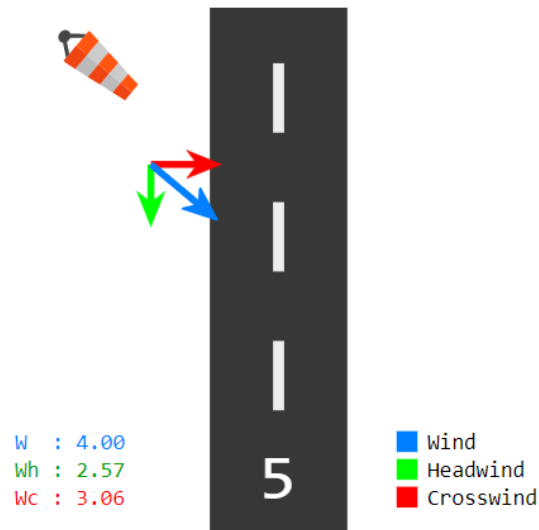
Figure 6: The crosswind component as per the weather report. (Source: <https://e6bx.com>)

- The report (above) indicates a constant wind speed and direction on the surface, this indicates absence of low-level wind shear turbulence.
- The crosswind component (which refers to the maximum crosswind velocity that an aircraft can handle during take-off and landing) for the Cirrus SR22 is 21 knots (kts).
