AIRCRAFT ACCIDENT REPORT AND EXECUTIVE SUMMARY

Reference:		CA18/2/3/10439	
Aircraft Registration	ZU-AVM	Date of Accident		12 April 2024		Time of Accident	1342Z
Type of Aircraft		Vans RV4		Type of Operation		Private (Part 94)	
Pilot-in-command Licence Type		Commercial Pilot Licence		Age	37	Licence Valid	Yes
Pilot-in-command Flying Experience		Total Flying Hours		1426.9		Hours on Type	106.5
Last Point of Departure		Tedderfield Aerodrome (FATA), Gauteng Province					
Next Point of Intended Landing		Brakpan Airfield (FABB), Gauteng Province					
Damage to Aircraft		Substantial					
Location of the accident site with reference to easily defined geographical points (GPS readings if possible)							
At Tedderfield Aerodrome (FATA) near a hangar							
Meteorological Information		Wind direction: 300°; Wind speed: 04kt; Visibility: 9999m; Temperature: 20°C; Cloud cover: Scattered					
Number of People On-board	1+1	Number of People Injured	1	Number of People Killed	0	Other (On Ground)	0

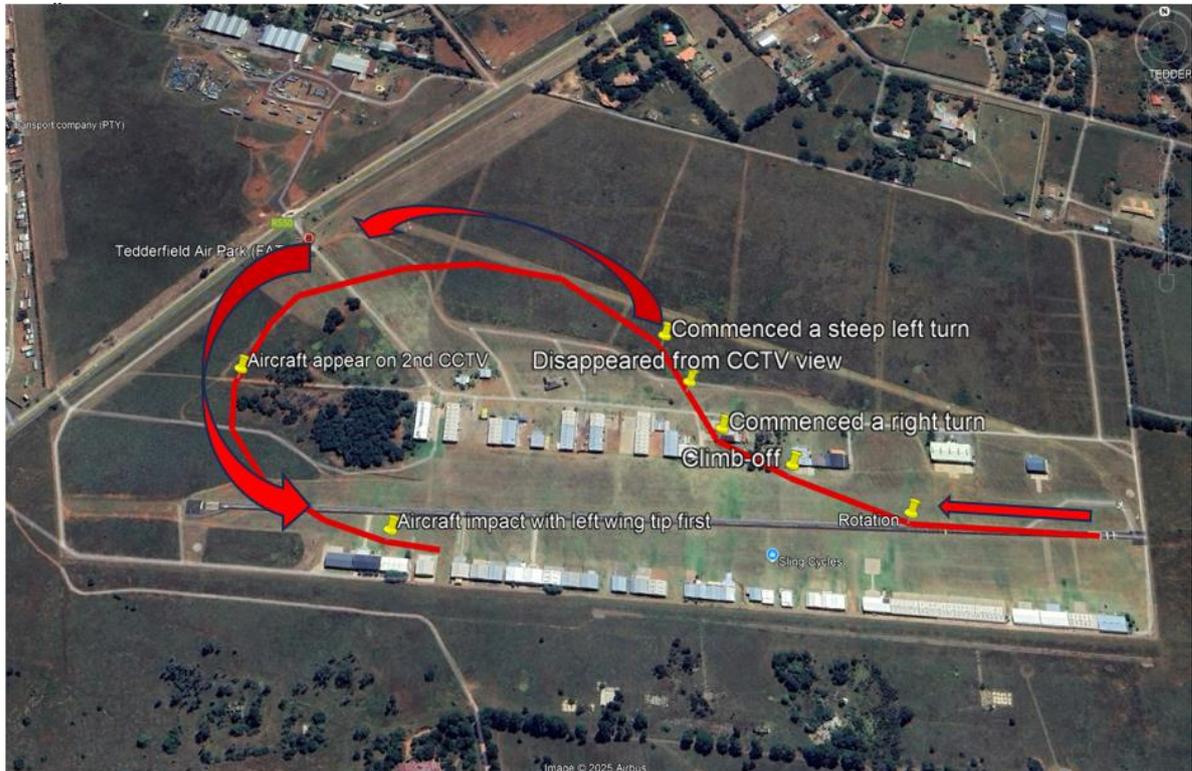
Figure 1: Plotting of the aircraft's take-off and flight path. (Source: Goole Earth Map)

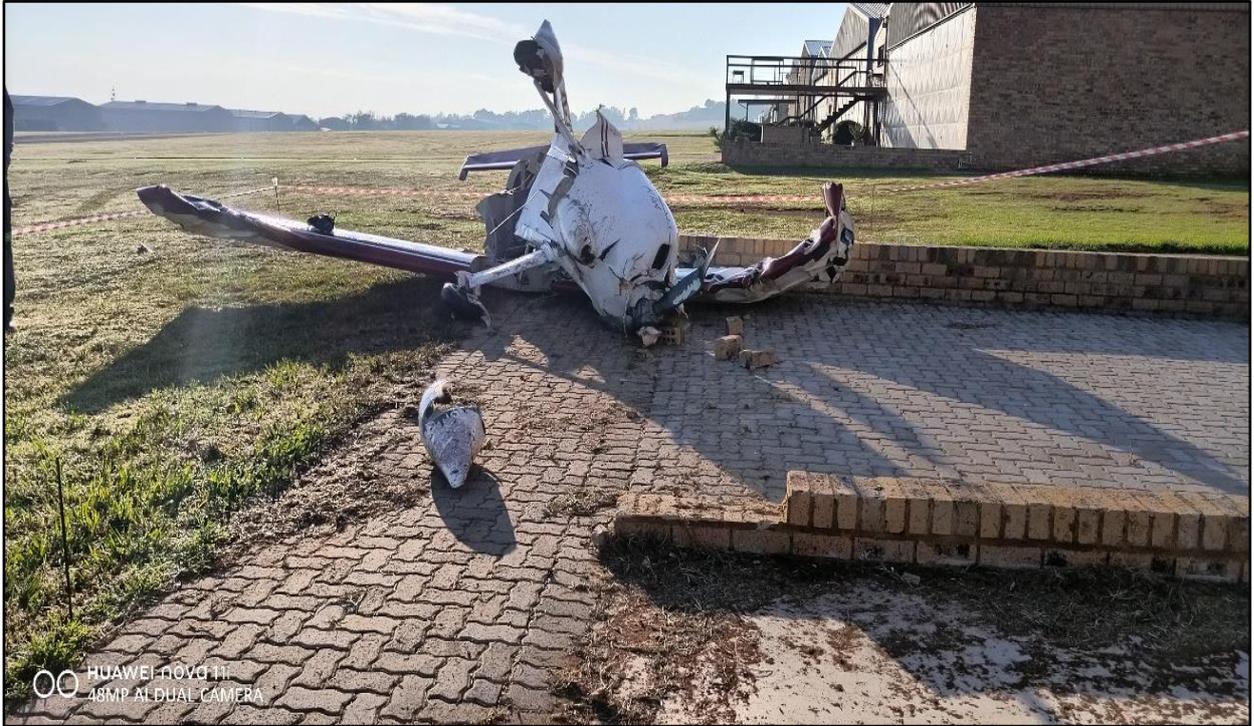
1.3.1 The aircraft was substantially damaged during the accident sequence. After the accident, the pilot's cockpit section was cut to rescue the flight instructor as he was trapped inside.

Figure 2: The aircraft after the accident.

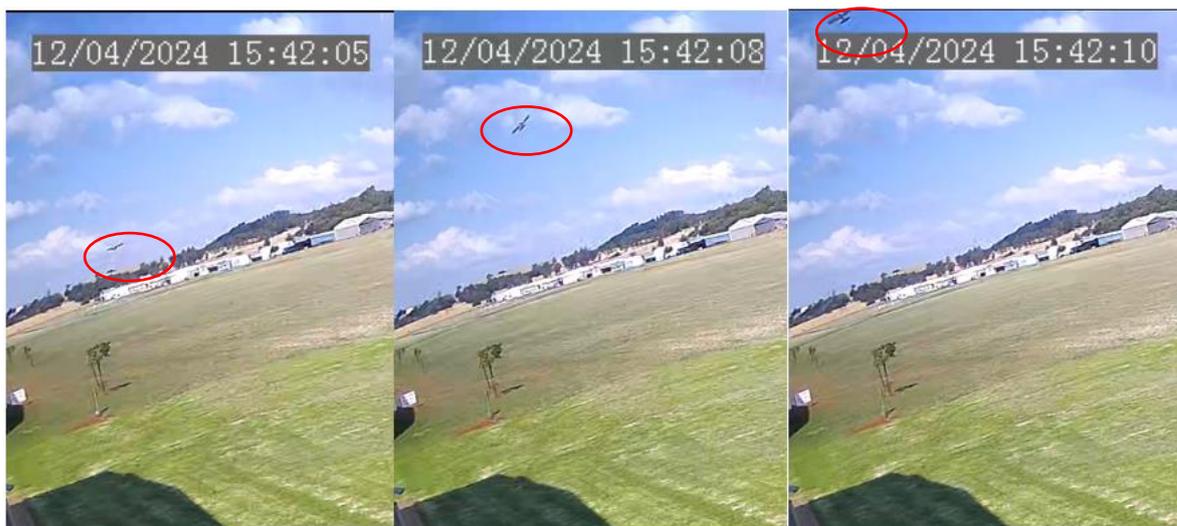
Figure 3: A snapshot of the first CCTV footage showing the aircraft's take-off.
(Source: Aerodrome manager)

- Figure 3 shows the take-off sequence of the aircraft as it appeared on the first CCTV age. The aircraft climbed and made a right turn before it disappeared from the view.

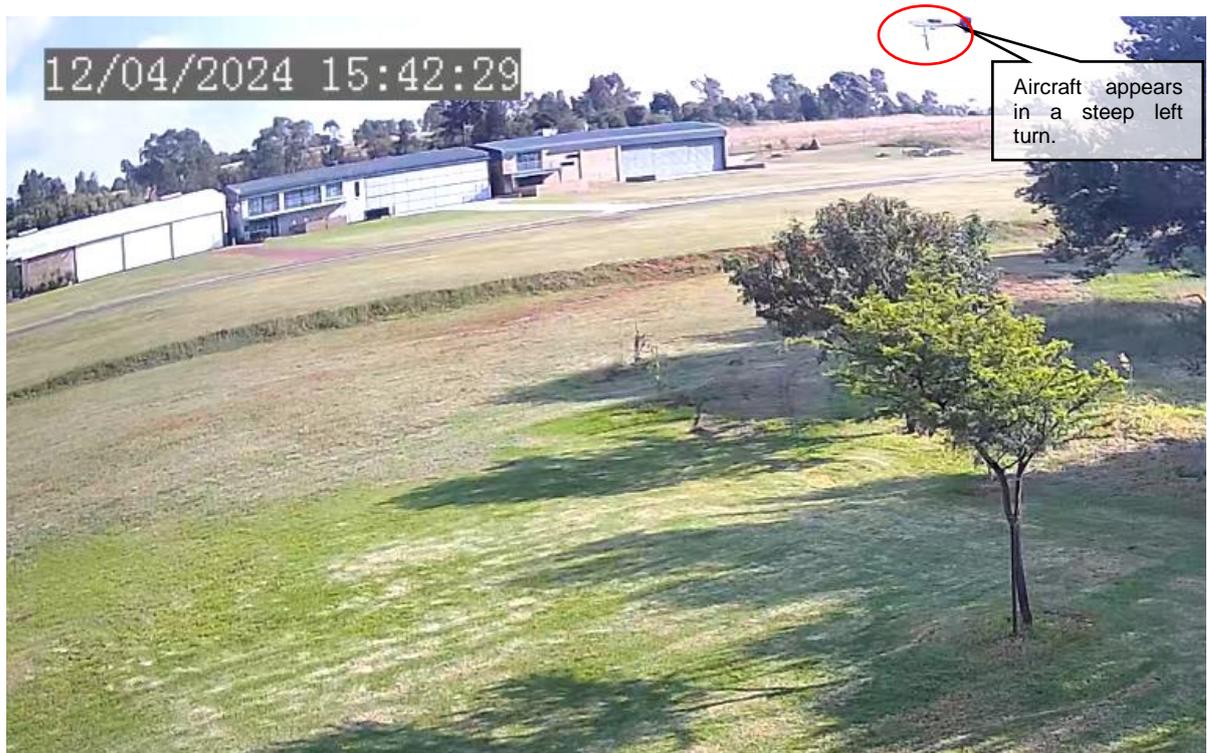
- Figure 4 shows the second CCTV footage depicting the aircraft as it appeared whilst in a steep left turn and with the left-wing low. The aircraft appeared to be losing height rapidly.

Figure 4: The snapshot of the aircraft as it appears on the second CCTV making a steep left turn.

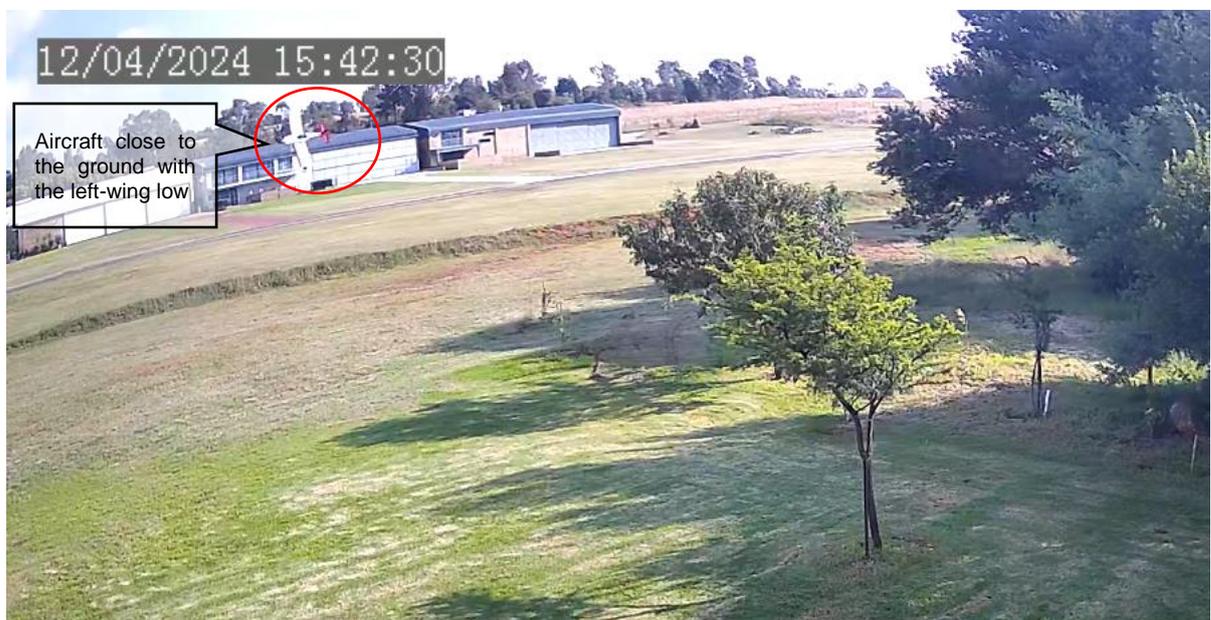
Figure 5: The snapshot of the aircraft before impact. (Source: Aerodrome manager)

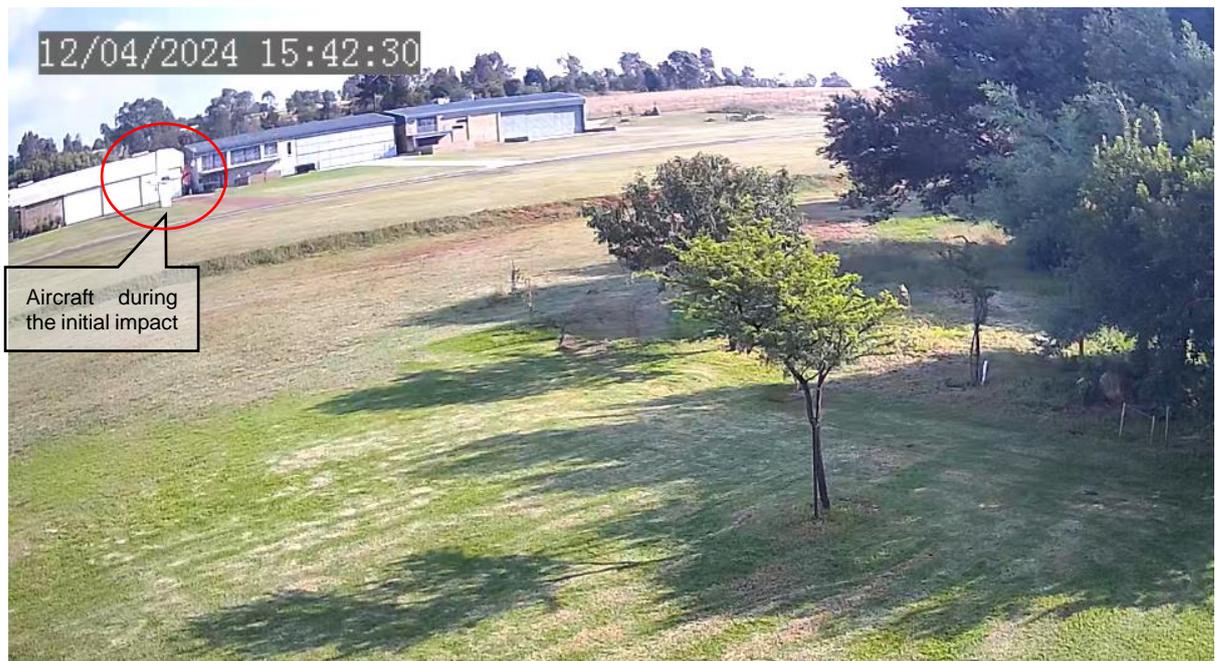
- The aircraft initially impacted a paved surface with its left-wing tip (outer part) as it was in a left-wing low and a slightly nose-down attitude. After impact, the aircraft

tumbled forward which caused the nose section to lower towards the ground; hence, the propeller and the nose impacted the ground.

Figure 6: The aircraft as it impacts the ground with its left wing (snapshot footage).
(Source: Aerodrome manager)

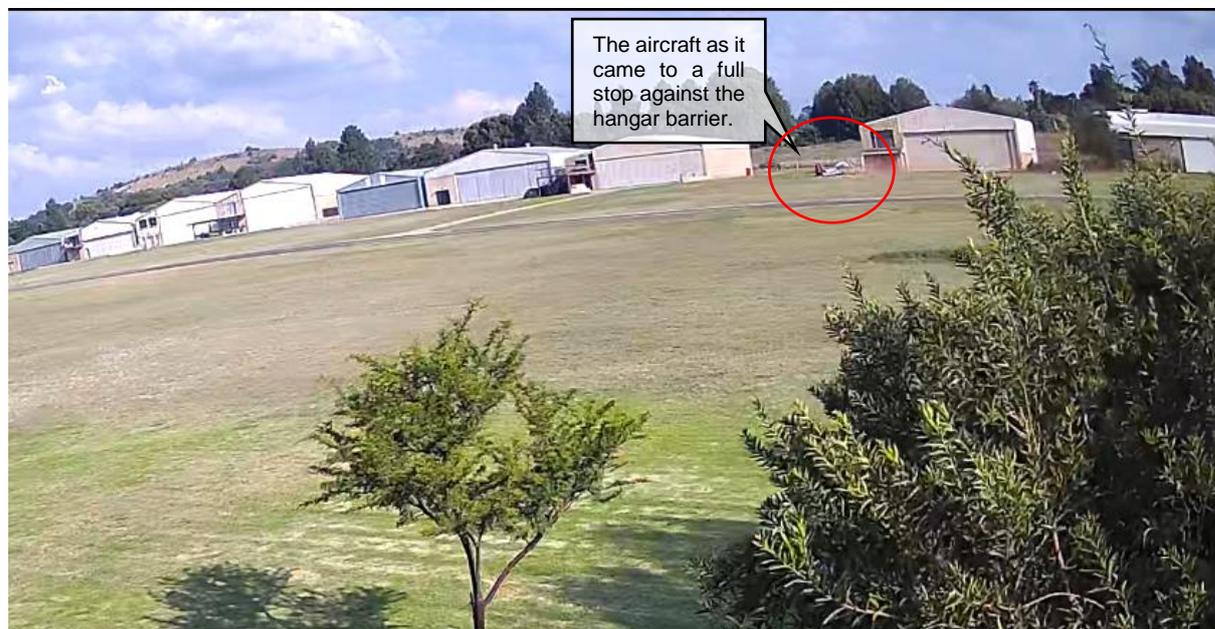
Figure 7: The aircraft came to a stop against the hangar barrier (wall), facing the opposite direction of approach (snapshot footage). (Source: Aerodrome manager)

- After the tumble, the aircraft's tail swivelled forward which caused the aircraft to face the opposite direction of approach; it skidded on the ground before it rested against the hangar's barrier (wall).

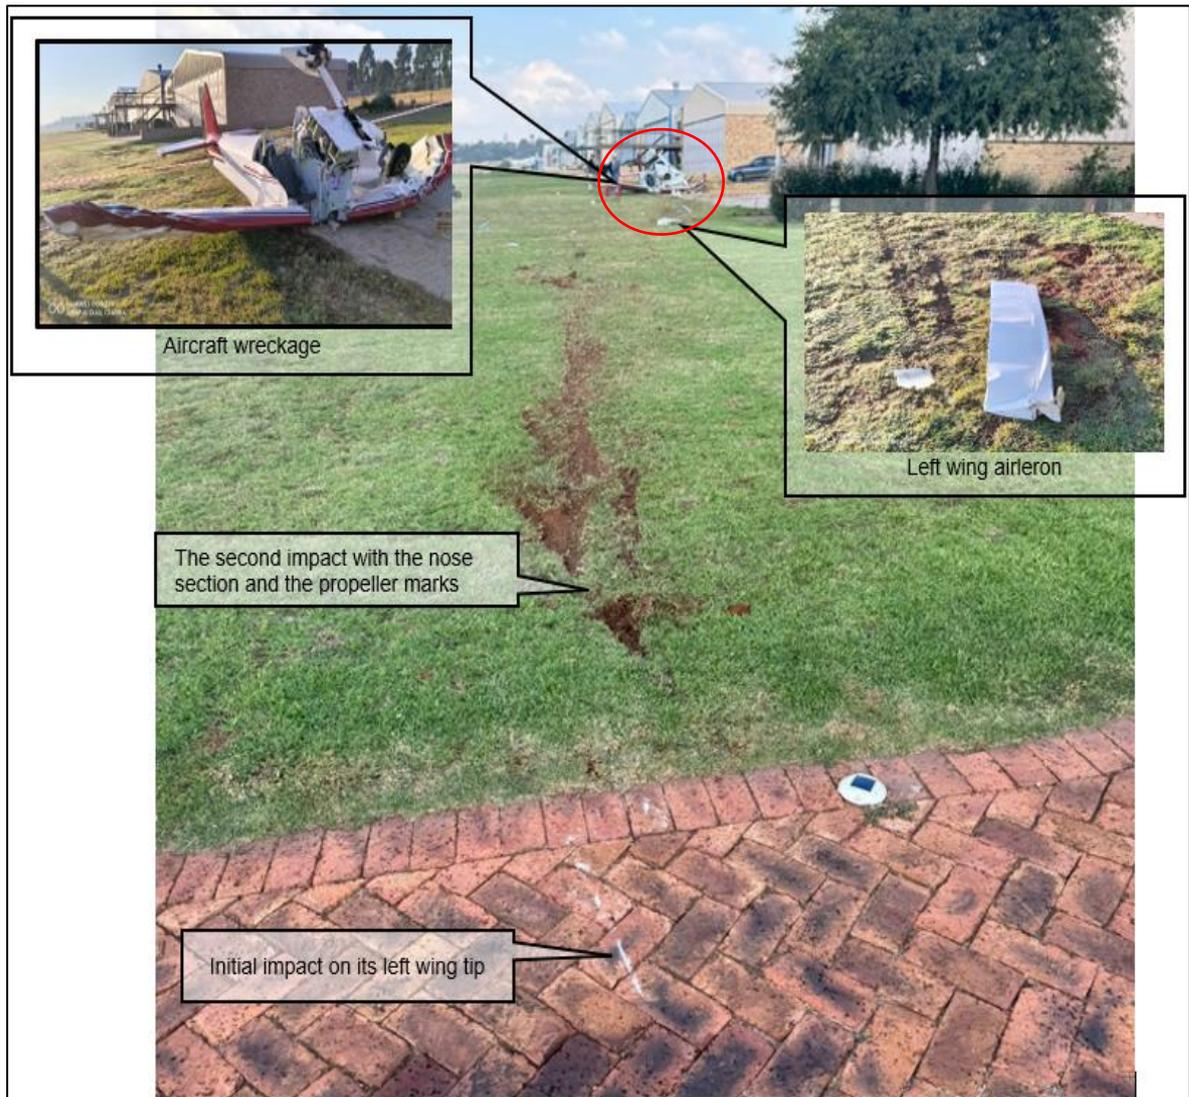
Figure 8: Wreckage distribution and impact marks.

- The impact marks (Figure 8) show that the aircraft initially contacted the paved area lightly with its left-wing tip and it wrinkled due to the aircraft’s weight as it continued to move forward. The aircraft then tumbled which caused the nose to lower towards the ground, whereafter the propeller impacted the ground three times. This trail of propeller marks showed that the aircraft’s engine was running (had power) at the time of impact.

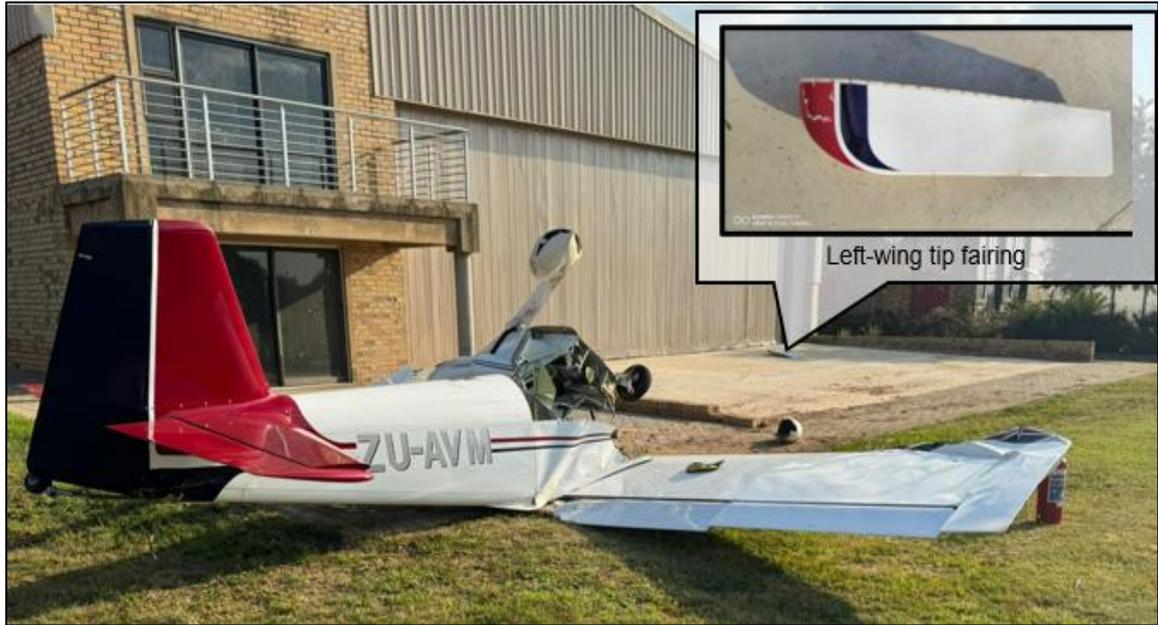
Figure 9: The wreckage after the flight instructor was rescued.

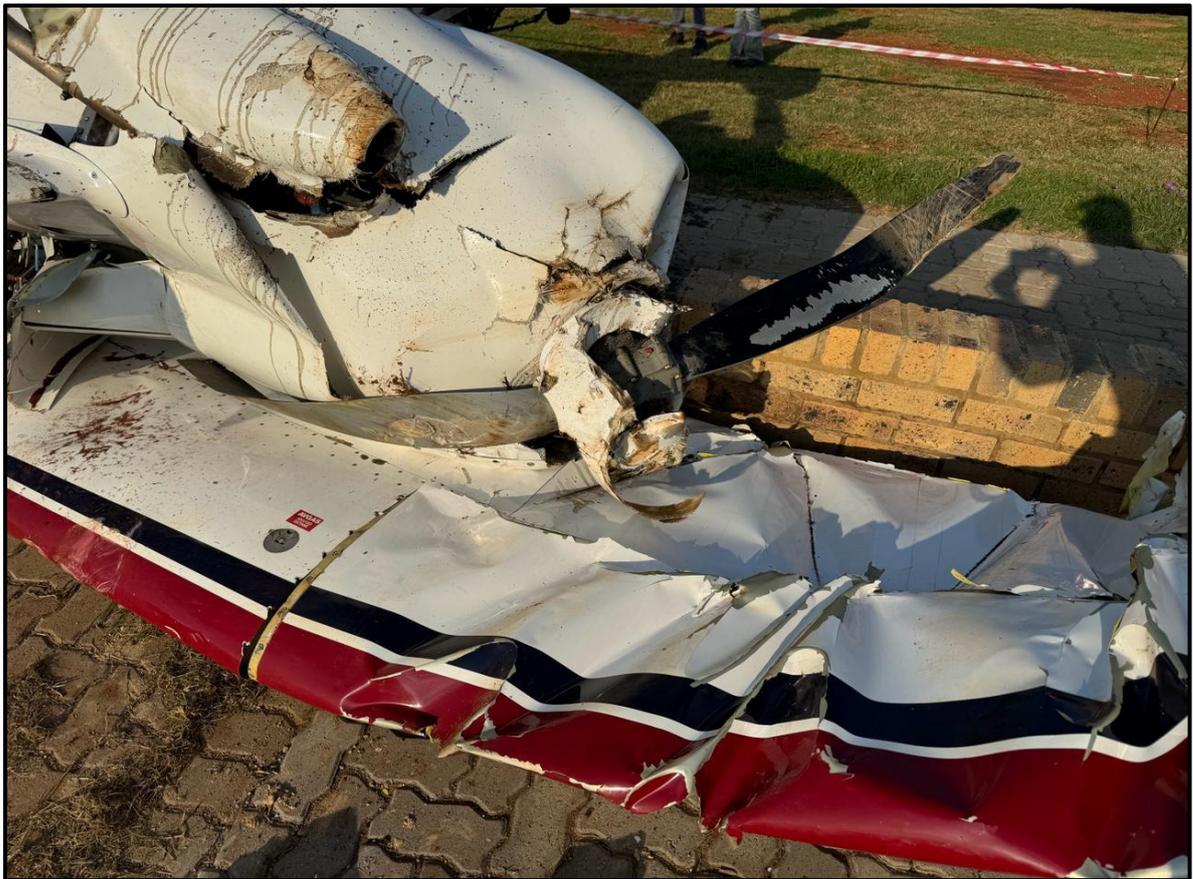
1.12.2 The right wing sustained damage to the leading edge, but it remained fairly intact. The wing tanks were intact; however, the fuel transfer pipelines were severed during the accident sequence which led to fuel leak. The propeller blade had signs of impact damage as they were turning with rotational energy at the time of the accident. The cockpit section was cut during rescue of the flight instructor. Both wings sustained substantial damage; extensive damage on the left wing was due to wrinkling. Both ailerons, flap and the wing-tip fairing separated during the accident sequence.

Figure 10: Damage on the propeller and left wing.
