LIMITED OCCURRENCE INVESTIGATION REPORT – FINAL

Reference Number	CA18/2/3/10440						
Classification	Accident	Date	26 March 2024	Time	0645Z		
Type of Operation	Training (Part 141)						
Location							
Place of Departure	Grand Central Aerodrome (FAGC), Gauteng Province		Place of Intended Landing	Grand Central Aerodrome (FAGC), Gauteng Province			
Place of Occurrence	Runway 35 at Grand Central Aerodrome (FAGC), Gauteng Province						
GPS Co-ordinates	Latitude	25° 58'55.88" S	Longitude	028° 08'16.41" E	Elevation	5 268 ft	
Aircraft Information							
Registration	ZS-IOI						
Make; Model; S/N	Cessna 172L (Serial Number: 172-60301)						
Damage to Aircraft	Substantial		Total Aircraft Hours	15 521.80			
Pilot-in-command							
Licence Type	Student Pilot Licence (SPL)		Gender	Female		Age	18
Licence Valid	Yes	Total Hours	21.3		Total Hours on Type	21.3	
Total Hours 30 Days	8.5		Total Flying on Type Past 90 Days	11.5			
People on-board	1+0	Injuries	0	Fatalities	0	Other (on ground)	0

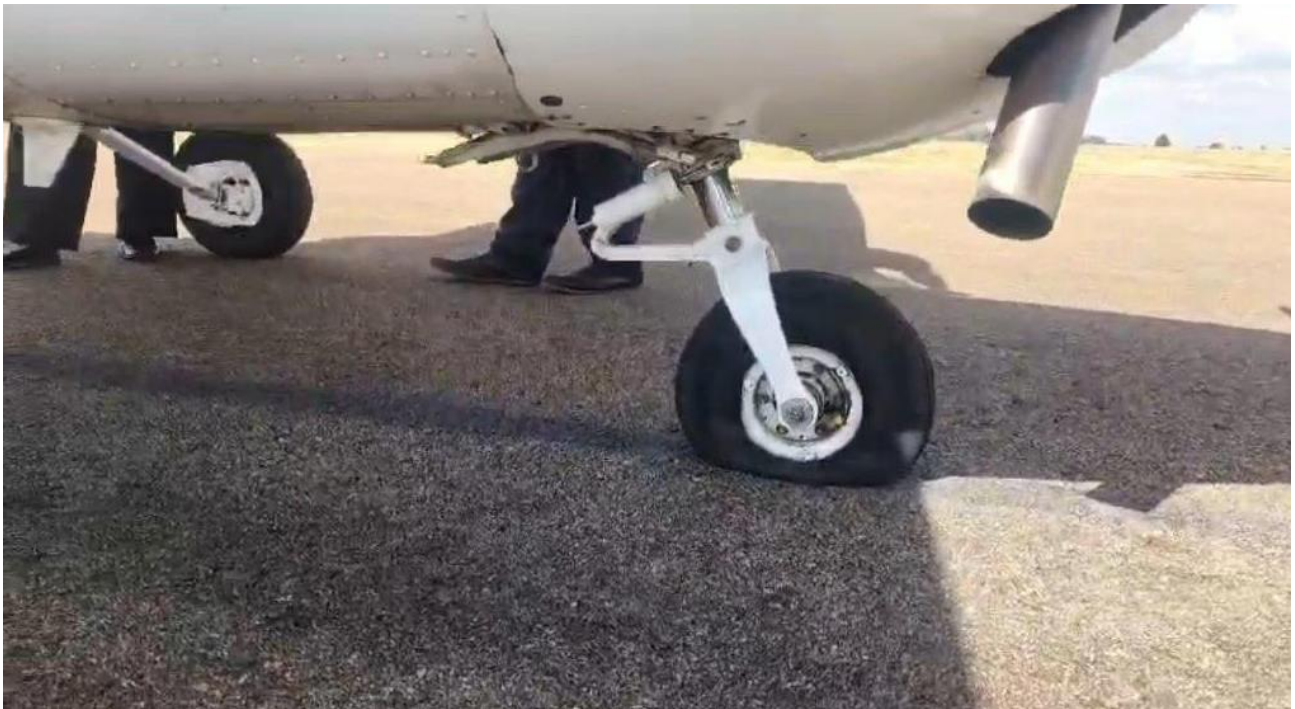
The student pilot was not injured. The aircraft sustained damage to the nose wheel and the firewall.

Figure 1: The deflated nose wheel. (Source: Operator)

The aircraft was incorrectly configured for landing, which was exacerbated by the aircraft that was flared too high. As a result, the aircraft touched down hard with its nose wheel and bounced; this caused damage to the nose gear.

Pilots should immediately initiate a go-around if they realise that their approach is unstable. This is a proven risk mitigation strategy to avoid a hard landing which could potentially cause damage to the aircraft and/or lead to injury to the people on-board the aircraft.
